Summary of Results

Walk the WBID Exercise for Philippi Creek (WBID1937)

FINAL DRAFT

September 27, 2017

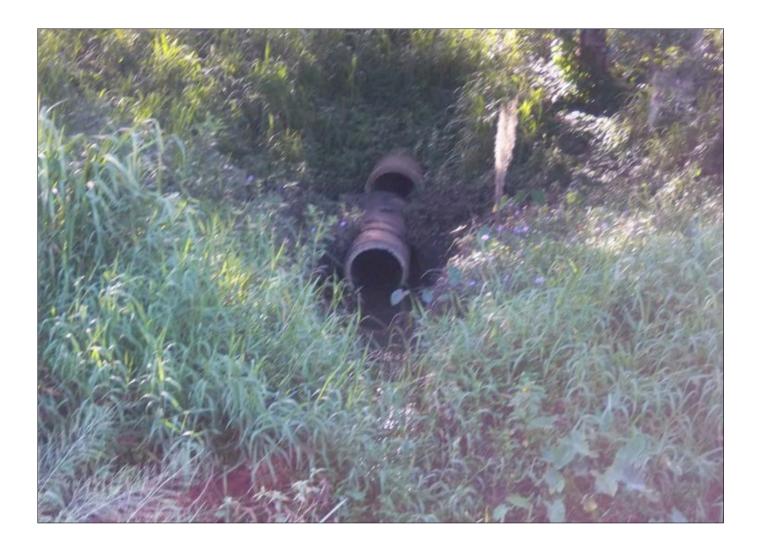
Inspector(s):	Date:	Photo Location	Photo Direction
M.Holland/R.Wells/J. Pate	8/26/2016	Phillippi Creek	NE

Comments: The second outfall on Amherst Street (the one to the north). Stormwater runoff from the same apartment complex. Lat/Long is 27.3401/82.4944. The piping system in to the creek is failing, as the pipe is now in 2 sections. There is erosion under these pipes from stormwater flow, which stirs up sediment from the ditch bottom and moves it down stream.

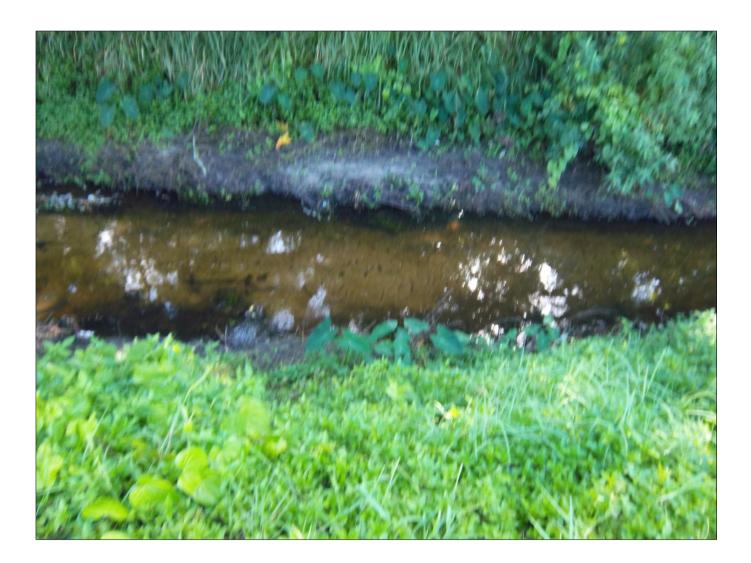
Inspector(s):	Date:	Photo Location	Photo Direction		
M. Holland	8/26/2016	Midwest south of Fruitville	East		
Comments: (g)4-37.3 Canal just south of Fruitville Rd. Water was clear but tannic, flowing south (left to right). The					
canal is heavily vegetated and the bottom was sandy. There were not odors coming from the canal or water.

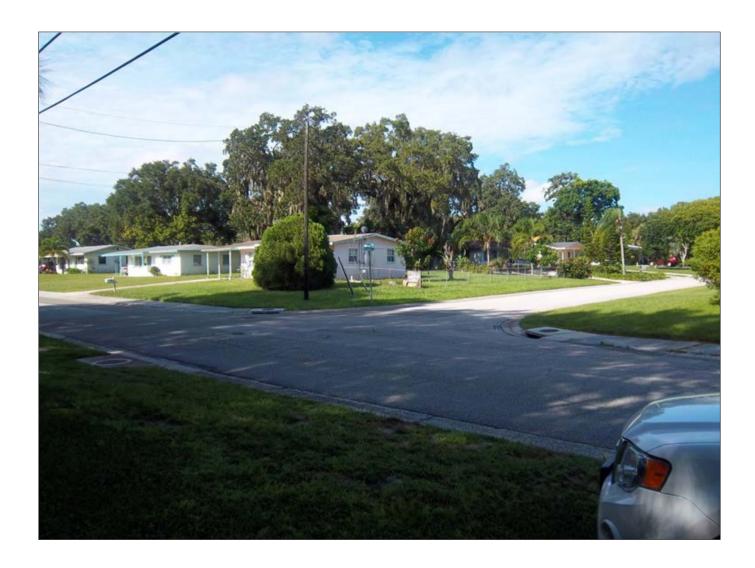
Inspector(s):	Date:	Photo Location	Photo Direction
M. Holland	8/26/2016	Same as Above	SW

Comments: (h) Showing the intersection of Midwest Pkwy and Wolverine as mentioned above. This neighborhood is on City Sewer. Homes in this area are moderate income type homes and vary in condition.

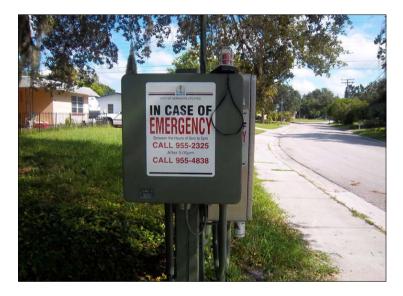
Inspector(s):	Date:	Photo Location	Photo Direction
M. Holland	8/26/2016	Midwest Pkwy and Davis	South
Comments: (i) Showing the City Lit	ft station at the co	rner. Site was secure. This station has	no history of overflows.

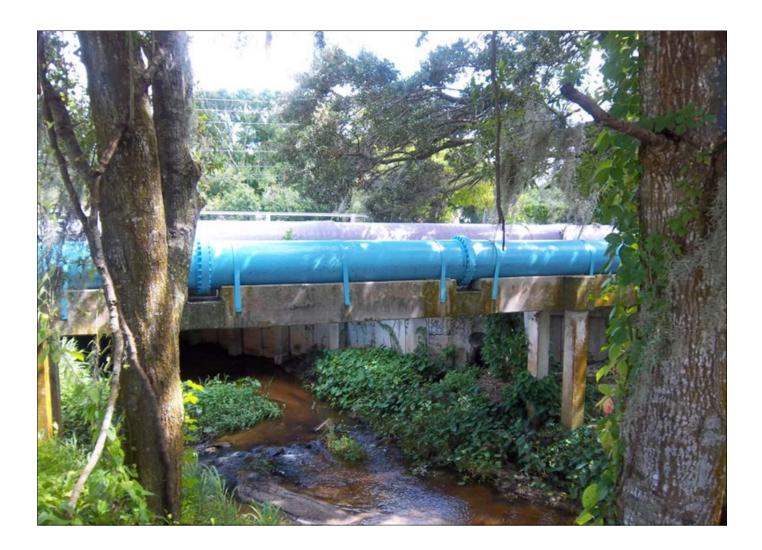
Inspector(s):	Date:	Photo Location	Photo Direction		
M. Holland	8/26/2016	Circus Blvd and 17th Street	NE		
Comments: (m)Showing Sewer an	d Reclaimed water	r lines for the City. Pipes appeared in ۽	good condition with no		
leaks. This pipe passes over the ca	nal just south of 1	7th Street and East of Circus Blvd.

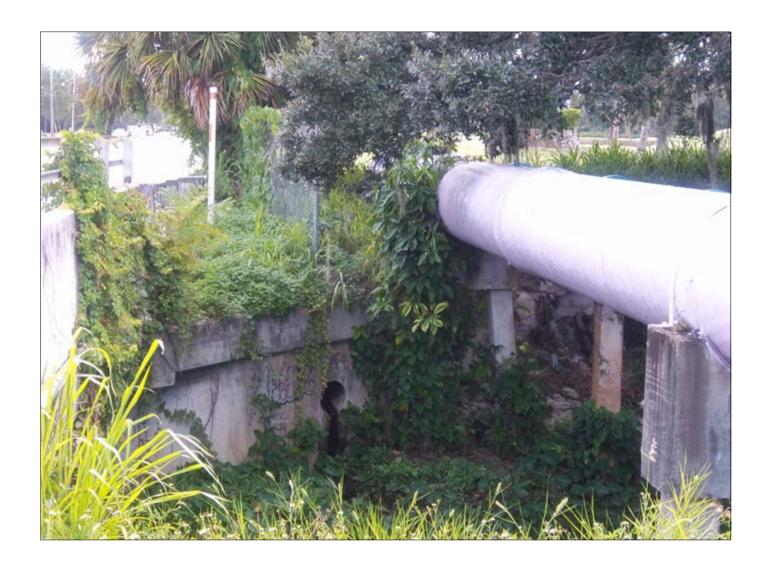
Inspector(s):	Date:	Photo Location	Photo Direction
M. Holland	8/26/2016	Same as Above	East
Comments: (m)Showing the lines a	as the cross 4-14. I	No apparent issues. 17th Street is to the	he left.

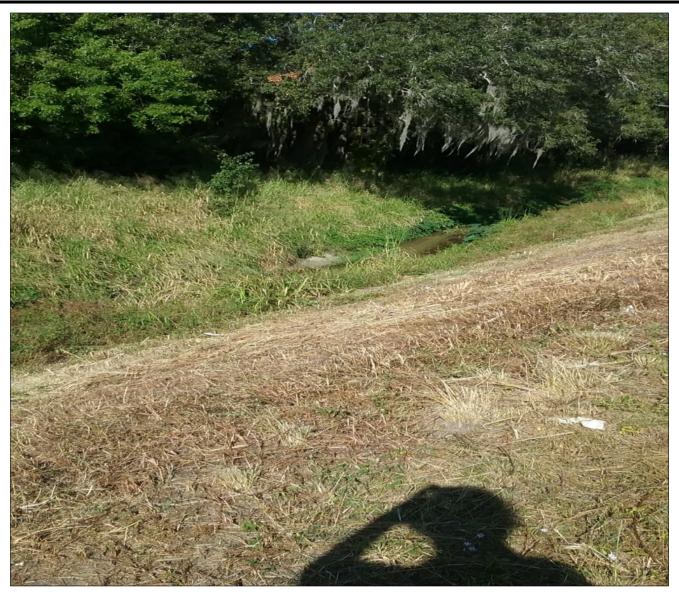
Inspector(s):	Date:	Photo Location	Photo Direction
A. Melton, J. Talbott, M. Holland	11/10/2016	West of Fruitville and Beneva	NW

Comments: (#1) Sample site is upstream of the regularly sampled site (noted by the red star in the narrative), about 100 yards. This site has the highest bacteria count on average for 2006-2016. There are homeless emcampments along the creek in a couple locations.

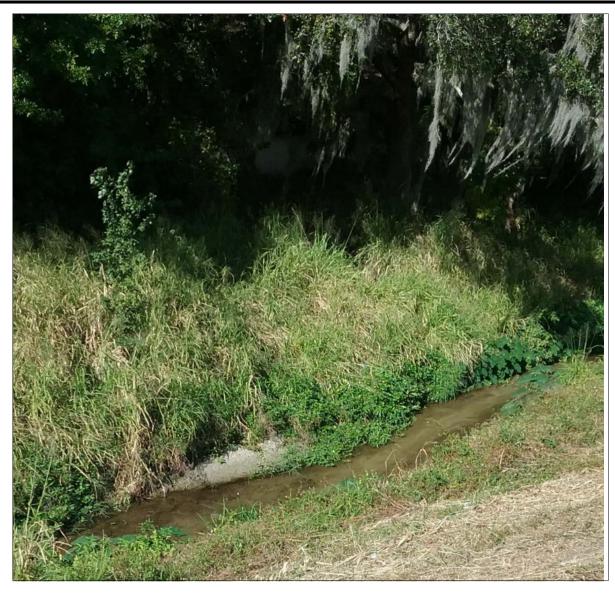
Inspector(s):	Date:	Photo Location	Photo Direction
A. Melton, J. Talbott, M. Holland	11/10/2016	Same as above	NW

Comments: (#1)Showing overall site conditions. Banks were heavily vegetated on the West side, right side had been recently maintained. Water depths varied from just a couple inches to 10 or 12 inches. Bottom sediment was sandy, ditch was flowing. Wildlife tracks in the bottom of the ditch (raccoon and bird).

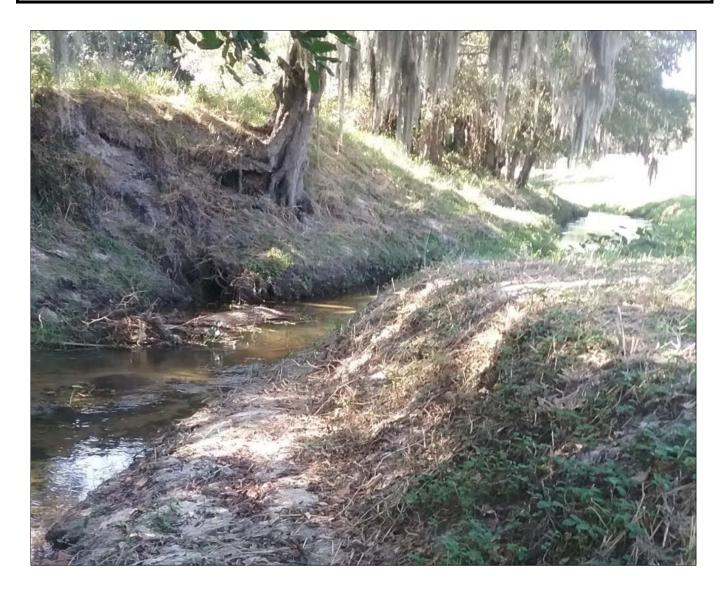
Inspector(s):	Date:	Photo Location	Photo Direction
A. Melton, J. Talbott, M. Holland	11/10/2016	N of Main B - Fruitville	South

Comments: (#3)Showing general conditions downstream of the sample site. Vegetation is present, but minimal. Lots of erosion and sediment depostion in the canal bottom during larger storm events. Water flows south (left to right). Area is adjacent to Circus Blvd.

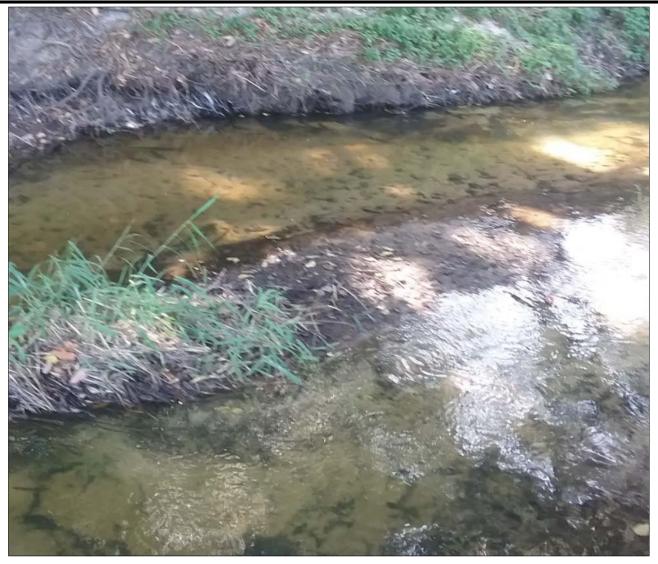
Inspector(s):	Date:	Photo Location	Photo Direction
A. Melton, J. Talbott, M. Holland	11/10/2016	Same as above	SE

Comments: (#3). Showing the bottom sediments. Sandy with little organic matter. Large(ish) fish seen upstream. Additional sampling done here today. Also adjacent to Circus Blvd. Sarasota County Inspection/Investigation Report - Fruitville Rd and Circus Blvd.

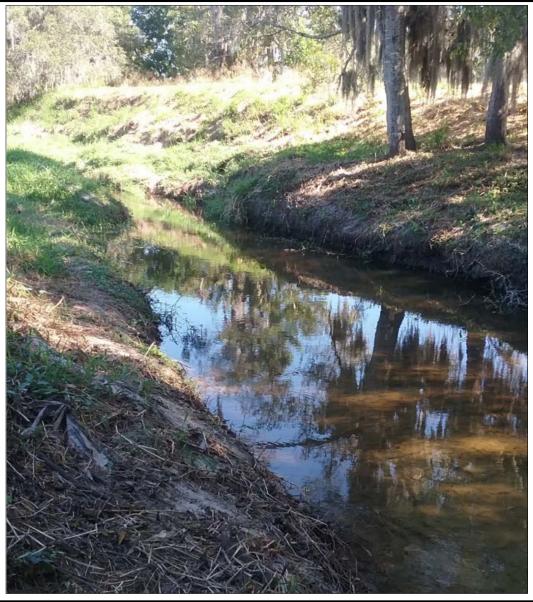
Inspector(s):	Date:	Photo Location	Photo Direction
A. Melton, J. Talbott, M. Holland	11/10/2016	Same as Above	NW

Showing conditions upstream of the sampling site. Overall canal has canopy cover and steeply eroding sides in most areas. Evidence of wildlife in the ditch - tracks but no scat seen. Adjacent to Circus Blvd.

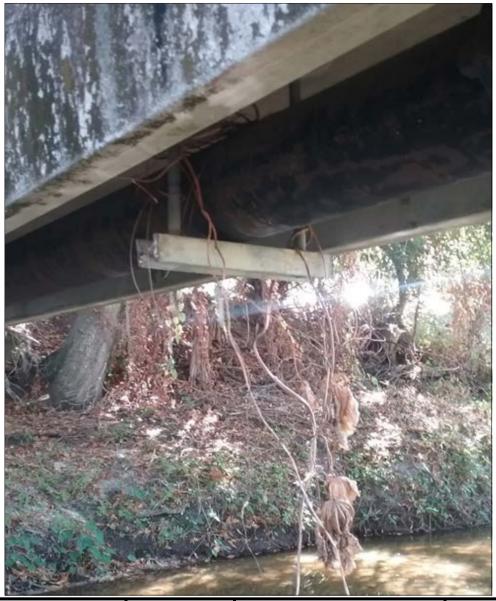
Inspector(s):	Date:	Photo Location	Photo Direction
A. Melton, J. Talbott, M. Holland	11/10/2016	Pipe for Lift Station	SE

Comments: (#4) Bobby Jones Golf Course (owned by the City of Sarasota) has its own lift station. Showing the connection between the lift station at Bobby Jones Golf Course to the rest of the City of Sarasota's sewer system. The Lift station was inspected previously with City Staff. No obvious signs of leaks in the pipe. The pipe is covered with a concrete sleeve on the top, but the bottom is exposed.

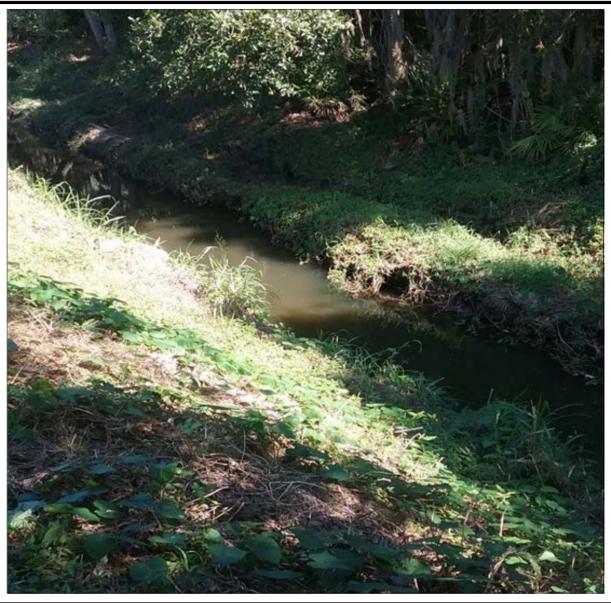
Inspector(s):	Date:	Photo Location	Photo Direction
A. Melton, J. Talbott, M. Holland	11/10/2016	N of Bobby Jones Entrance	North

Comments: (#4)Showing the overall condition upstream of the sample site. Canopy coverage is nearly 100%. Vegetation on the shore appears maintained. There was no aquatic vegetation. Water is a little cloudy, light brown in color.

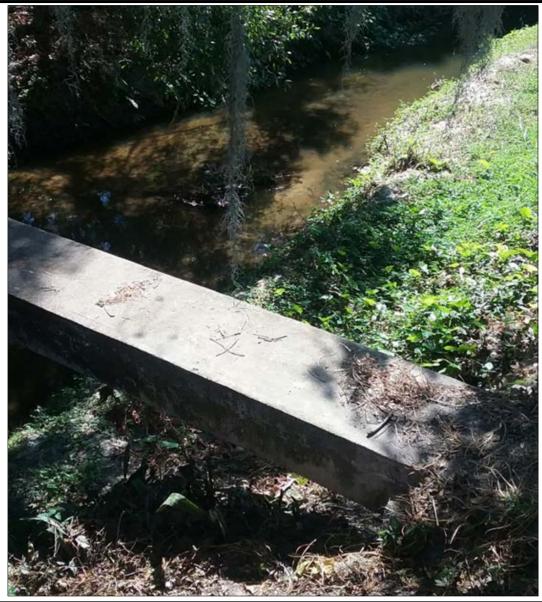
Inspector(s):	Date:	Photo Location	Photo Direction
A. Melton, J. Talbott, M. Holland	11/10/2016	Same as above	SE

Comments: (#4). Showing the concrete cover of the pipe and the surrounding conditions. No obvious signs of leaking from the pipe (smell, overgrown vegetation, stains on the pipe). Appears to be a good location for nesting/denning for animals under the pipe and a bit upstream under a palmetto.

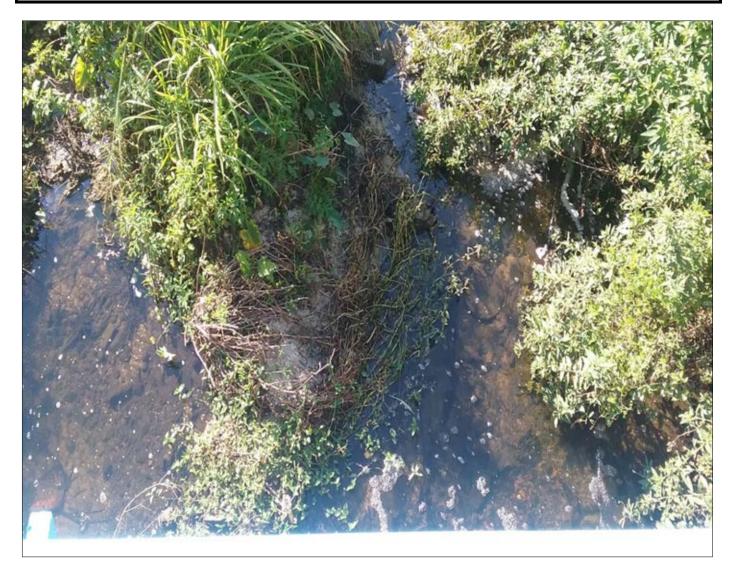
Inspector(s):	Date:	Photo Location	Photo Direction
A.Melton/M.Holland	11/16/2016	Davis Blvd.	South

Comments: (*1)Showing canal bottom about 20ft down from the bottom of the bridge at Davis Blvd. Water was flowing, bottom was rocky. Sample was taken here, at the downstream (south) side of the bridge. We are about 1,400 ft upstream from Woodview Dr, a documented hot spot for bacteria.

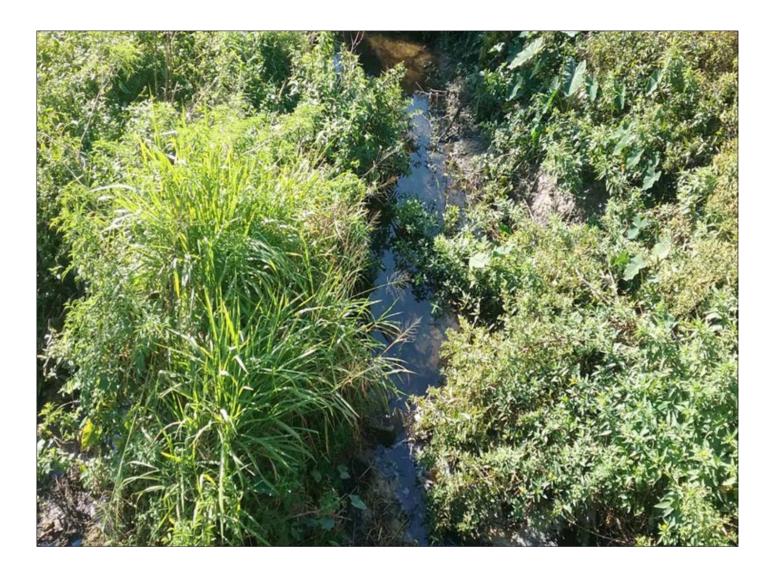
Inspector(s):	Date:	Photo Location	Photo Direction
A.Melton/M.Holland	11/16/2016	Same as above	South

Comments: (#1*) Showing downstream conditions. Slopes are very steep and covered in vegetation. Areas further downstream are eroded and somewhat unstable, with evidence of sloughing in.

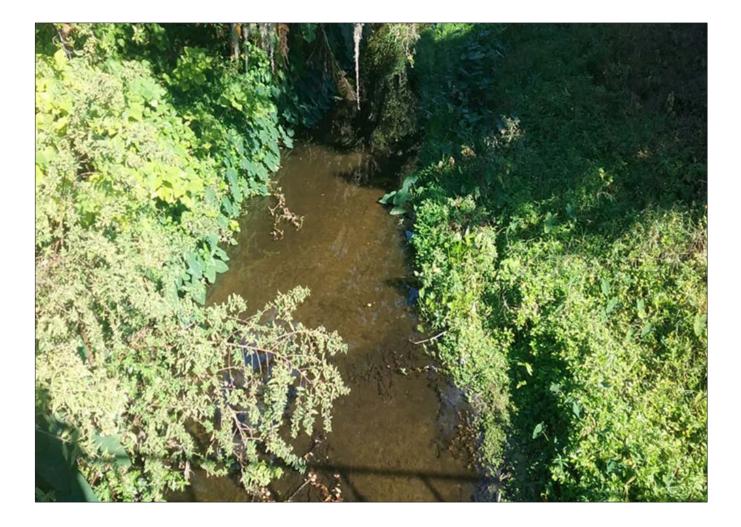
Inspector(s):	Date:	Photo Location	Photo Direction
A.Melton/M.Holland	11/16/2016	N of Davis Blvd	North

Comments:(#1*)Looking upstream of the sample site. Slopes are steep and heavily vegetated. Canal upstream is mostly shaded. Residental and roadway runoff are conveyed to this canal both upstream and downstream of the sample site. Canal bottom is a mix of sand and decaying matter (mucky). There was a feral cat in the area at the time of sampling. This area is serviced by the City of Sarasota sewer system.

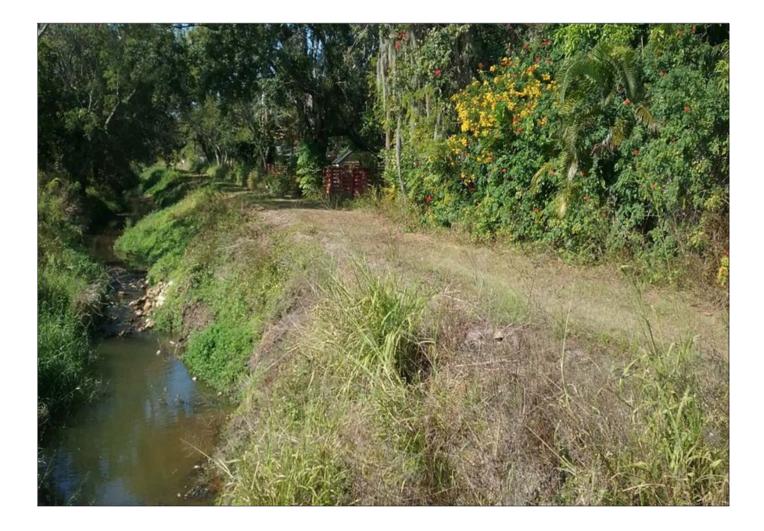
Inspector(s):	Date:	Photo Location	Photo Direction
A.Melton/M.Holland	11/16/2016	Same as above	West

Comments:(#1*) Showing residental on the north side of the canal upstream of the sample sight. Potential for sheet flow into the canal. We could hear dogs barking throughout the neighborhood. Strong smell of feces in the area, but none seen. This area is not a planned septic replacement area.

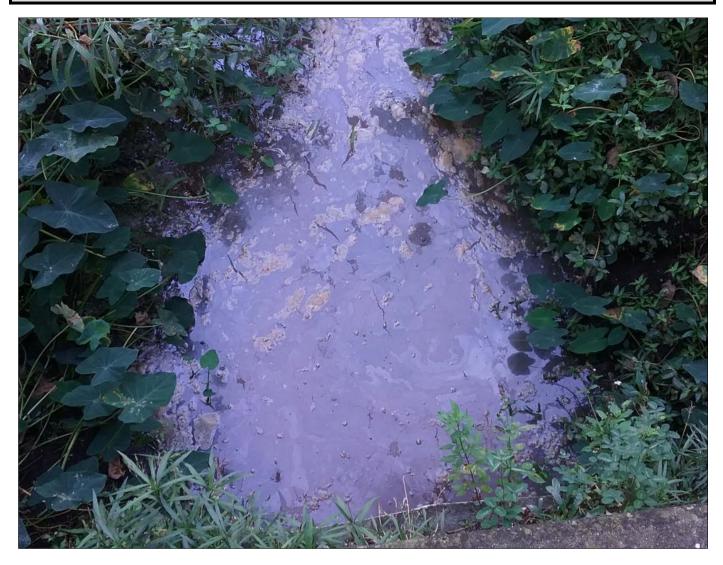
Inspector(s):	Date:	Photo Location	Photo Direction		
A. Melton, M. Holland	11/29/2016	West side of S. Shade	North		
Comments: Showing the cloudy w	ater as it comes ou	ut of the pipe. Water is comin	g in from the south. Film and		
bubbles on the surface, odor is that	at of rust. Sample v	was taken at this point.

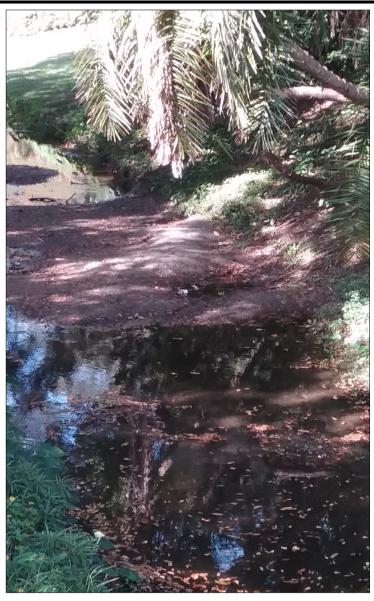
Inspector(s):	Date:	Photo Location	Photo Direction
A. Melton/M.Holland	11/29/2016	Same as Above	West

Comments: Showing the sand bar, where in in the past, many birds have been seen foraging. There is a patch of bare ground below the palms that appears to be worn bare by frequent animal activities, and there is a worn path from the palm up the slope. Additionally, as seen in the photograph, there is a lot of leaf litter that collectes in this area.

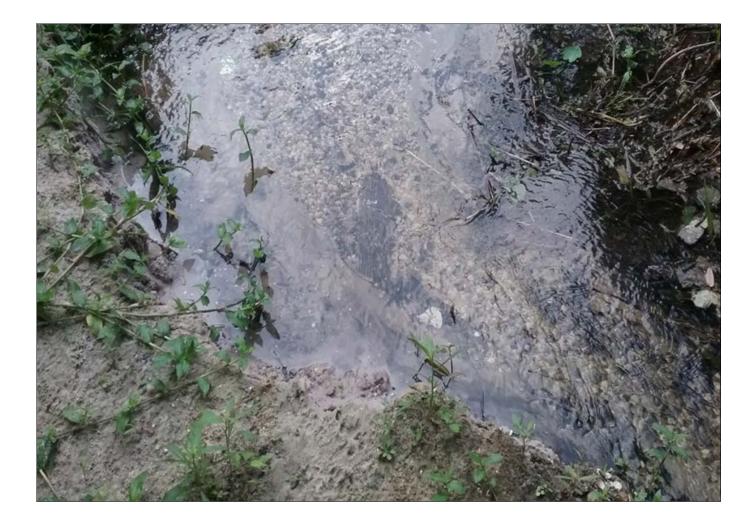
Inspector(s):	Date:	Photo Location	Photo Direction
K.O'Hara/M.Holland	12/15/2016	Same as above	Ν

Comments: Showing typical animal crossing under the bridge. Water here was clear and flowing. The water had a musty odor to it, similar to areas where there is low flow and decaying vegetation. There were a lot of opened bivalves on the sand bar.

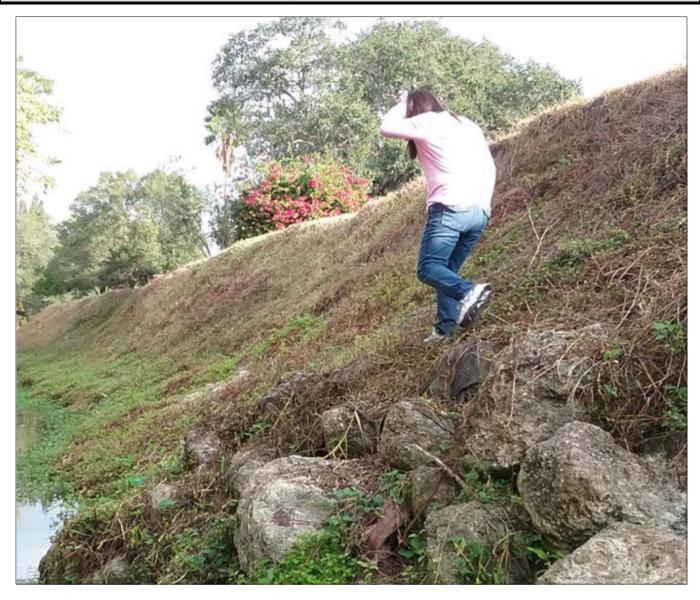
Inspector(s):	Date:	Photo Location	Photo Direction
K.O'Hara/M.Holland	12/15/2016	Upstream of the Bridge	NE

Comments: Showing Kate walking north along the Phillippi Lateral. She found no evidence of dog walking (pet waste) along the top of bank.

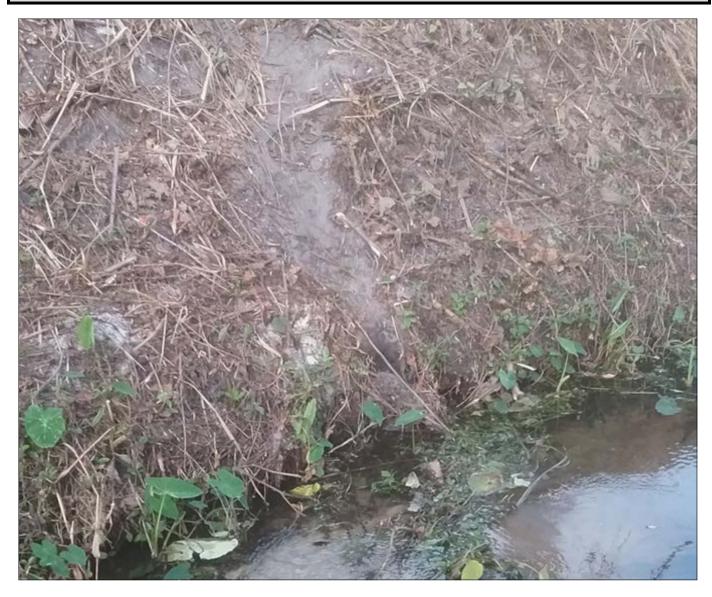
Inspector(s):	Date:	Photo Location	Photo Direction
K.O'Hara/M.Holland	12/15/2016	Same as above	West

Comments: Showing a well worn animal trail to the canal. On the west side of the canal, just upstream of the outfall for the above pond.

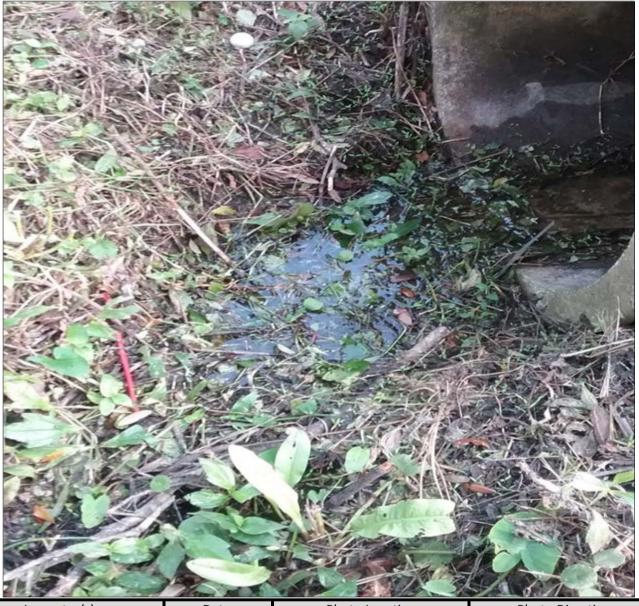
Inspector(s):	Date:	Photo Location	Photo Direction
K.O'Hara/M.Holland	12/15/2016	Outfall of P4-40	N/A

Comment: Outfall of P4-40. Some discharge from the pipe. It is not stormwater but groundwater infiltration. No smell to the water or the pipe.

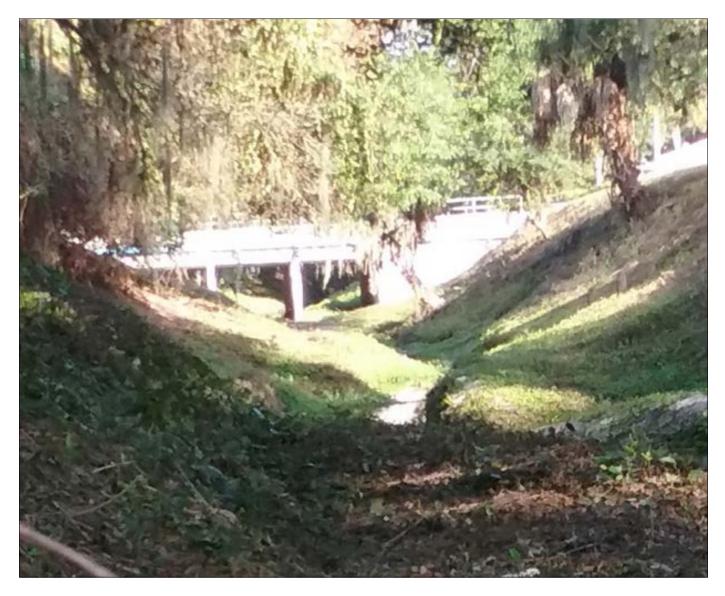
Inspector(s):	Date:	Photo Location	Photo Direction
K.O'Hara/M.Holland	12/15/2016	Bridge at Davis Blvd	North

Comments: Showing east and west banks of the canal. Recently cleared of vegetation. No pipes or potential point discharges were noted along this portion of the canal. Additionally, it appears that properties on the east side (right) of the canal have been graded to drain to the streets, not to the canal. This is not the case for some properties on the west side (left).

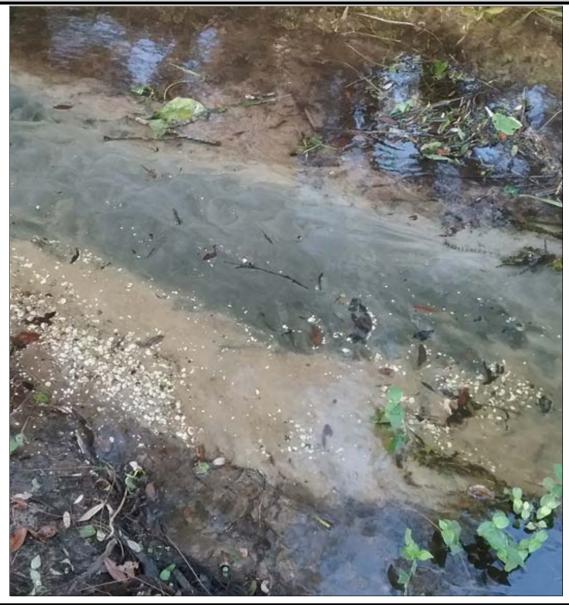
Inspector(s):	Date:	Photo Location	Photo Direction
K.O'Hara/M.Holland	12/15/2016	At outfall by Hawkeye Cir	SW

Comments: Showing while material on the sediment, as well as a fine greyish sediment as well. This is found on areas of the canal south of the outfall.

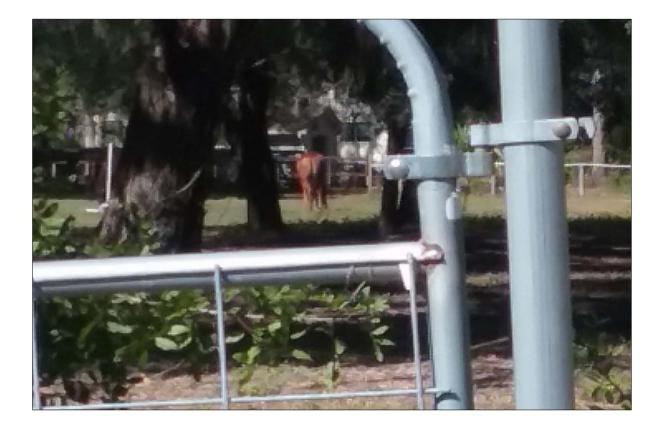
Inspector(s):	Date:	Photo Location	Photo Direction
M.Holland	1/31/2017	5167 Desoto Rd	North

Comments: (#4). Showing the second place where livestock was found. Owners have at least 2 horses on several acres. Unsure if there is a stable/paddock area where the animals congregate. There appears to be no direct connecton to major ditches and swales which convey to Phillippi Creek.

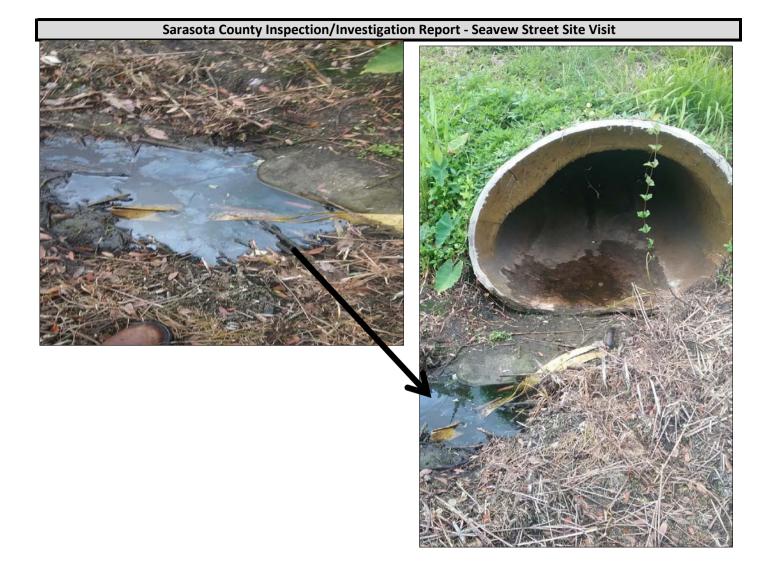
Inspector(s):	Date:	Photo Location	Photo Direction	
M.Holland	2/23/2017	Mouth of the pipe	West	
Comments: (#3). Showing well travelled area in from of the pipe - pipe collar begins at the concrete bag in the middle right of the picture. Plenty of raccoon tracks around this puddle.				
initiale right of the picture. Fienty

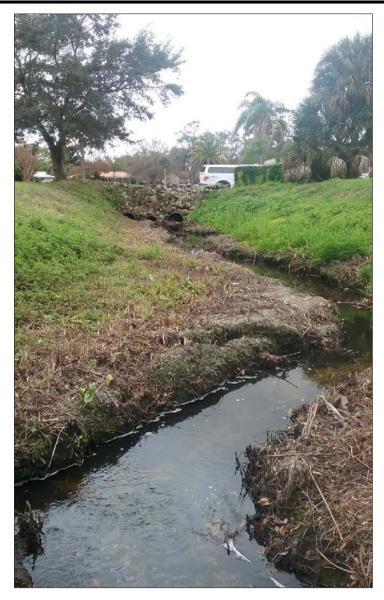
Inspector(s):	Date:	Photo Location	Photo Direction		
M.Holland	2/23/2017	Looking at Seaview Dr	South		
Comments: (#3). Showing the condition of the ditch heading south to Seaview. Recently maintained. Lots of					
decaying vegetation in the ditch, b	decaying vegetation in the ditch, but not in the water currently. Flowing at the time of the site visit.

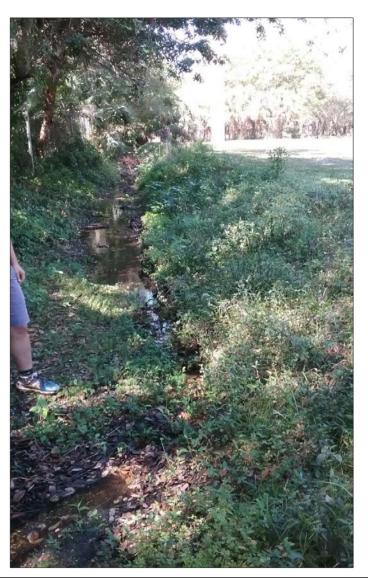
Inspector(s):	Date:	Photo Location	Photo Direction
M. Holland/J. Talbott/N.Iadavia	3/1/2017	Same as above	West

Comments: (#3). In the ditch bottom showing the conditions. Water was moving, barely. All but the flow way is vegetated. Flow way is sandy/mucky with quite a bit of decaying leaves.
