Summary of Results

Walk the WBID Exercise for Philippi Creek
(WBID1937)

FINAL DRAFT

September 27, 2017

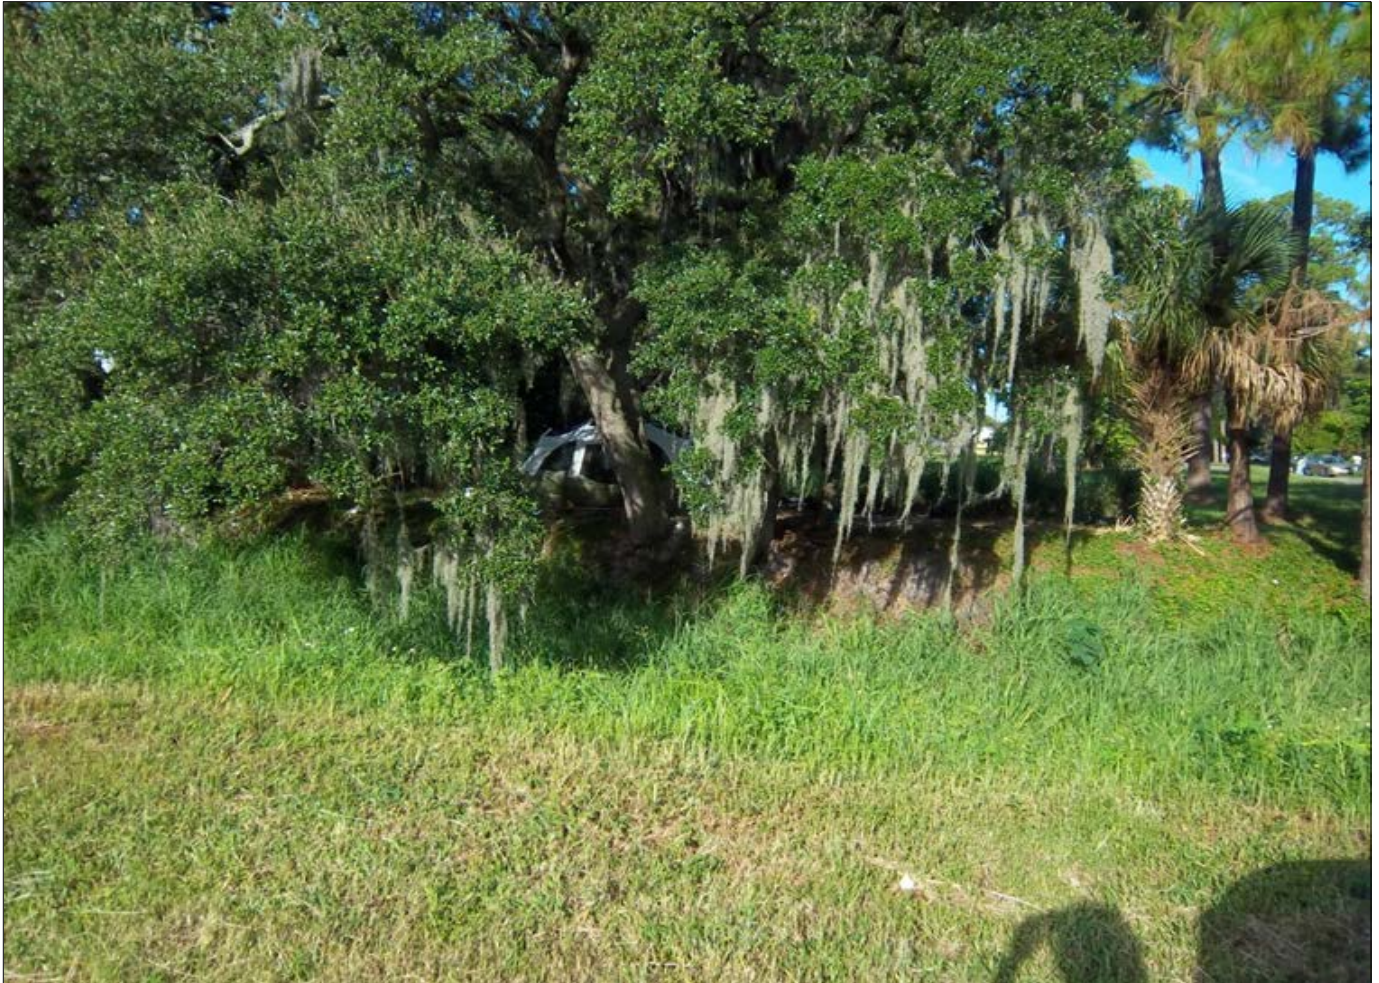
Inspector(s):	Date:	Photo Location	Photo Direction
M.Holland/R.Wells/J. Pate	8/26/2016	McDonalds on Fruitville	West
Comments: (a)Appears to be a homeless camp on vacant property west of McDonalds and directly adjacent to the creek. This encampment is upstream from the established sampling site.

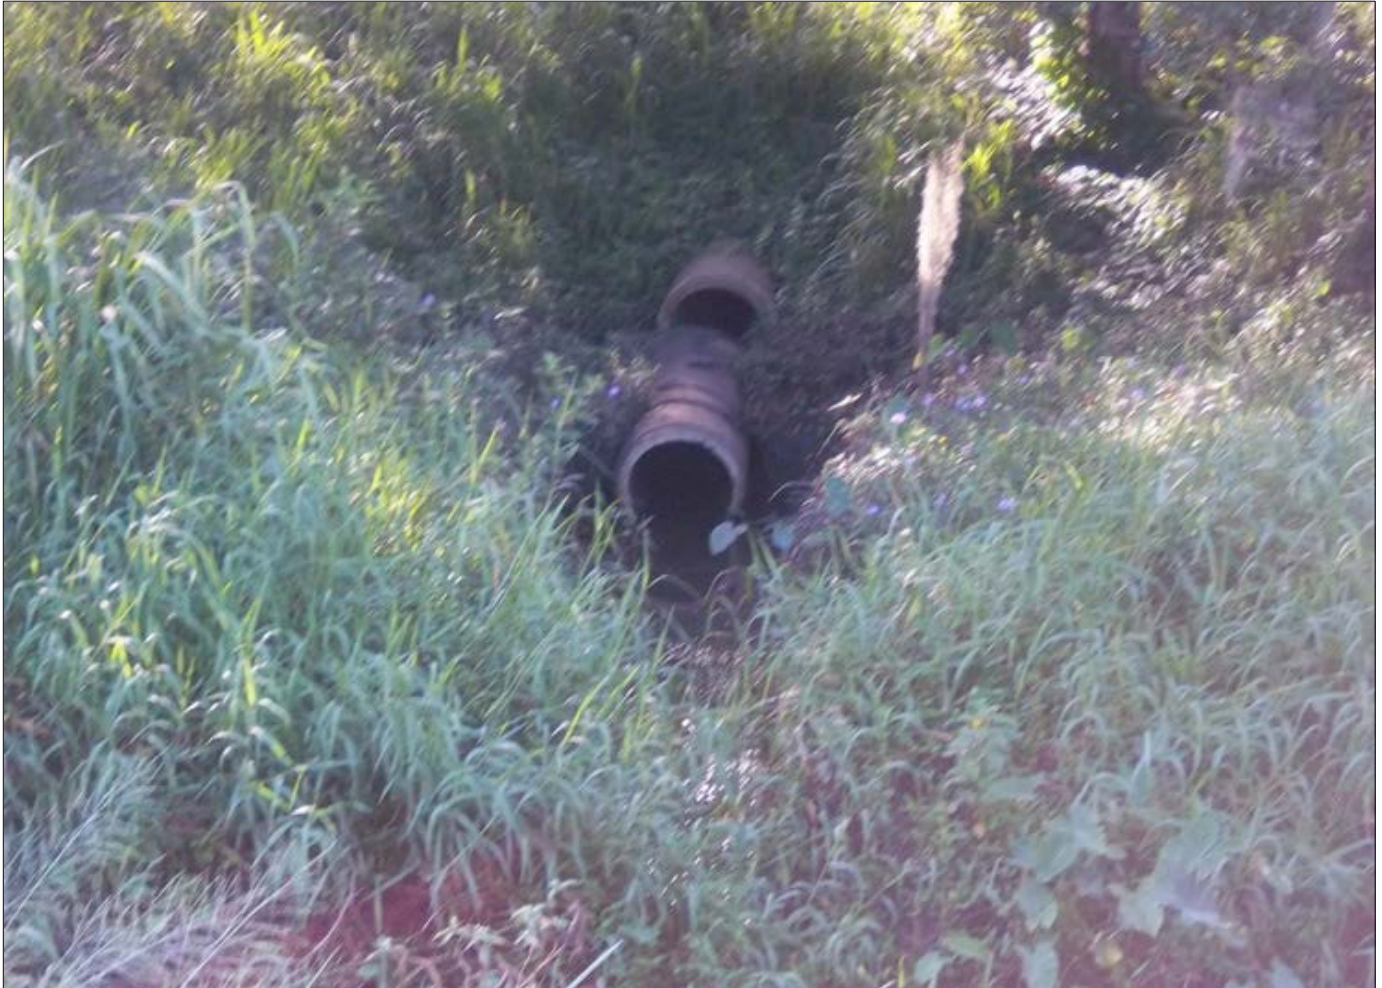
Inspector(s):	Date:	Photo Location	Photo Direction
M.Holland/R.Wells/J. Pate	8/26/2016	Phillippi Creek	NE
Comments: The second outfall on Amherst Street (the one to the north). Stormwater runoff from the same apartment complex. Lat/Long is 27.3401/82.4944. The piping system in to the creek is failing, as the pipe is now in 2 sections. There is erosion under these pipes from stormwater flow, which stirs up sediment from the ditch bottom and moves it down stream.

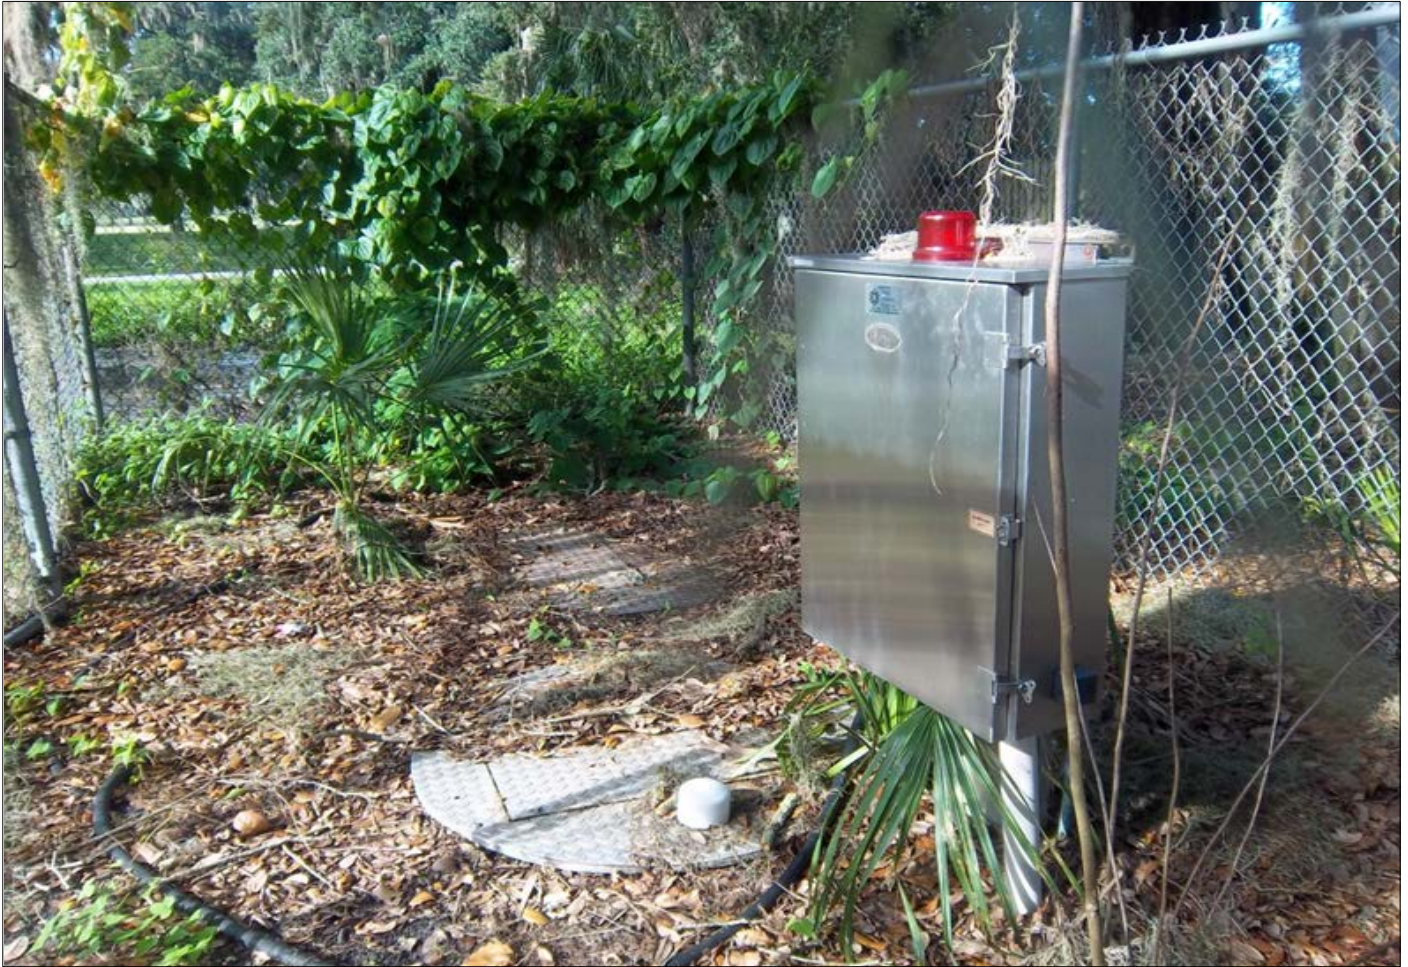
Inspector(s):	Date:	Photo Location	Photo Direction
M.Holland/R.Wells/J. Pate	8/26/2016	N end of Azinger Way	South
Comments: (e)City Lift station. The maintenance entity for this lift station is the contractor that maintains the golf course. The site was secure at the time of the investigation. There is a history of problems at this station, but no issues recently.

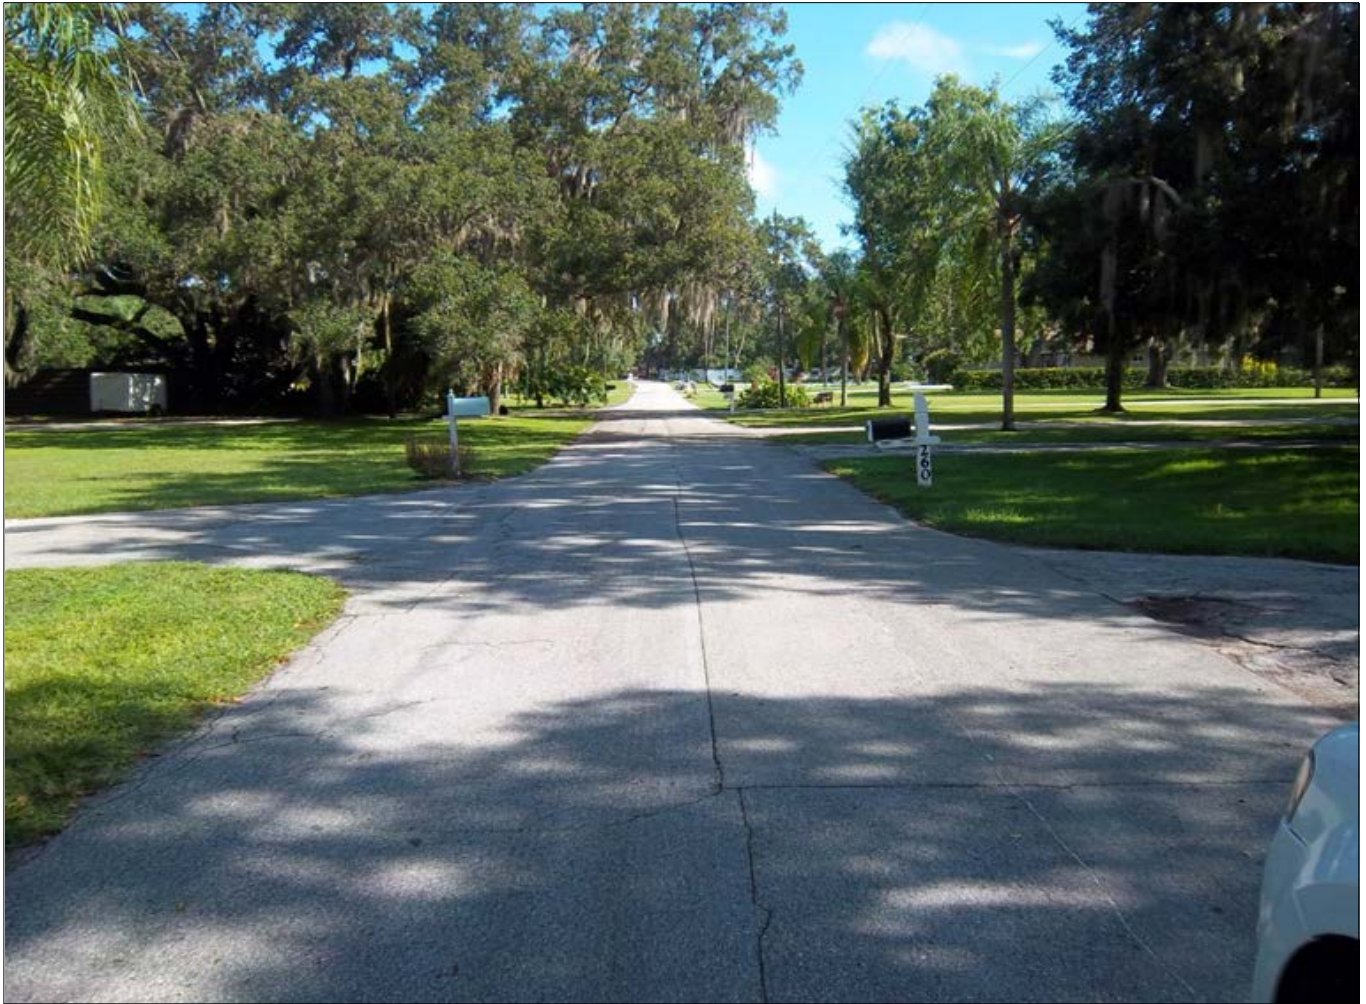
Inspector(s):	Date:	Photo Location	Photo Direction
M.Holland/R.Wells/J. Pate	8/26/2016	Same as Above	North
Comments: (f)Same as above, but looking towards Fruitville Rd. There are no obvious signs of septic failure in the front yards. Houses and lots are large and well taken care of. The lots of the left (west of this road - Bearded Oaks Drive) back up to the canal shown later, Canal 4-37.3. This is the last sight visited with Rich and John from the City due to time constraints on their end. The site investigations continued in the adjacent neighborhood and a linear park in the same vicinity as Phillipp Creek and Circus Blvd without them.

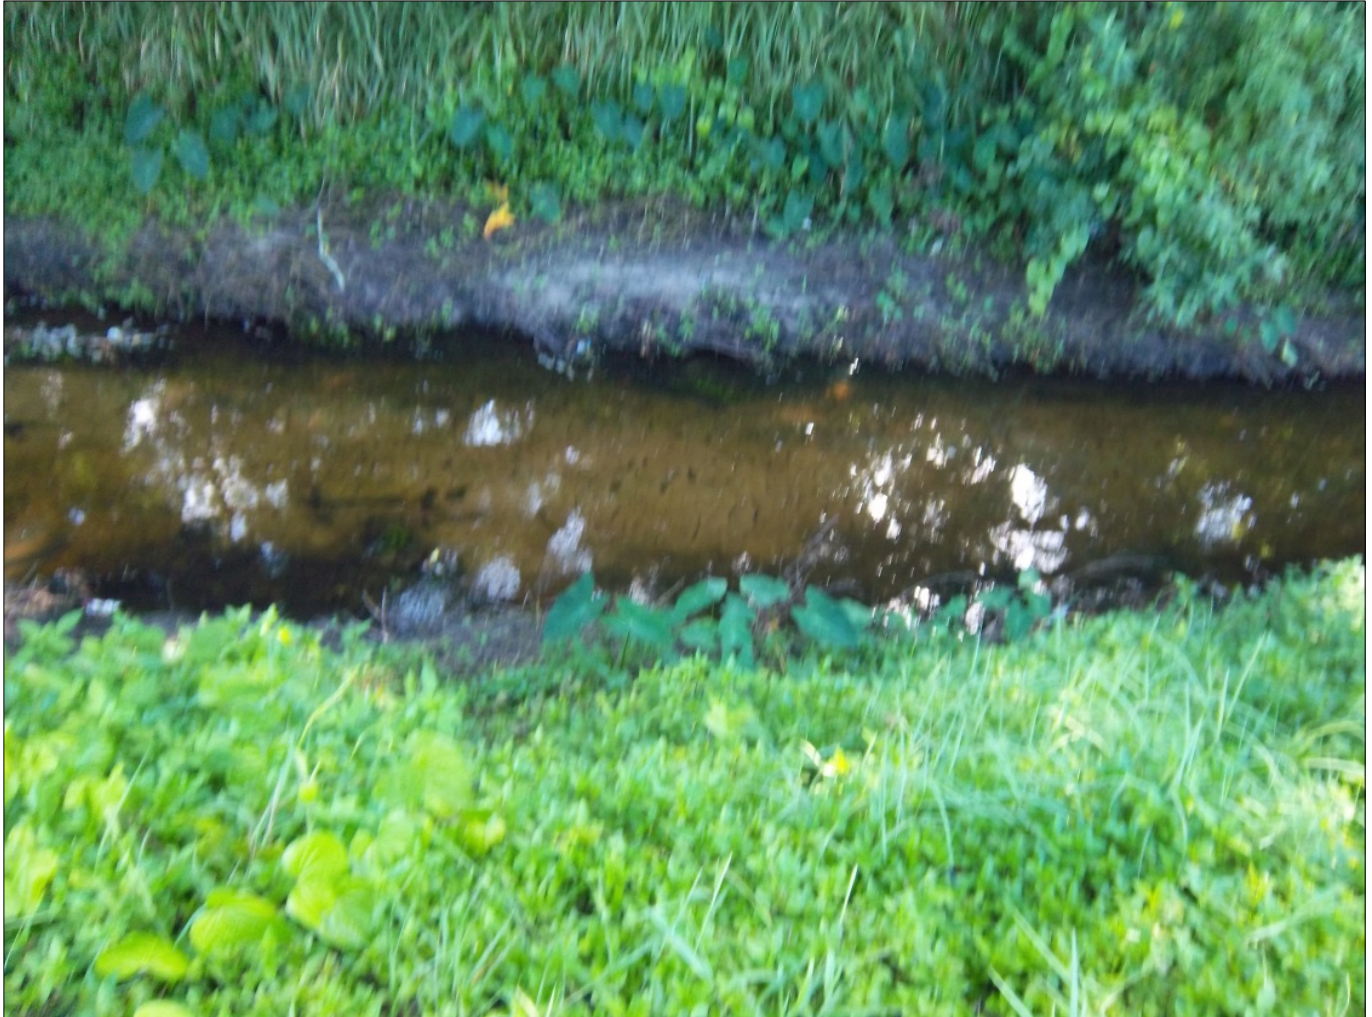
Inspector(s):	Date:	Photo Location	Photo Direction
M. Holland	8/26/2016	Midwest south of Fruitville	East
Comments: (g)4-37.3 Canal just south of Fruitville Rd. Water was clear but tannic, flowing south (left to right). The canal is heavily vegetated and the bottom was sandy. There were not odors coming from the canal or water.

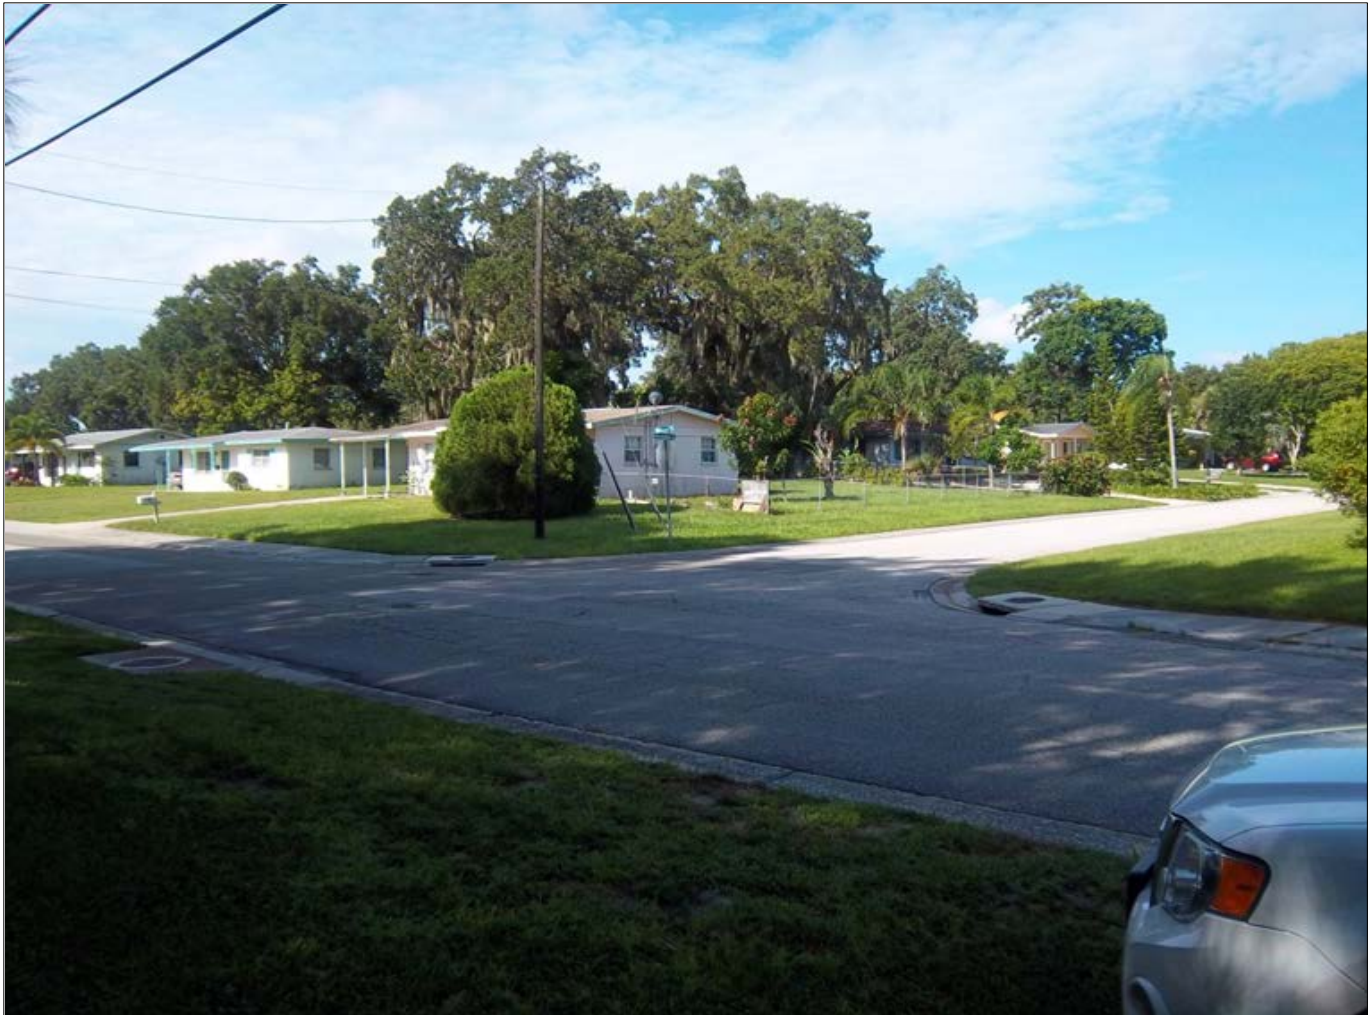
Inspector(s):	Date:	Photo Location	Photo Direction
M. Holland	8/26/2016	Same as Above	SW
Comments: (h) Showing the intersection of Midwest Pkwy and Wolverine as mentioned above. This neighborhood is on City Sewer. Homes in this area are moderate income type homes and vary in condition.

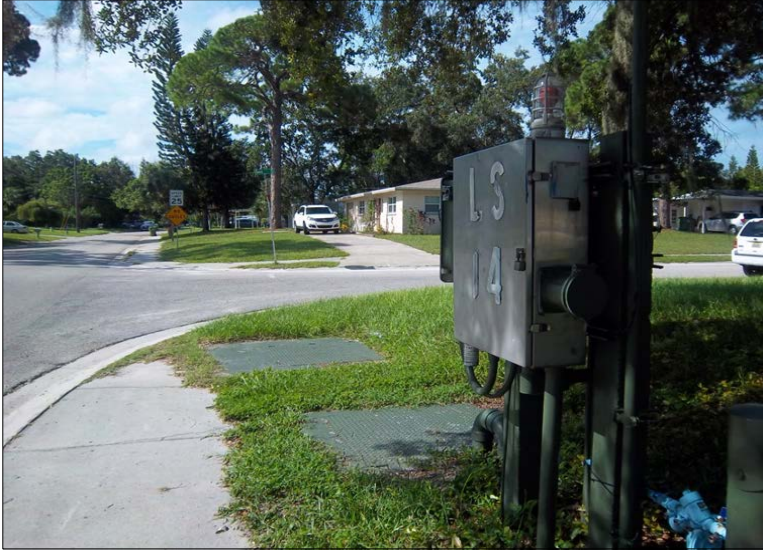
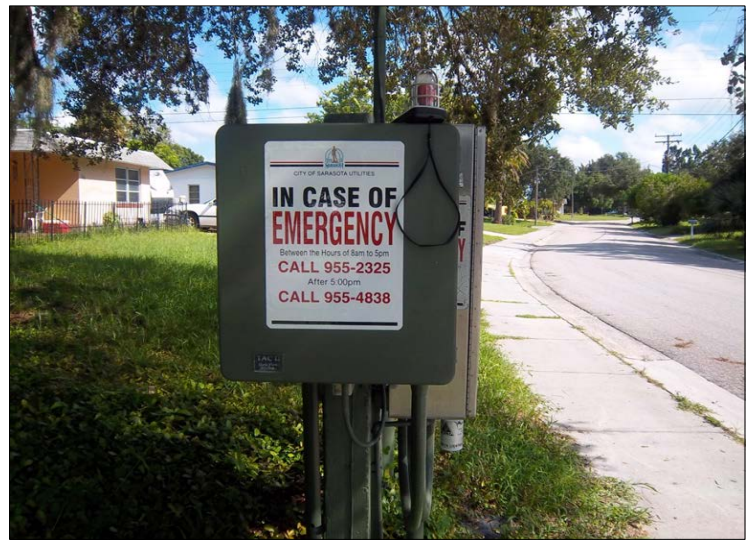
Inspector(s):	Date:	Photo Location	Photo Direction
M. Holland	8/26/2016	Midwest Pkwy and Davis	South
Comments: (i) Showing the City Lift station at the corner. Site was secure. This station has no history of overflows.

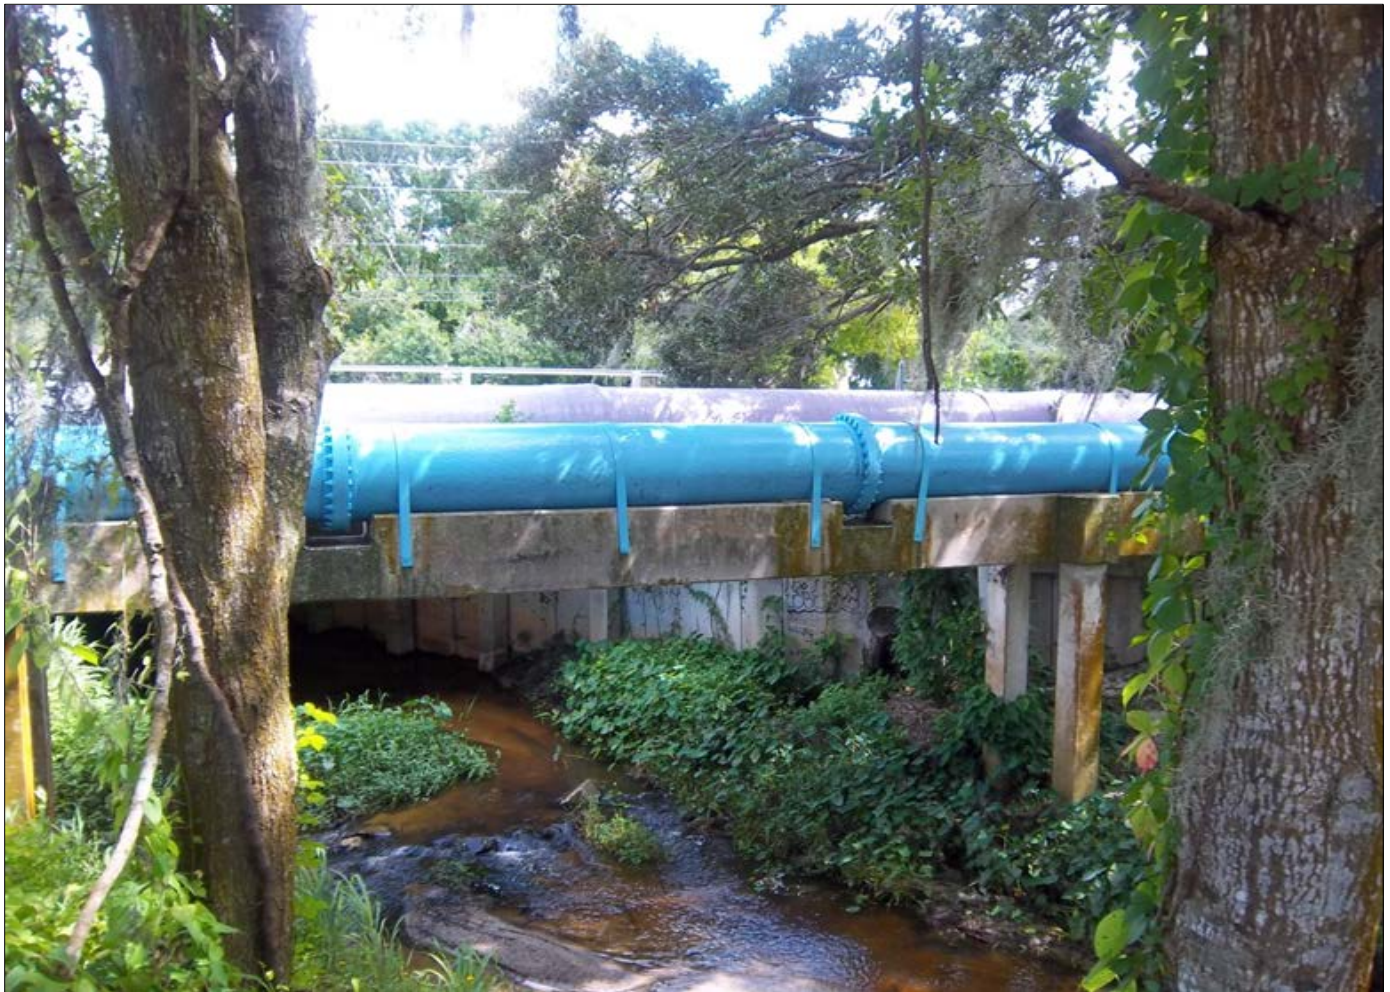
Inspector(s):	Date:	Photo Location	Photo Direction
M. Holland	8/26/2016	Circus Blvd and 17th Street	NE
Comments: (m)Showing Sewer and Reclaimed water lines for the City. Pipes appeared in good condition with no leaks. This pipe passes over the canal just south of 17th Street and East of Circus Blvd.

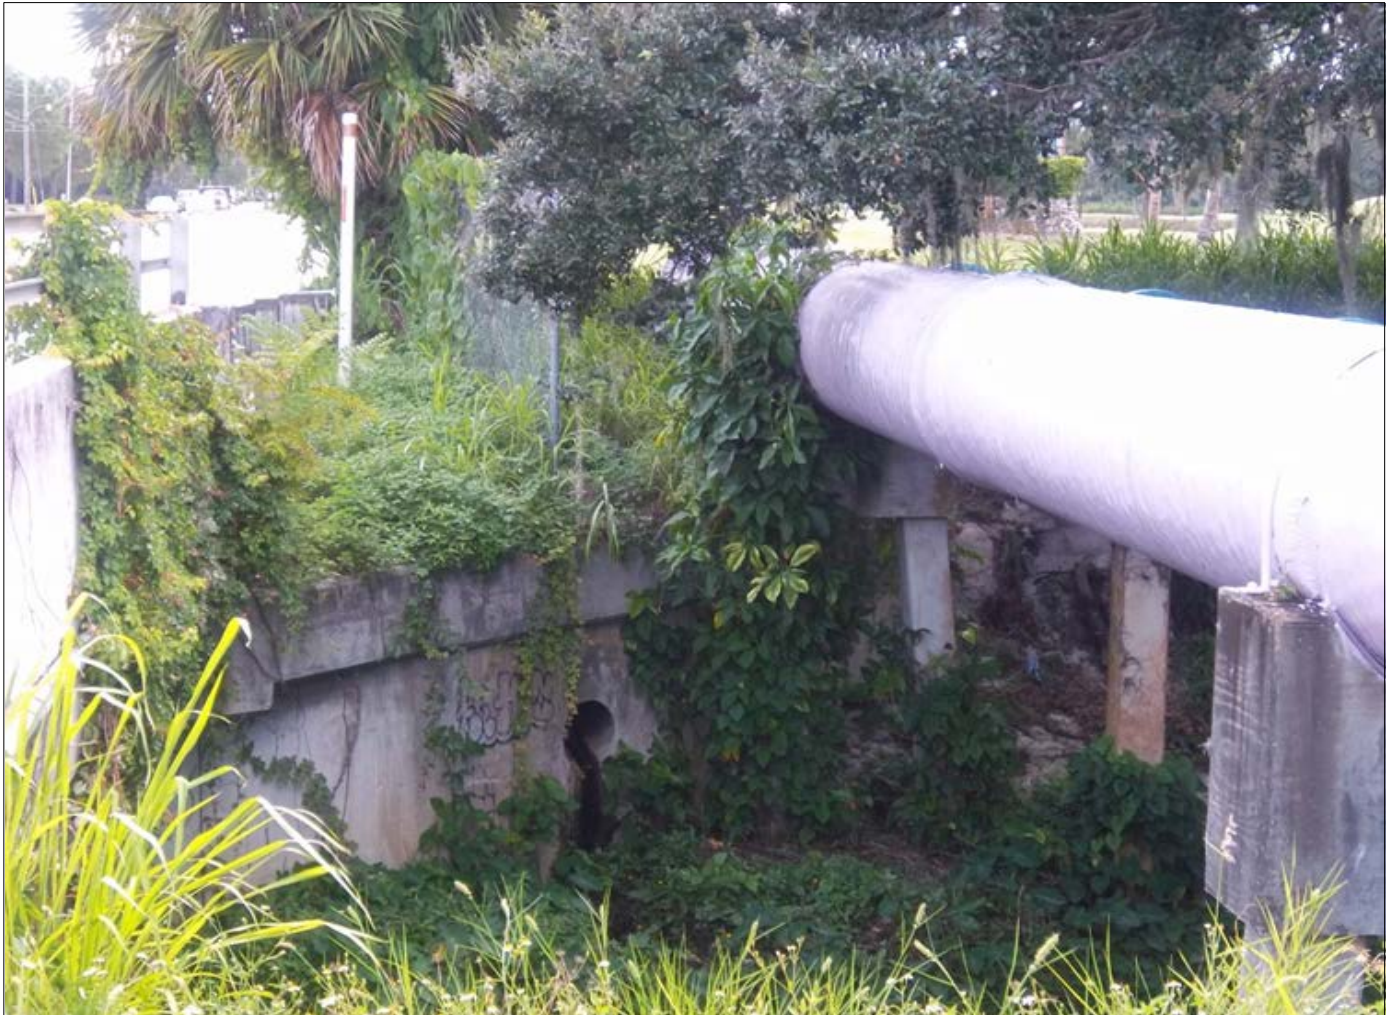
Inspector(s):	Date:	Photo Location	Photo Direction
M. Holland	8/26/2016	Same as Above	East
Comments: (m)Showing the lines as the cross 4-14. No apparent issues. 17th Street is to the left.

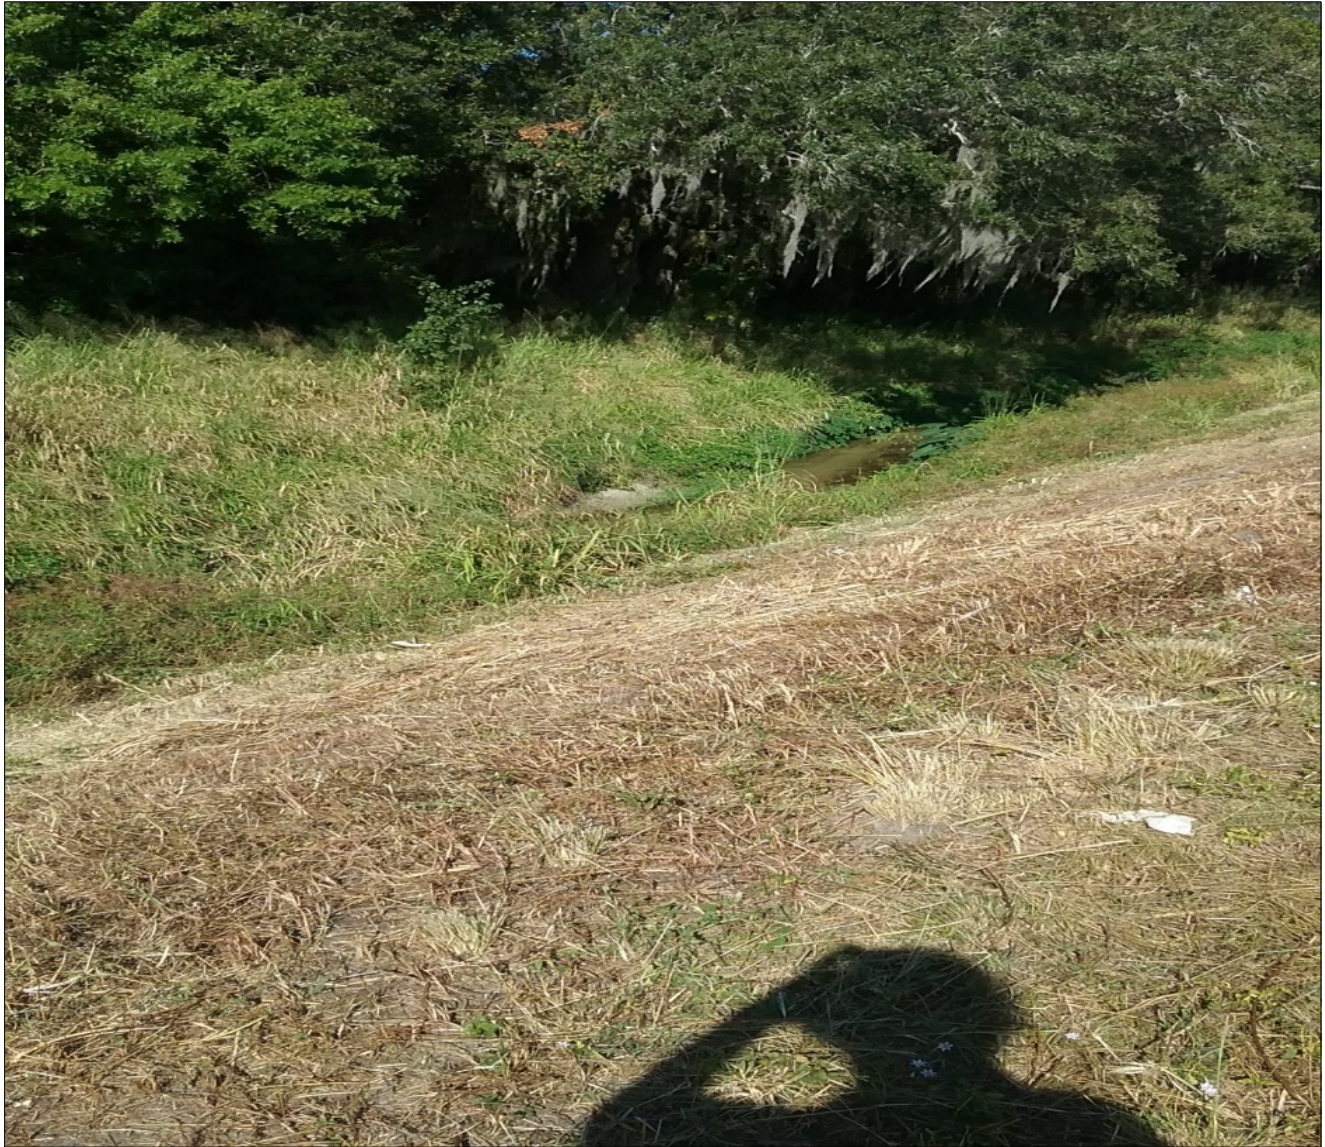
Inspector(s):	Date:	Photo Location	Photo Direction
A. Melton, J. Talbott, M. Holland	11/10/2016	West of Fruitville and Beneva	NW
Comments: (#1) Sample site is upstream of the regularly sampled site (noted by the red star in the narrative), about 100 yards. This site has the highest bacteria count on average for 2006-2016. There are homeless emcampments along the creek in a couple locations.

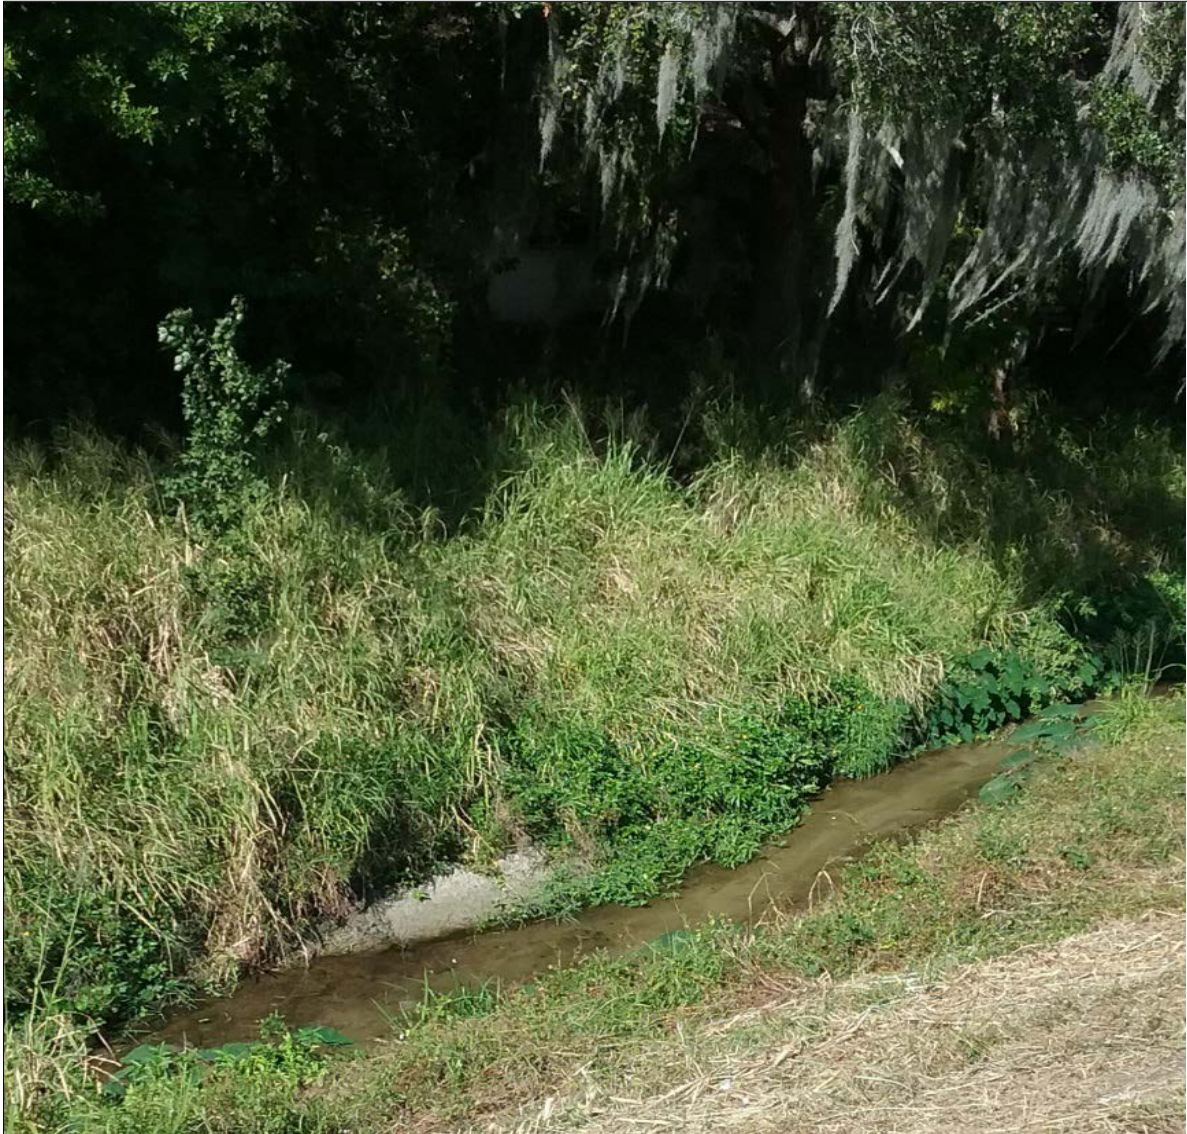
Inspector(s):	Date:	Photo Location	Photo Direction
A. Melton, J. Talbott, M. Holland	11/10/2016	Same as above	NW
Comments: (#1)Showing overall site conditions. Banks were heavily vegetated on the West side, right side had been recently maintained. Water depths varied from just a couple inches to 10 or 12 inches. Bottom sediment was sandy, ditch was flowing. Wildlife tracks in the bottom of the ditch (raccoon and bird).

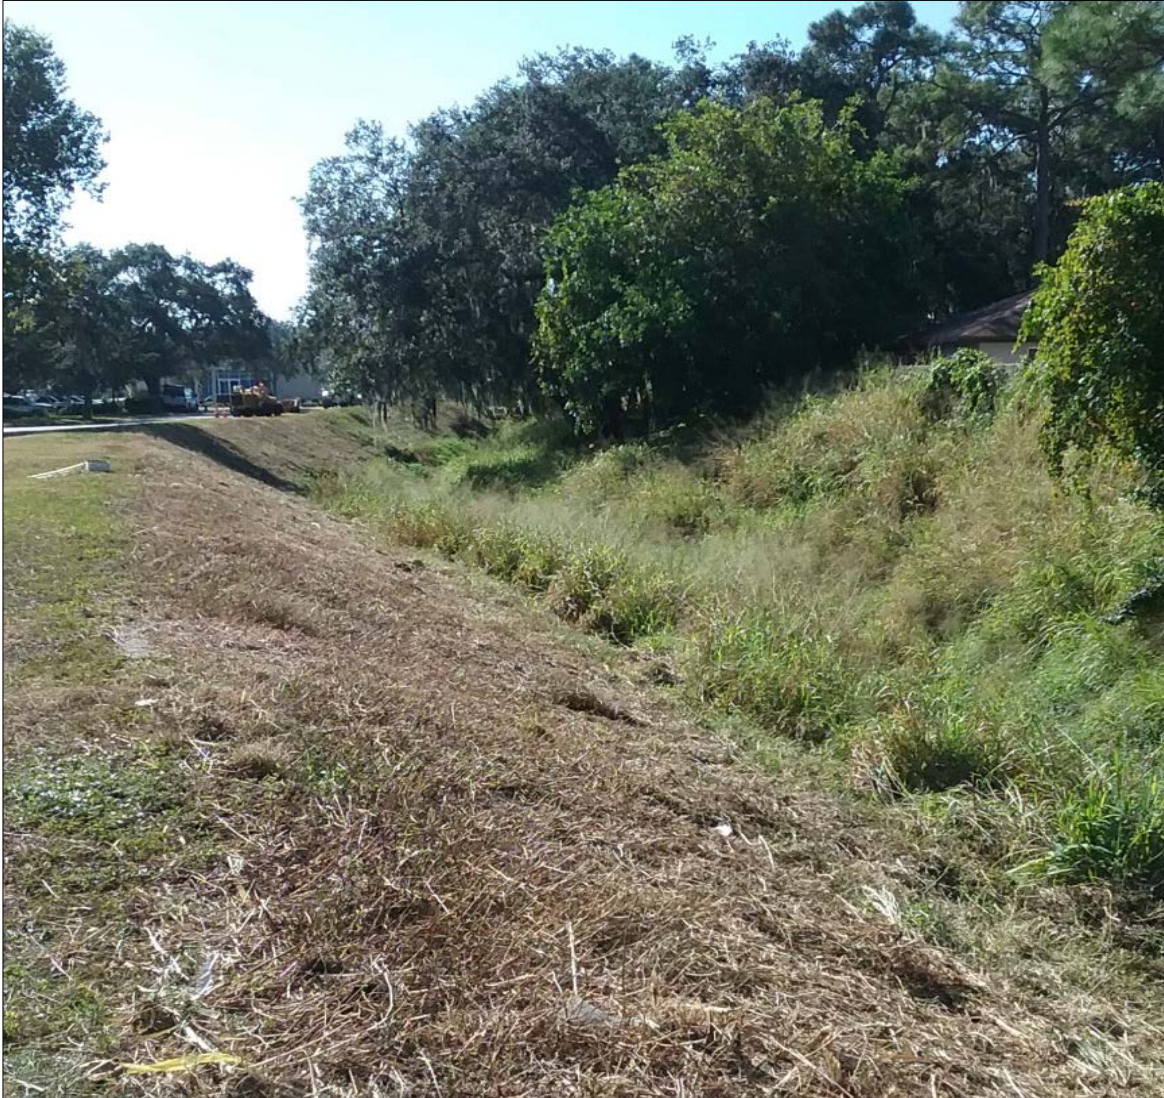
Inspector(s):	Date:	Photo Location	Photo Direction
A. Melton, J. Talbott, M. Holland	11/10/2016	Same as above	South
Comments: (#1)Showing the upstream of the sample site. The east side had been recently maintained, but not to the water's edge. Land use is commercial on the east side of the ditch, residential on the west side.

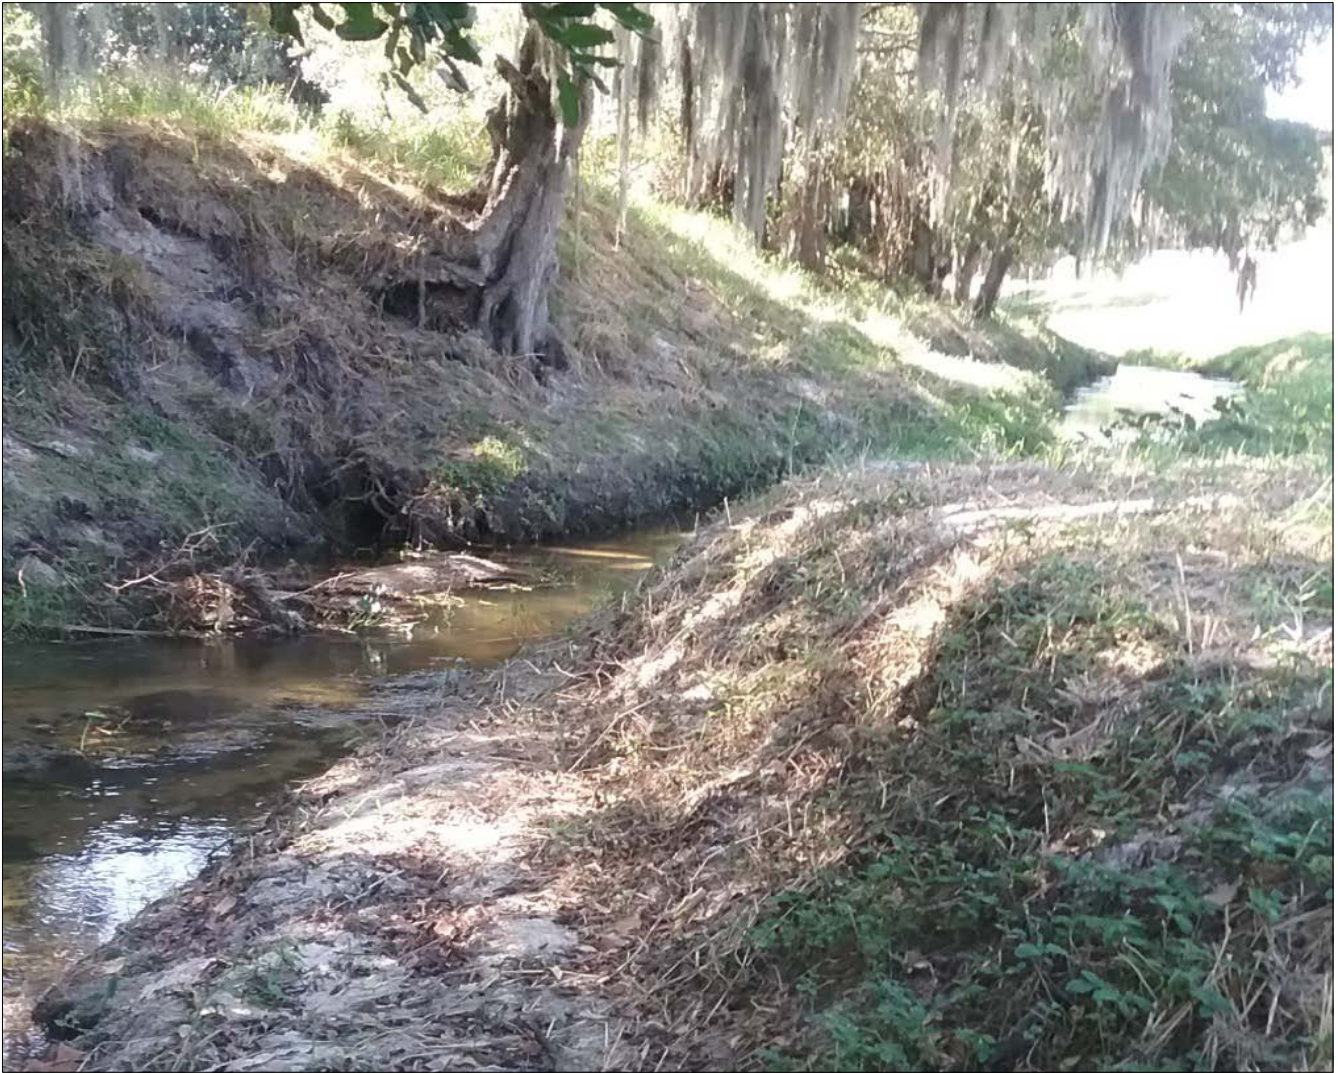
Inspector(s):	Date:	Photo Location	Photo Direction
A. Melton, J. Talbott, M. Holland	11/10/2016	N of Main B - Fruitville	South
Comments: (#3)Showing general conditions downstream of the sample site. Vegetation is present, but minimal. Lots of erosion and sediment depostion in the canal bottom during larger storm events. Water flows south (left to right). Area is adjacent to Circus Blvd.

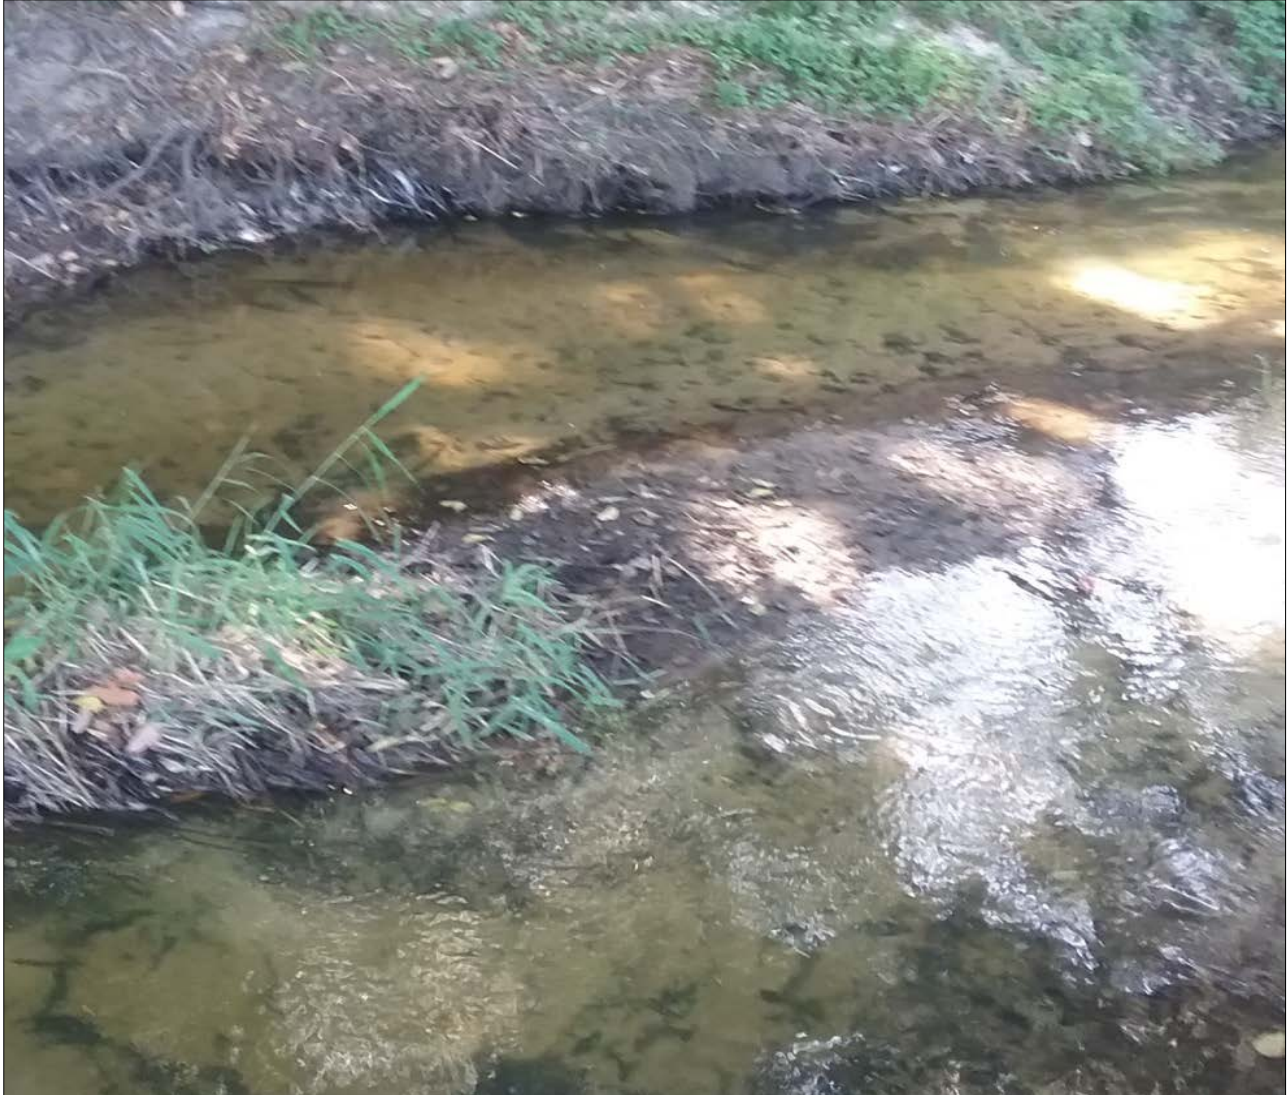
Inspector(s):	Date:	Photo Location	Photo Direction
A. Melton, J. Talbott, M. Holland	11/10/2016	Same as above	SE
Comments: (#3). Showing the bottom sediments. Sandy with little organic matter. Large(ish) fish seen upstream. Additional sampling done here today. Also adjacent to Circus Blvd.

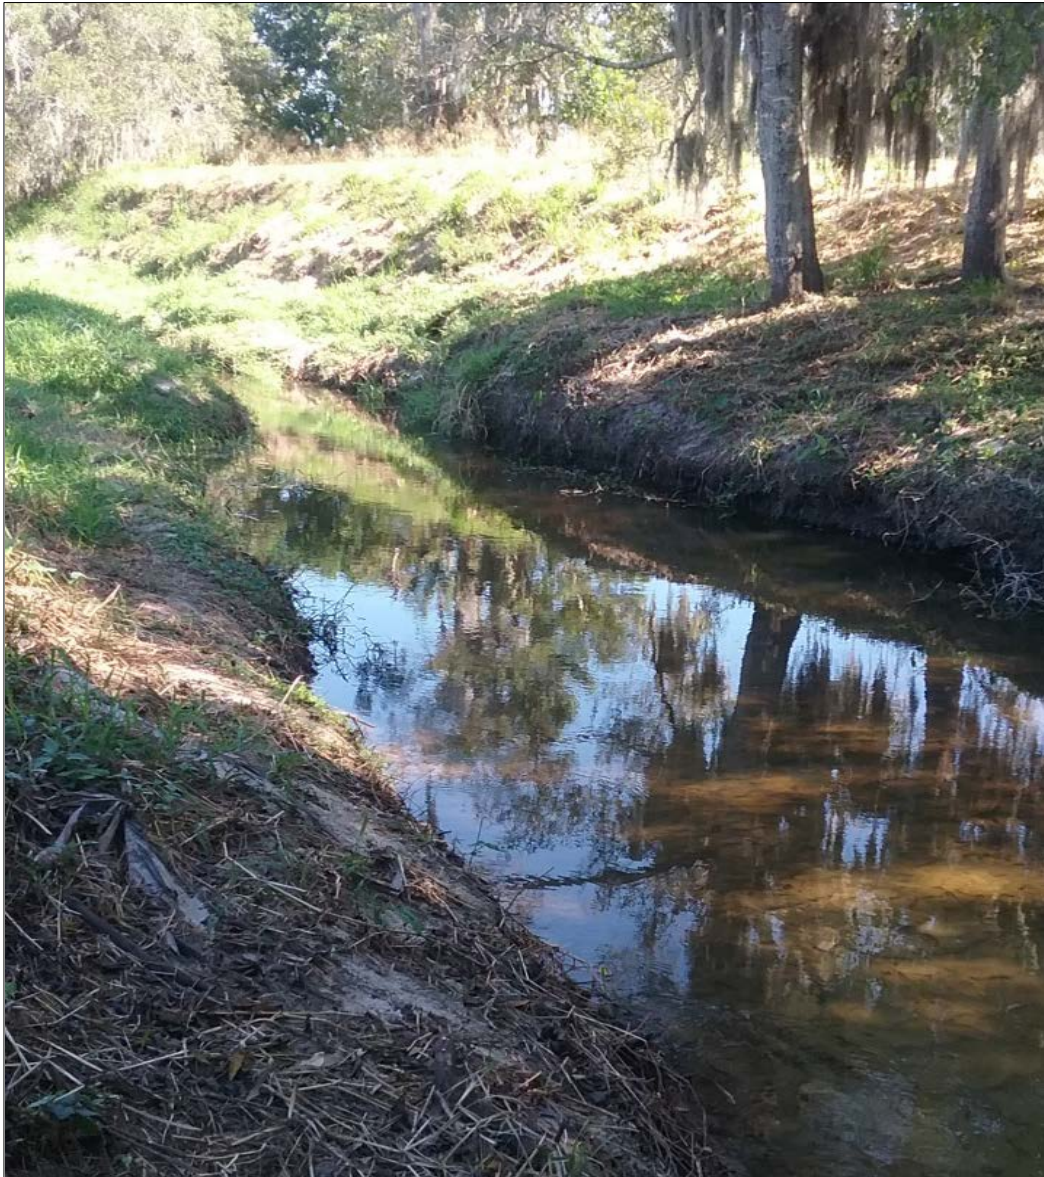
Inspector(s):	Date:	Photo Location	Photo Direction
A. Melton, J. Talbott, M. Holland	11/10/2016	Same as Above	NW

Showing conditions upstream of the sampling site. Overall canal has canopy cover and steeply eroding sides in most areas. Evidence of wildlife in the ditch - tracks but no scat seen. Adjacent to Circus Blvd.

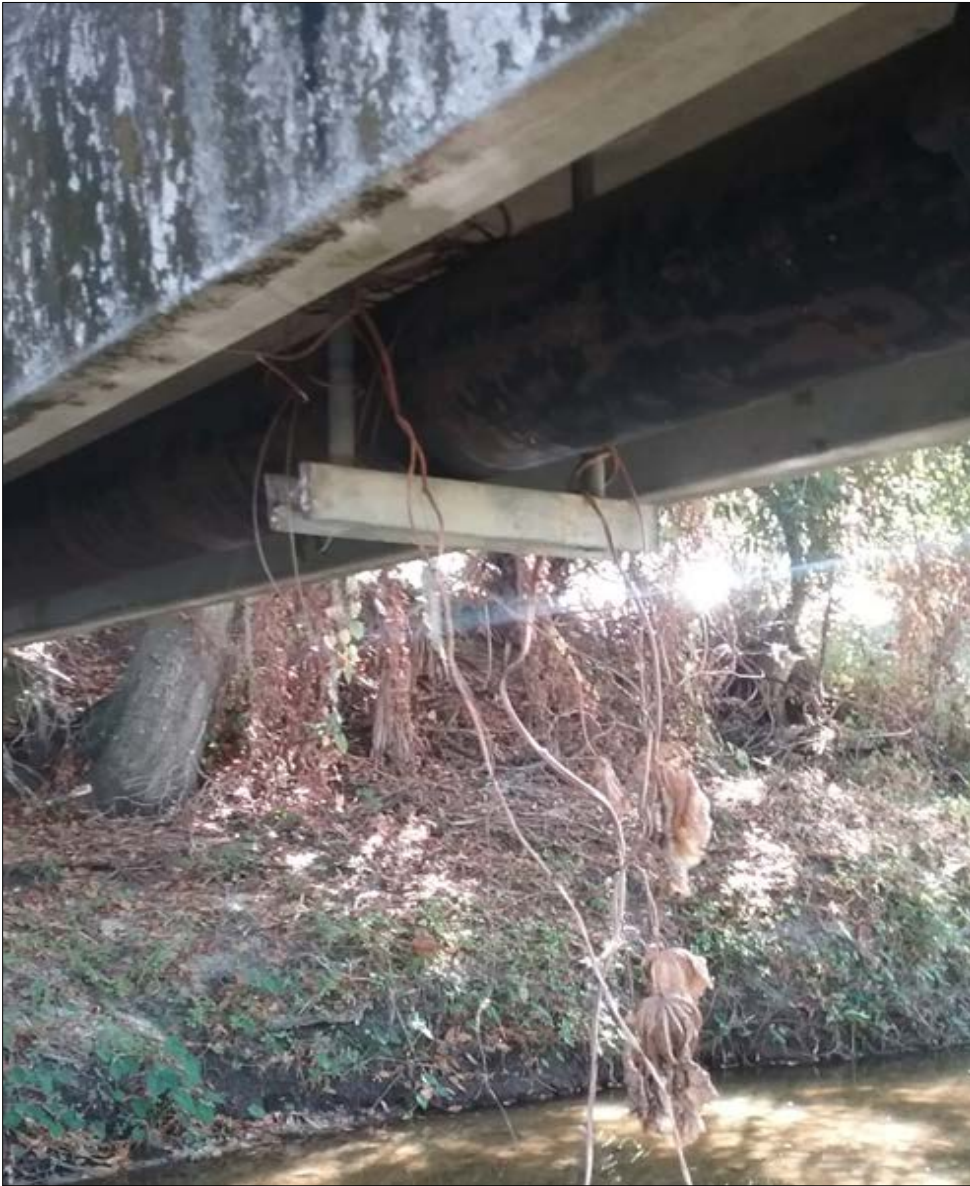
Inspector(s):	Date:	Photo Location	Photo Direction
A. Melton, J. Talbott, M. Holland	11/10/2016	Pipe for Lift Station	SE

Comments: (#4) Bobby Jones Golf Course (owned by the City of Sarasota) has its own lift station. Showing the connection between the lift station at Bobby Jones Golf Course to the rest of the City of Sarasota's sewer system. The Lift station was inspected previously with City Staff. No obvious signs of leaks in the pipe. The pipe is covered with a concrete sleeve on the top, but the bottom is exposed.
