Summary of Results

Walk the WBID Exercise for Philippi Creek
(WBID1937)

FINAL DRAFT

September 27, 2017

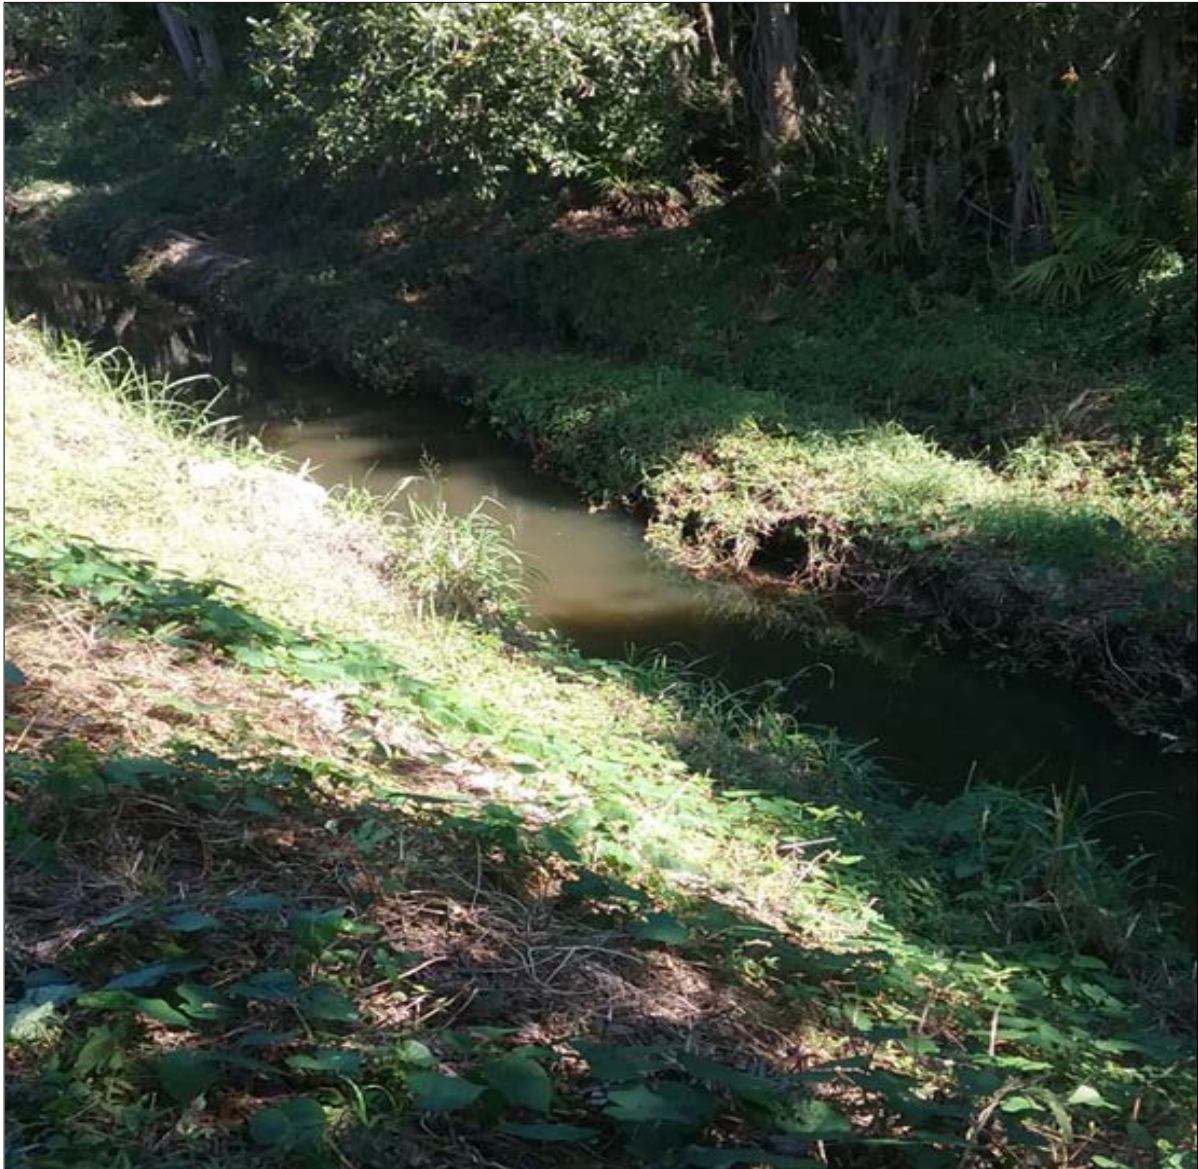
Inspector(s):	Date:	Photo Location	Photo Direction
A. Melton, J. Talbott, M. Holland	11/10/2016	N of Bobby Jones Entrance	North

Comments: (#4) Showing the overall condition upstream of the sample site. Canopy coverage is nearly 100%. Vegetation on the shore appears maintained. There was no aquatic vegetation. Water is a little cloudy, light brown in color.

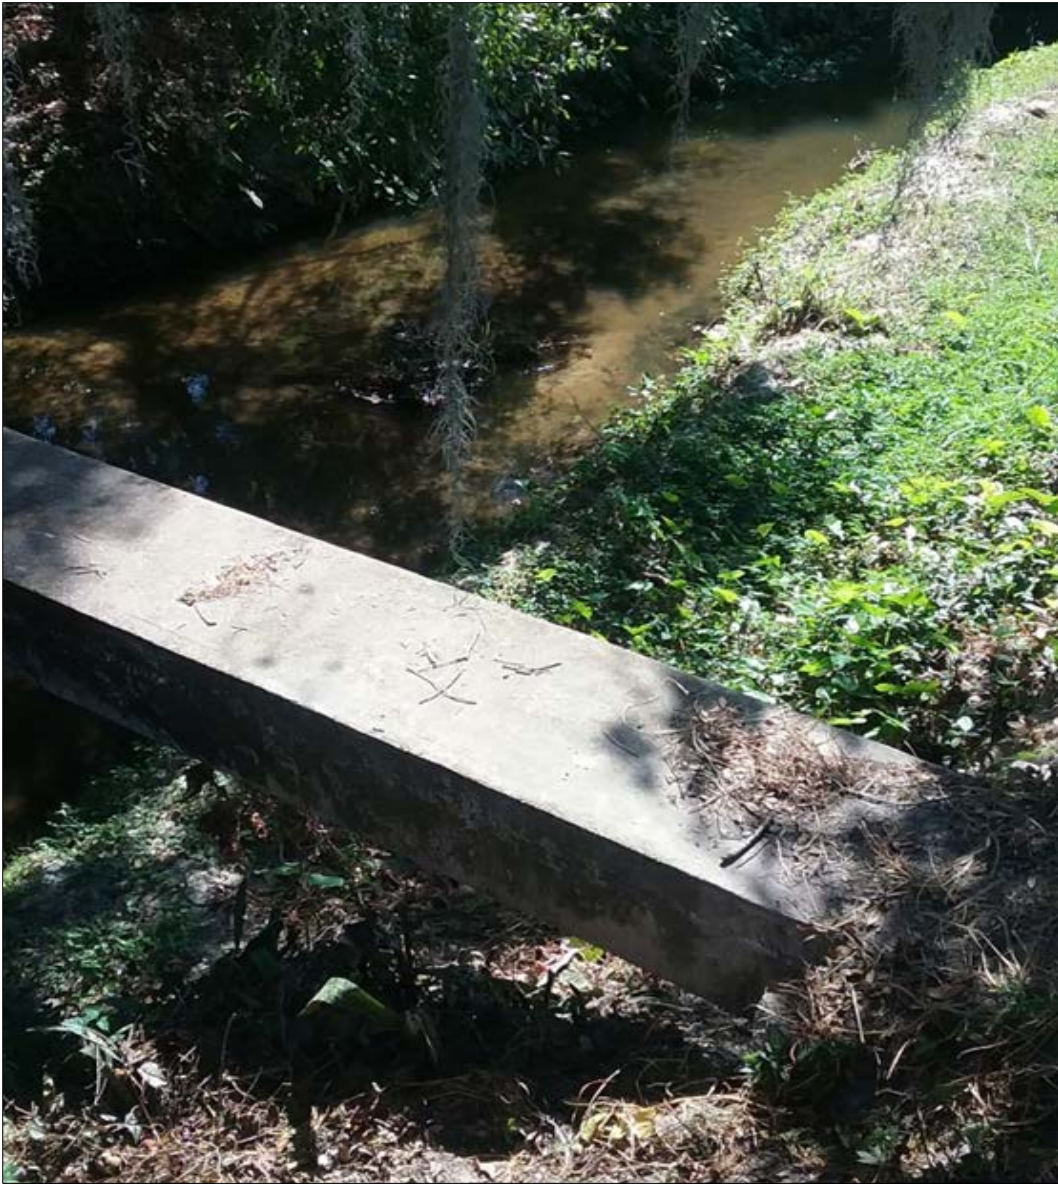
Inspector(s):	Date:	Photo Location	Photo Direction
A. Melton, J. Talbott, M. Holland	11/10/2016	Same as above	SE

Comments: (#4). Showing the concrete cover of the pipe and the surrounding conditions. No obvious signs of leaking from the pipe (smell, overgrown vegetation, stains on the pipe). Appears to be a good location for nesting/denning for animals under the pipe and a bit upstream under a palmetto.

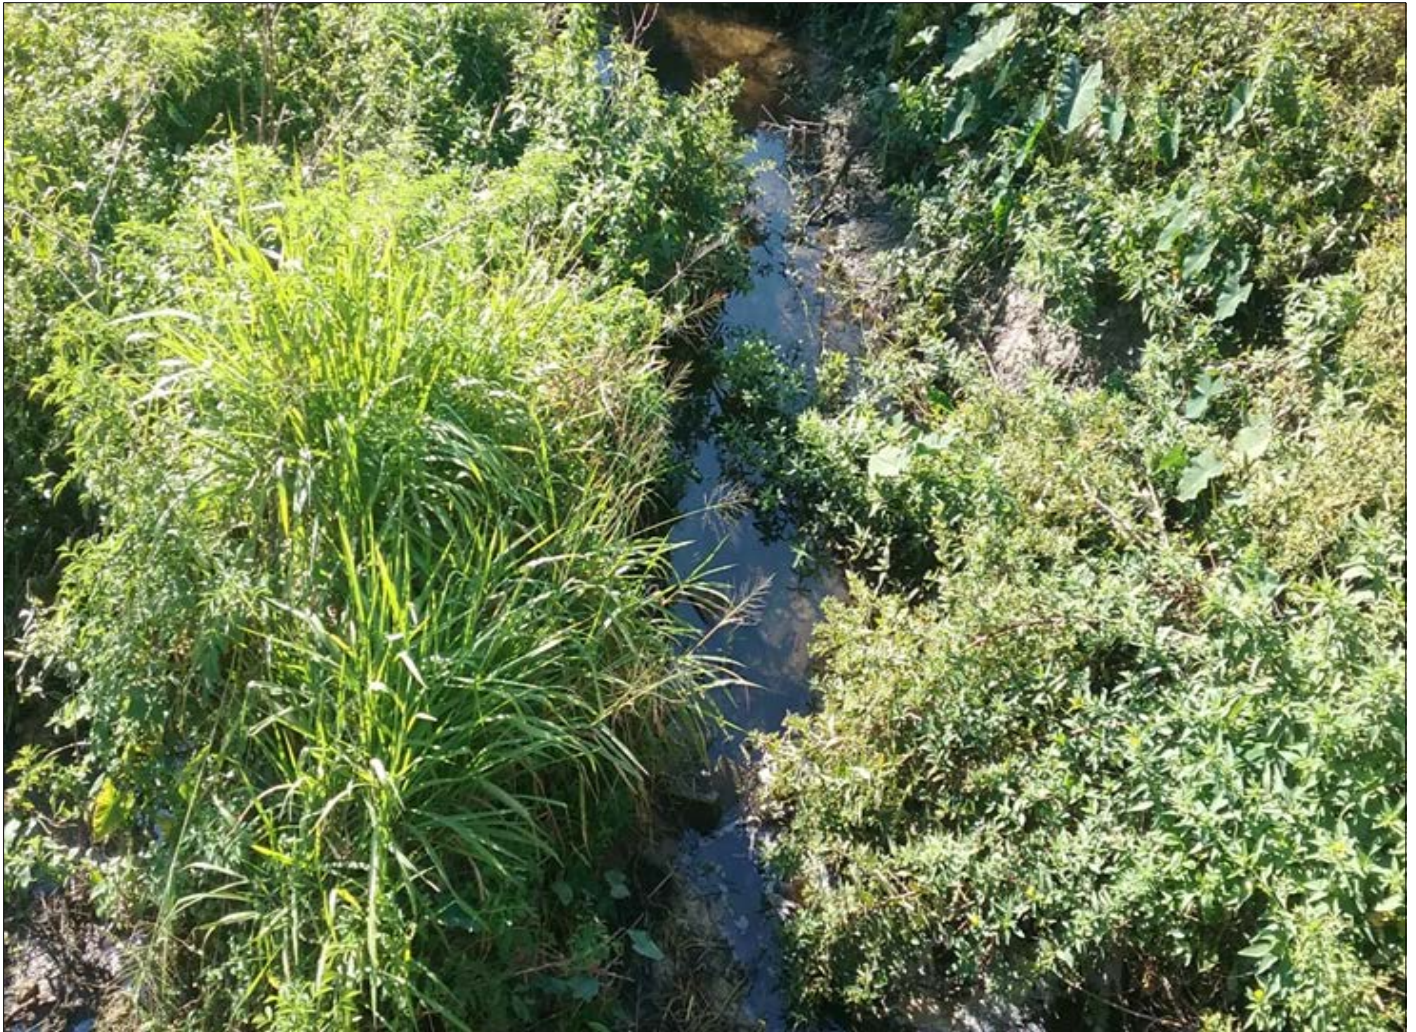
Inspector(s):	Date:	Photo Location	Photo Direction
A.Melton/M.Holland	11/16/2016	Same as above	South
Comments: (#1*) Showing downstream conditions. Slopes are very steep and covered in vegetation. Areas further downstream are eroded and somewhat unstable, with evidence of sloughing in.

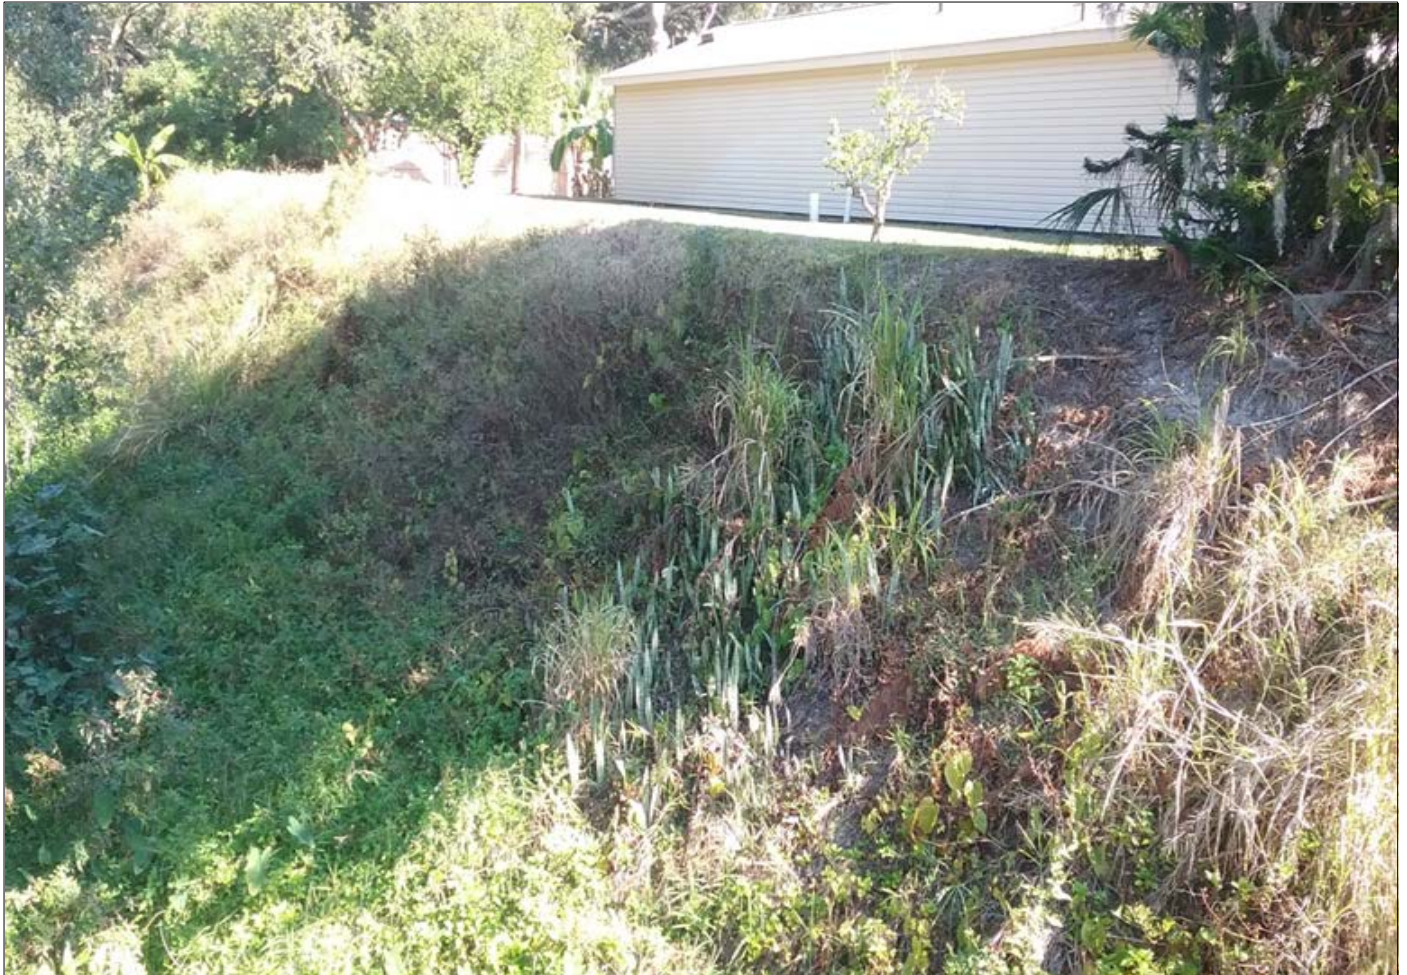
Inspector(s):	Date:	Photo Location	Photo Direction
A.Melton/M.Holland	11/16/2016	Davis Blvd.	West
Comment(s): (#2)Showing residential on east of the canal. It appears there is no direct discharge, at least from this residence, as there is a berm between the lot and the canal. Unsure of what occurs in the back of the residence in the rear of the picture.

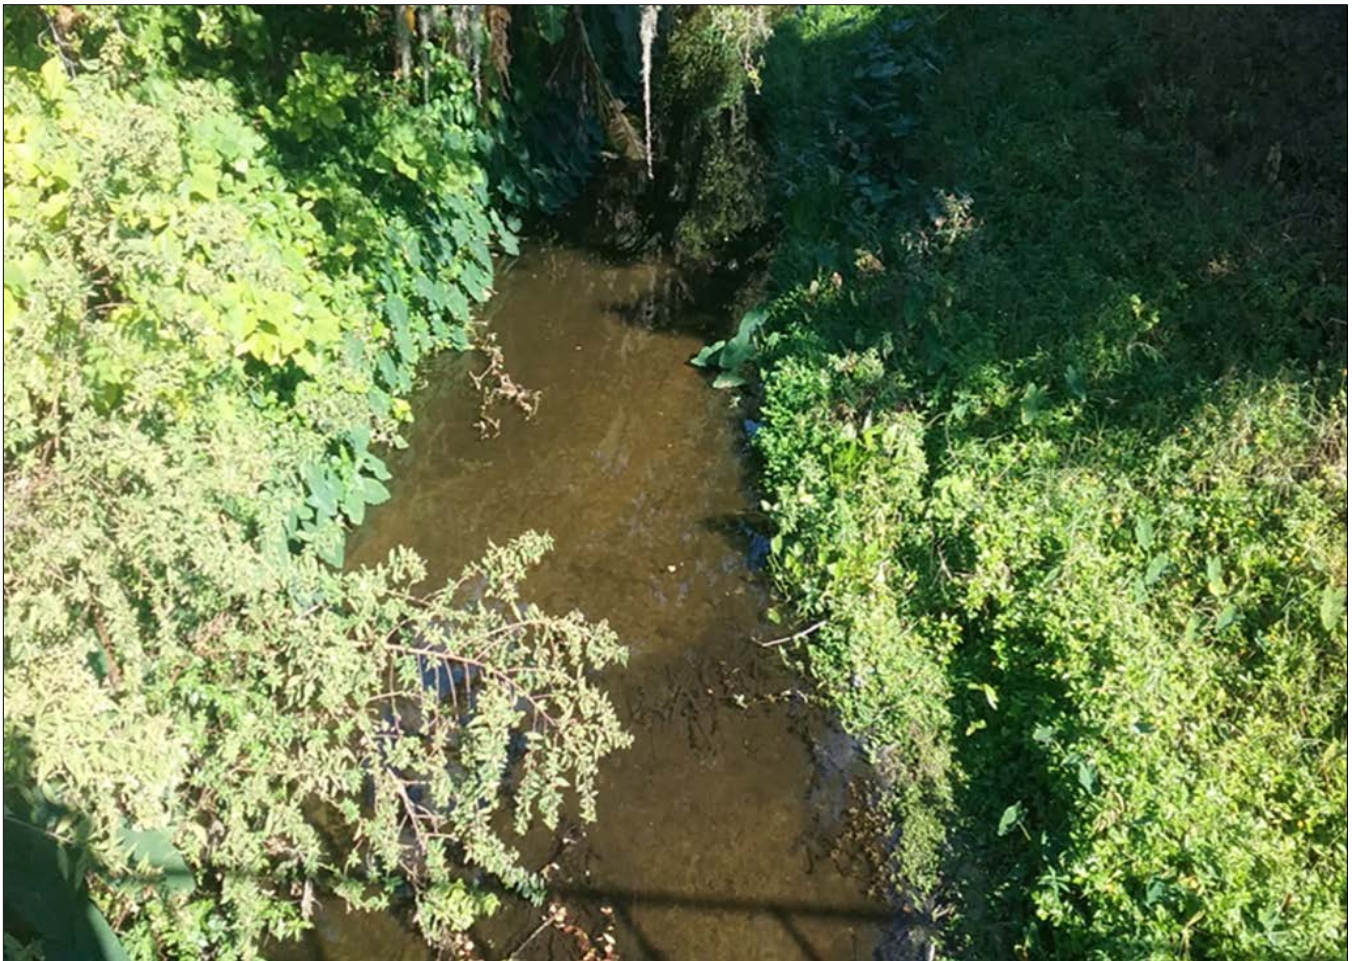
Inspector(s):	Date:	Photo Location	Photo Direction
A.Melton/M.Holland	11/16/2016	N of Davis Blvd	North
Comments:(#1*)Looking upstream of the sample site. Slopes are steep and heavily vegetated. Canal upstream is mostly shaded. Residential and roadway runoff are conveyed to this canal both upstream and downstream of the sample site. Canal bottom is a mix of sand and decaying matter (mucky). There was a feral cat in the area at the time of sampling. This area is serviced by the City of Sarasota sewer system.

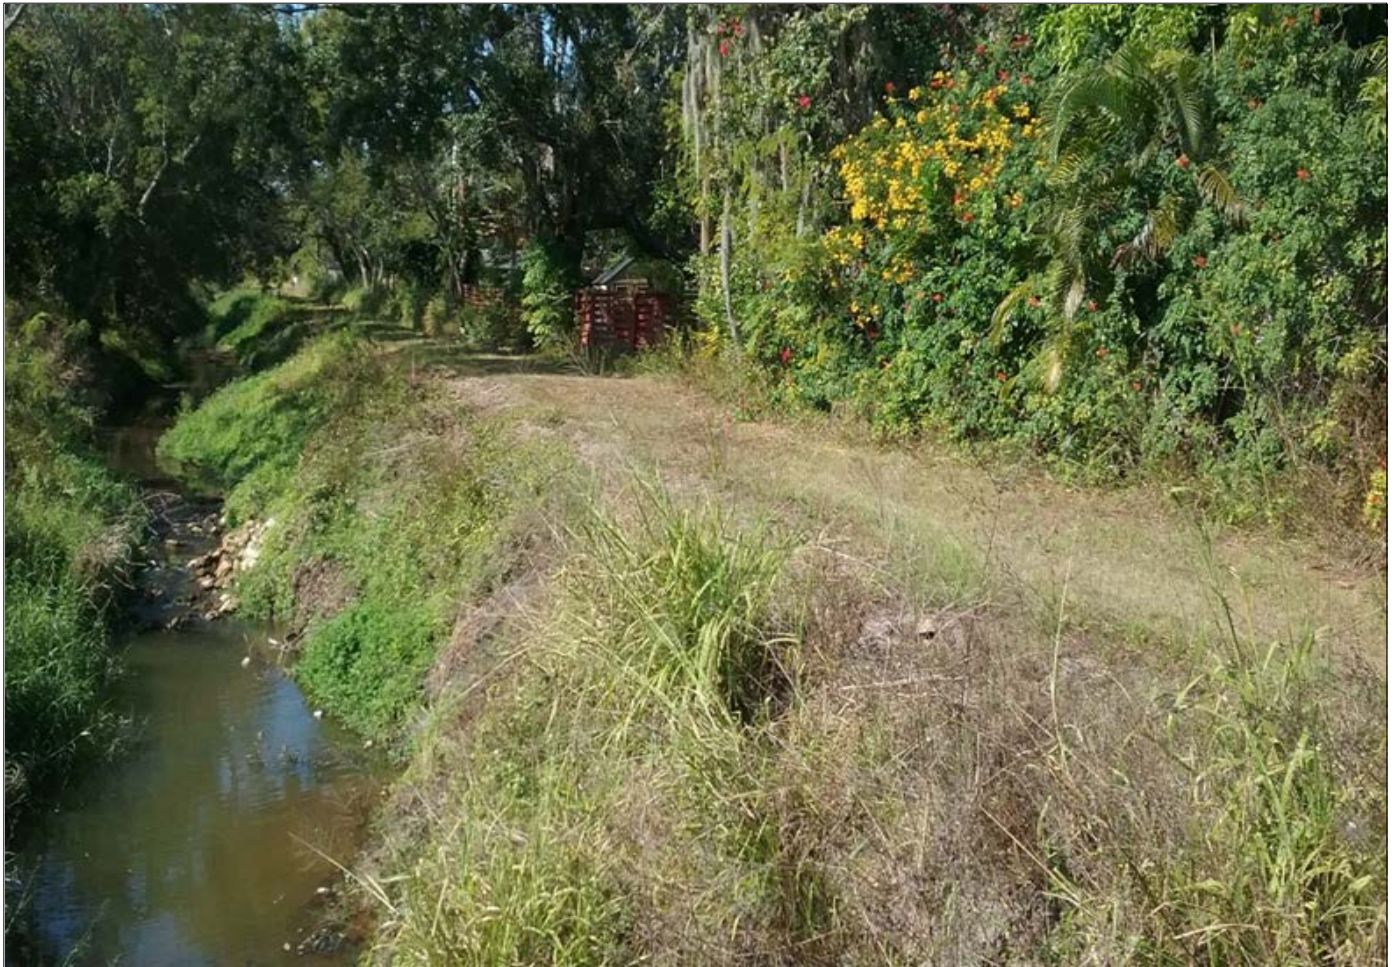
Inspector(s):	Date:	Photo Location	Photo Direction
A.Melton/M.Holland	11/16/2016	Same as above	West
Comments:(#1*) Showing residential on the north side of the canal upstream of the sample sight. Potential for sheet flow into the canal. We could hear dogs barking throughout the neighborhood. Strong smell of feces in the area, but none seen. This area is not a planned septic replacement area.

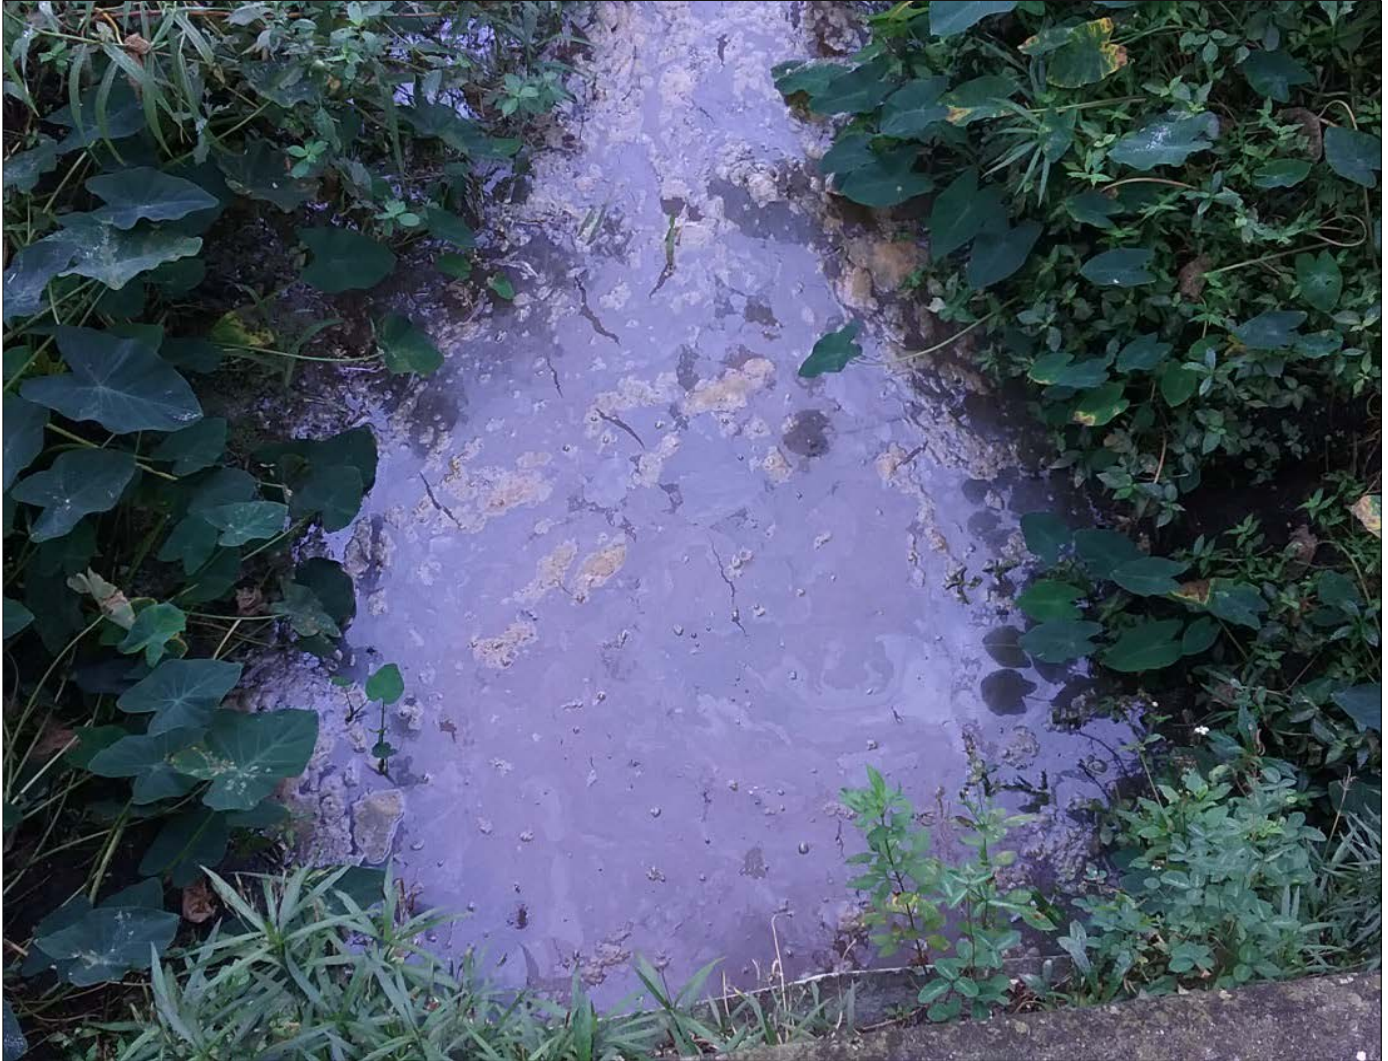
Inspector(s):	Date:	Photo Location	Photo Direction
A. Melton, M. Holland	11/29/2016	West side of S. Shade	North
Comments: Showing the cloudy water as it comes out of the pipe. Water is coming in from the south. Film and bubbles on the surface, odor is that of rust. Sample was taken at this point.

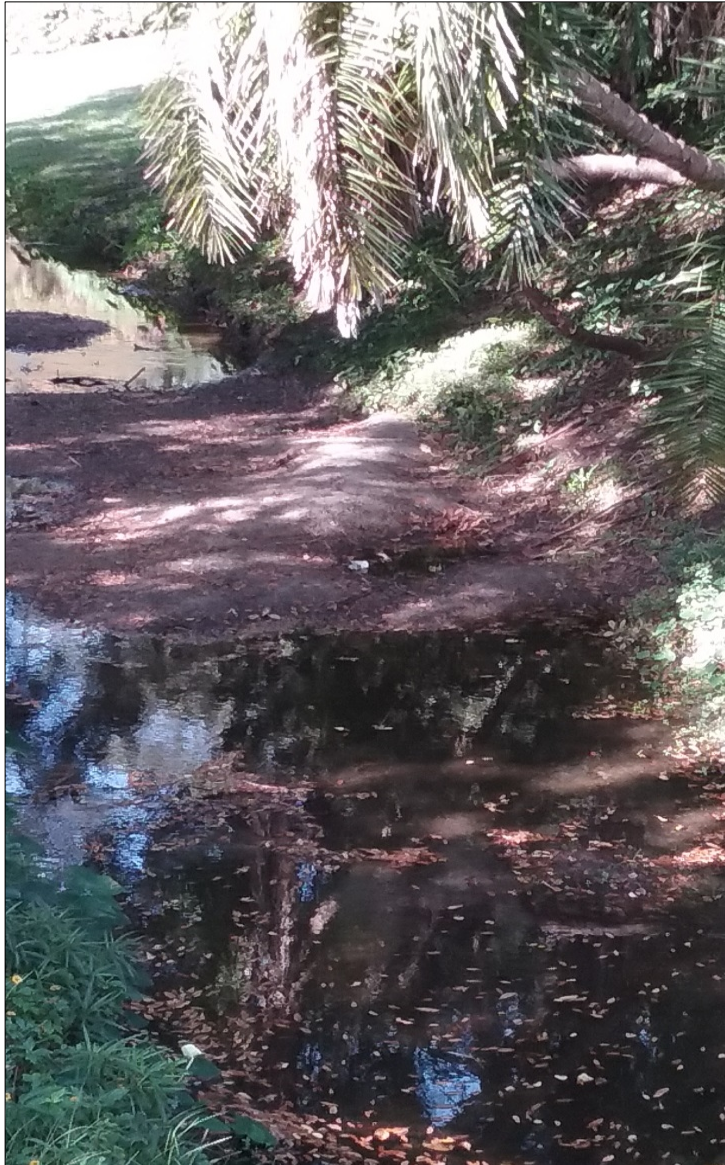
Inspector(s):	Date:	Photo Location	Photo Direction
A. Melton/M.Holland	11/29/2016	Same as Above	West

Comments: Showing the sand bar, where in the past, many birds have been seen foraging. There is a patch of bare ground below the palms that appears to be worn bare by frequent animal activities, and there is a worn path from the palm up the slope. Additionally, as seen in the photograph, there is a lot of leaf litter that collects in this area.

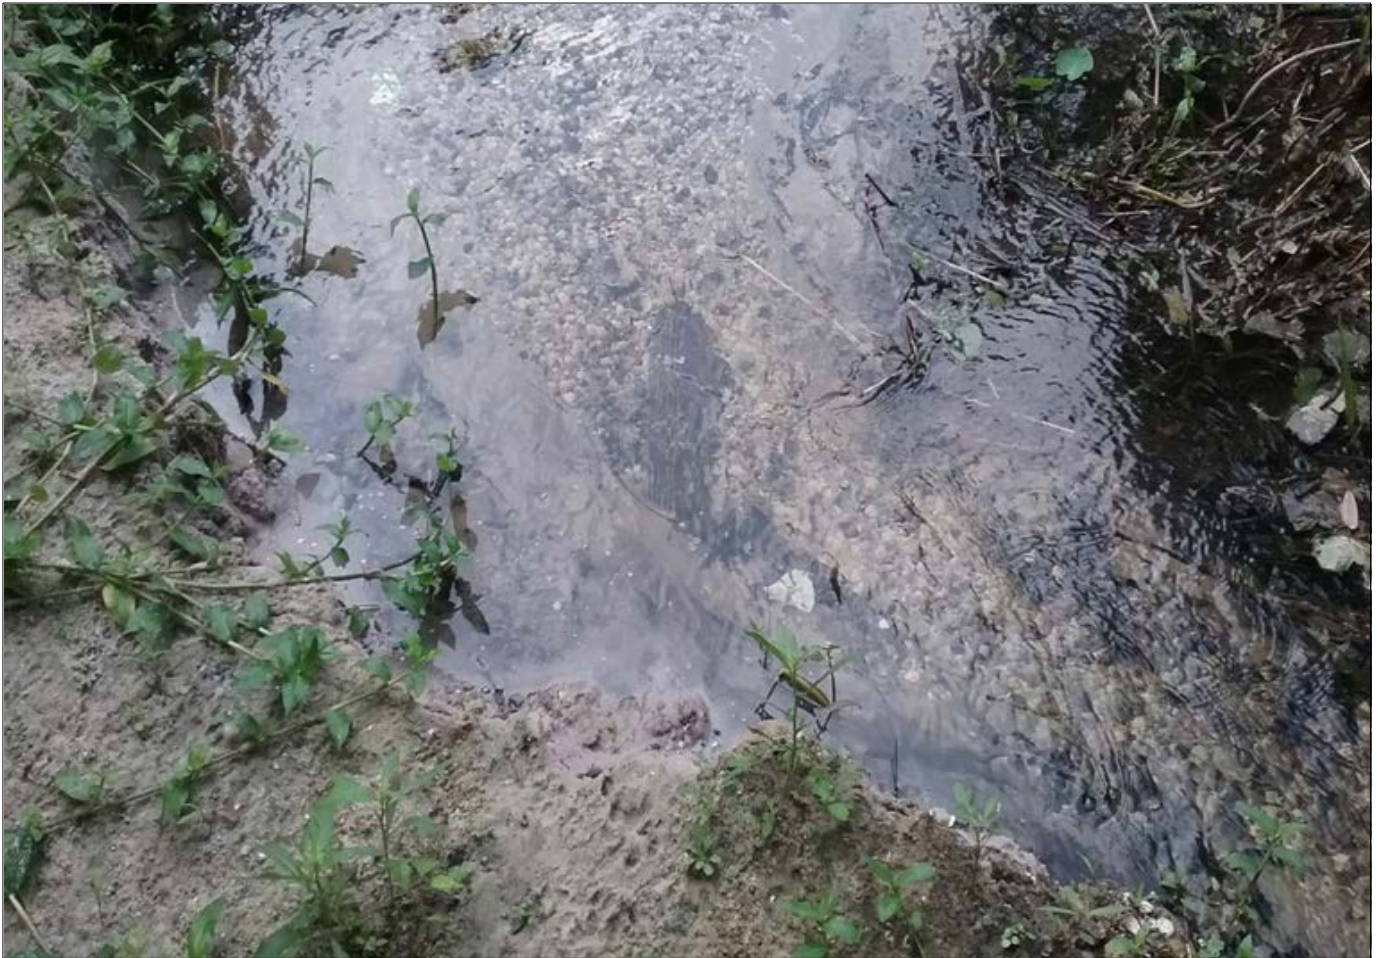
Inspector(s):	Date:	Photo Location	Photo Direction
K.O'Hara/M.Holland	12/15/2016	Same as above	N
Comments: Showing typical animal crossing under the bridge. Water here was clear and flowing. The water had a musty odor to it, similar to areas where there is low flow and decaying vegetation. There were a lot of opened bivalves on the sand bar.

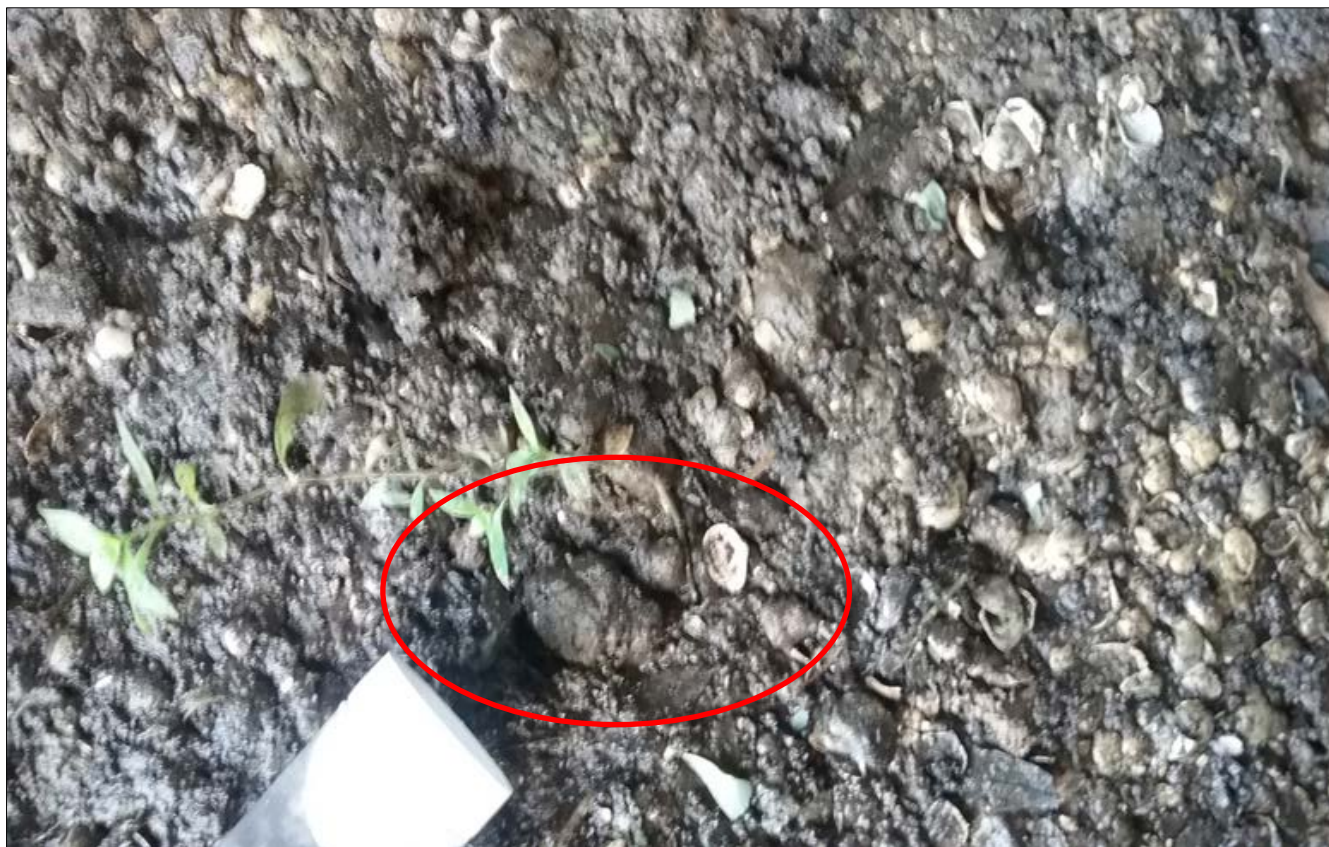
Inspector(s):	Date:	Photo Location	Photo Direction
K.O'Hara/M.Holland	12/15/2016	Same as above	N/A
Comments: Showing animal scat (just to the right of the white pole) on the sand bar, along with dozens of opened bivalves. This is upstream of the sample area.

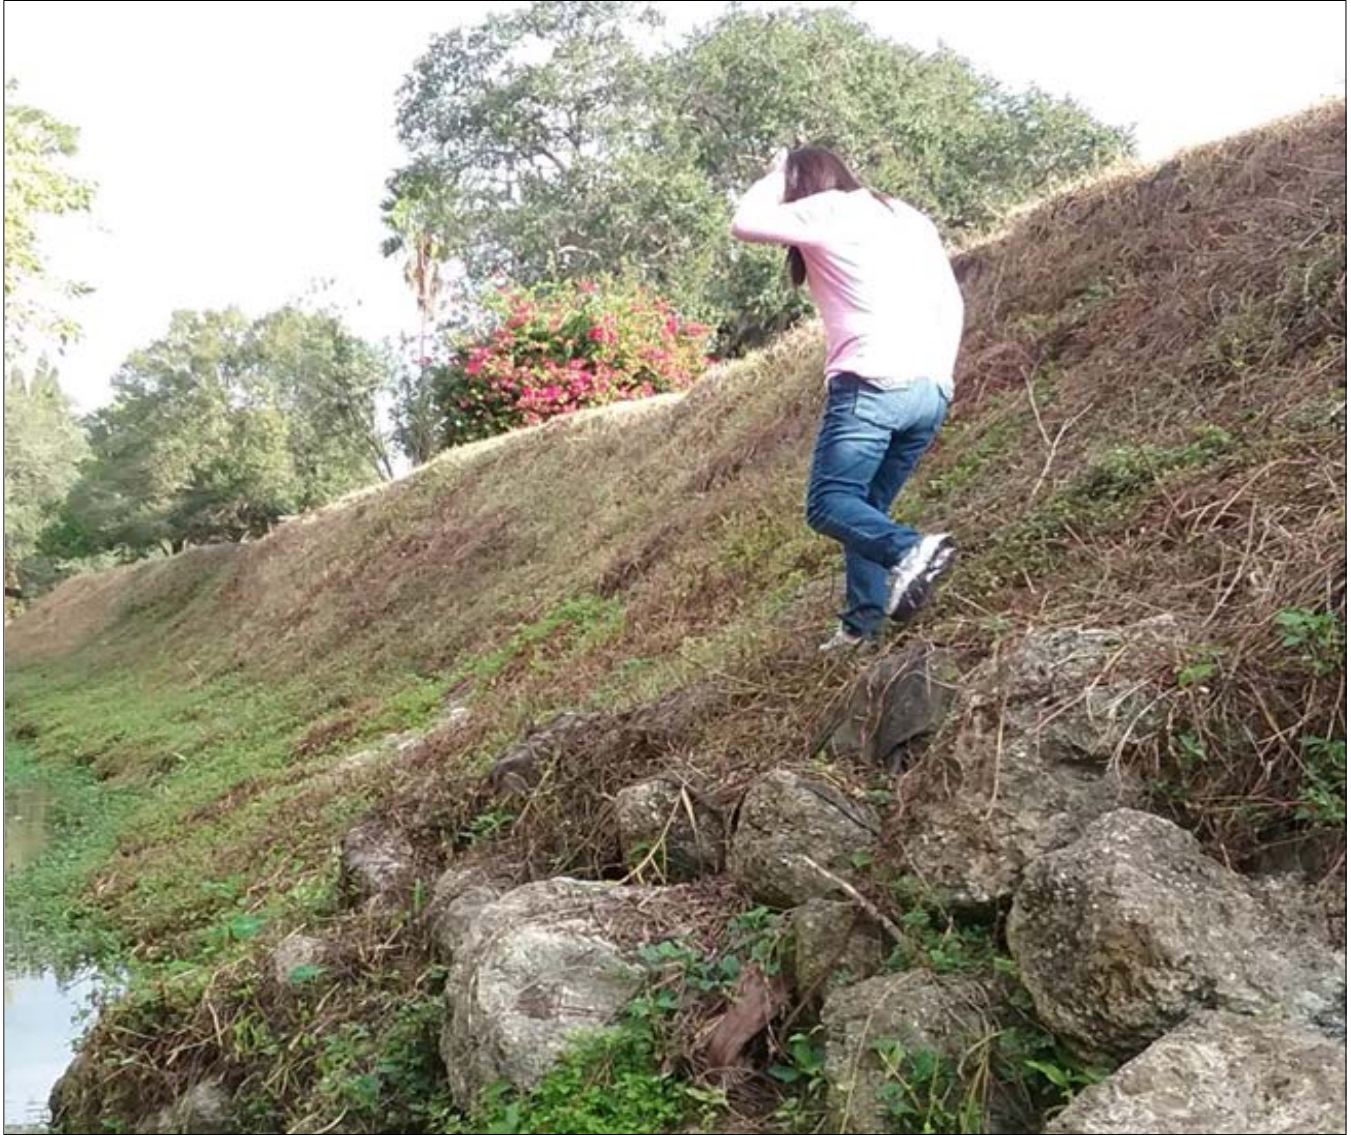
Inspector(s):	Date:	Photo Location	Photo Direction
K.O'Hara/M.Holland	12/15/2016	Upstream of the Bridge	NE
Comments: Showing Kate walking north along the Phillippi Lateral. She found no evidence of dog walking (pet waste) along the top of bank.

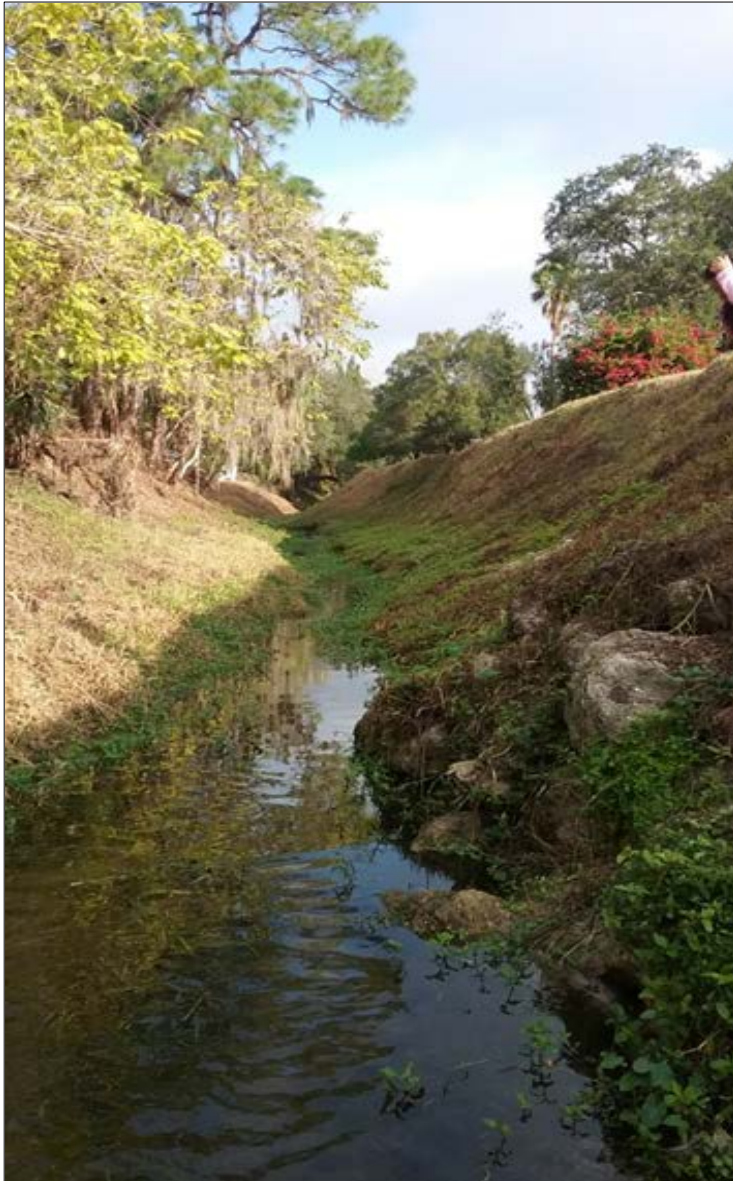
Inspector(s):	Date:	Photo Location	Photo Direction
K.O'Hara/M.Holland	12/15/2016	Same as above	North
Comments: Showing the canal to be inspected. Banks on each side are usually heavily vegetated, but there was a recent maintenance event. Slopes are steep and heavily vegetated.

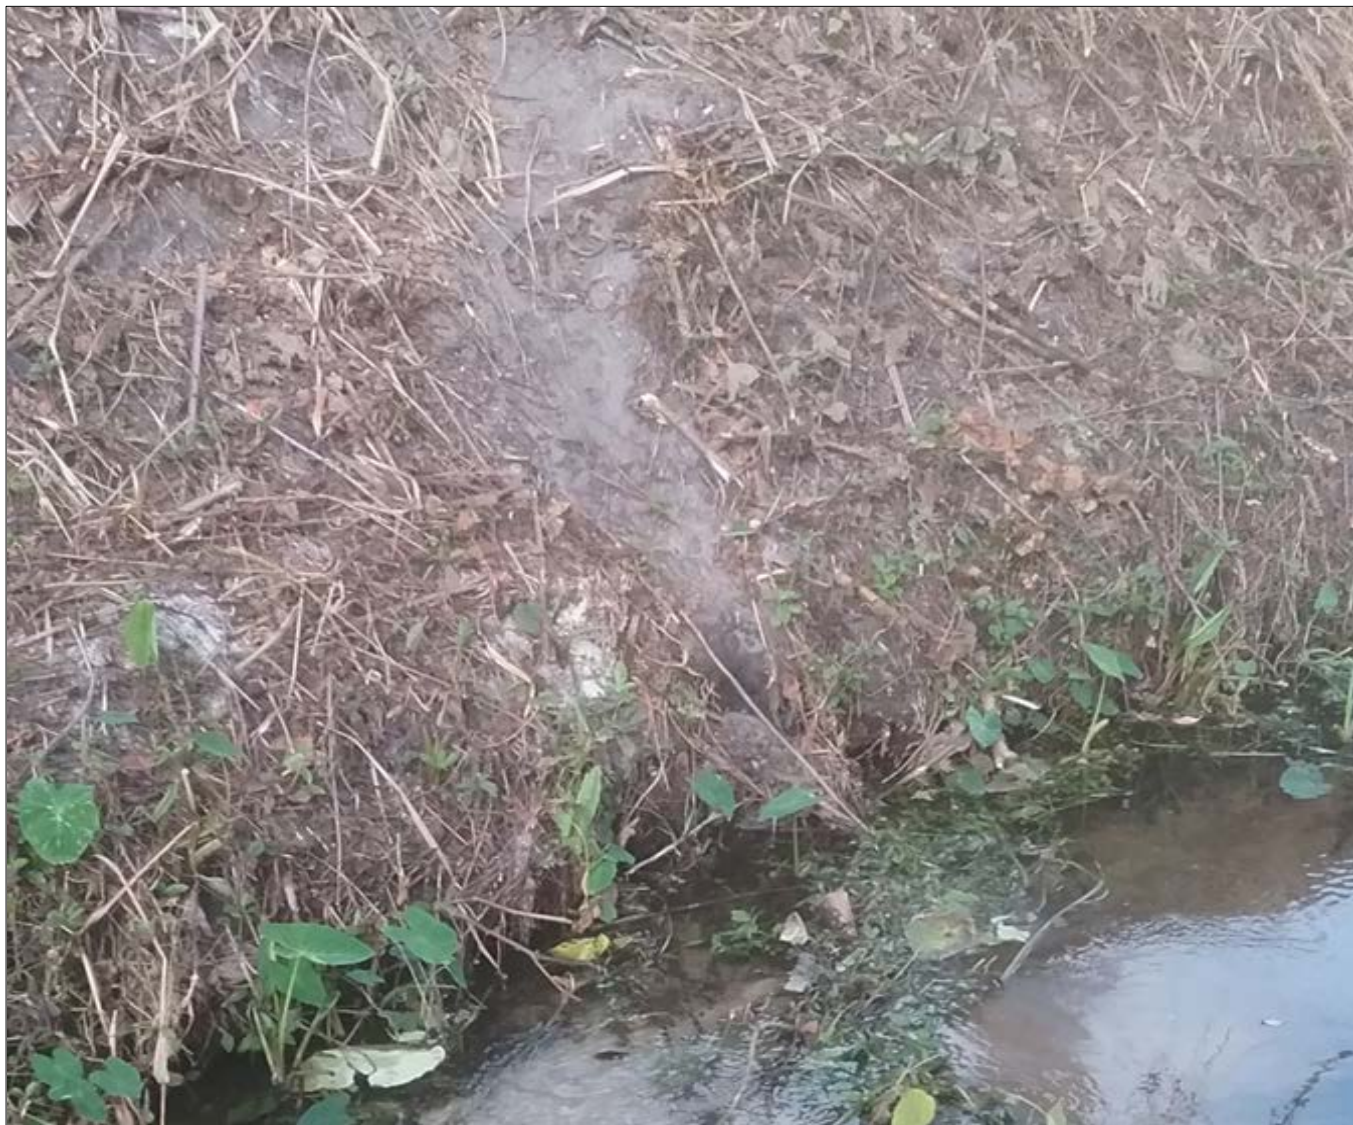
Inspector(s):	Date:	Photo Location	Photo Direction
K.O'Hara/M.Holland	12/15/2016	Same as above	West
Comments: Showing a well worn animal trail to the canal. On the west side of the canal, just upstream of the outfall for the above pond.

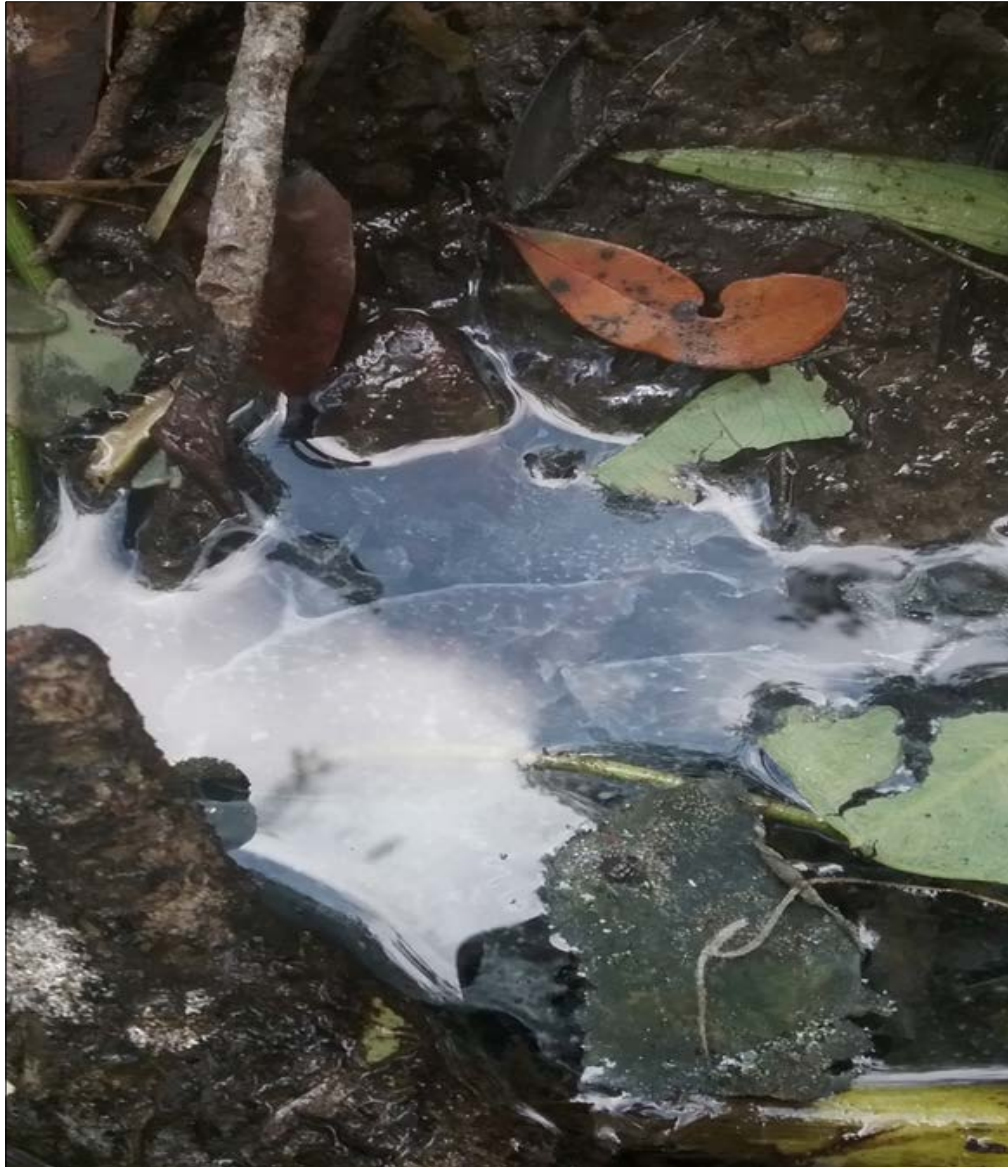
Inspector(s):	Date:	Photo Location	Photo Direction
K.O'Hara/M.Holland	12/15/2016	North of sample area	N/A
<p>Comments: About a quarter of the way up the canal, areas of a white film on the sediment started to appear. In areas along the bank where vegetation was present, there was a film on the water. Film on the water can be a natural result of a microbial process of iron loving bacteria. Evidence of the presence of iron is shown in some following photographs.</p>

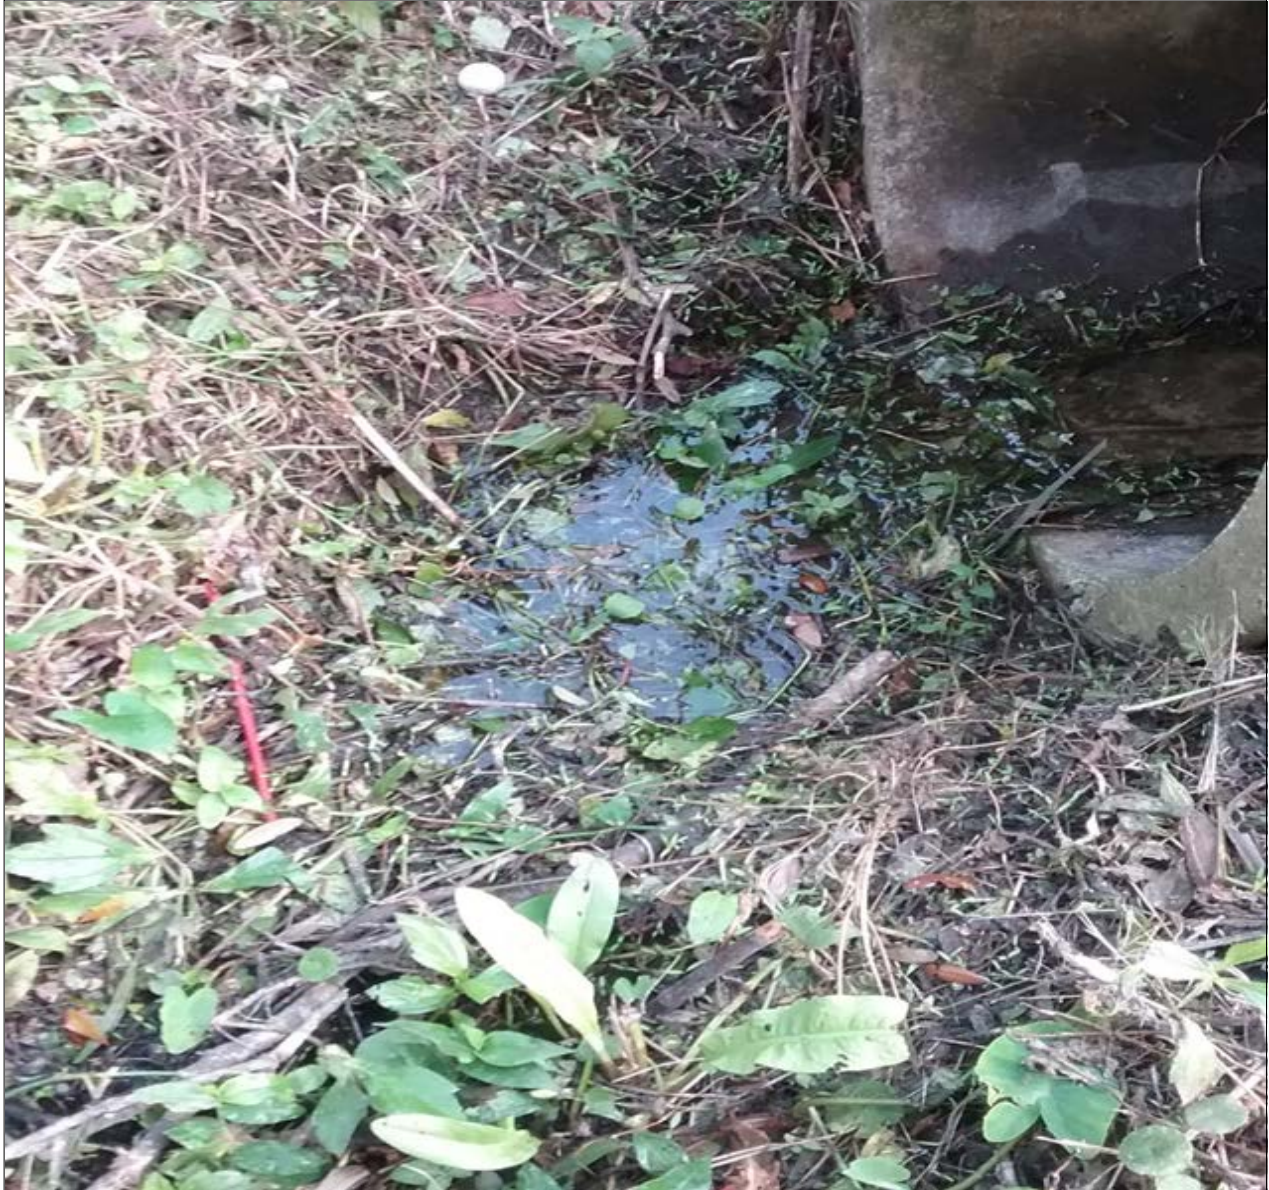
Inspector(s):	Date:	Photo Location	Photo Direction
K.O'Hara/M.Holland	12/15/2016	Outfall of P4-40	N/A

Comment: Outfall of P4-40. Some discharge from the pipe. It is not stormwater but groundwater infiltration. No smell to the water or the pipe.

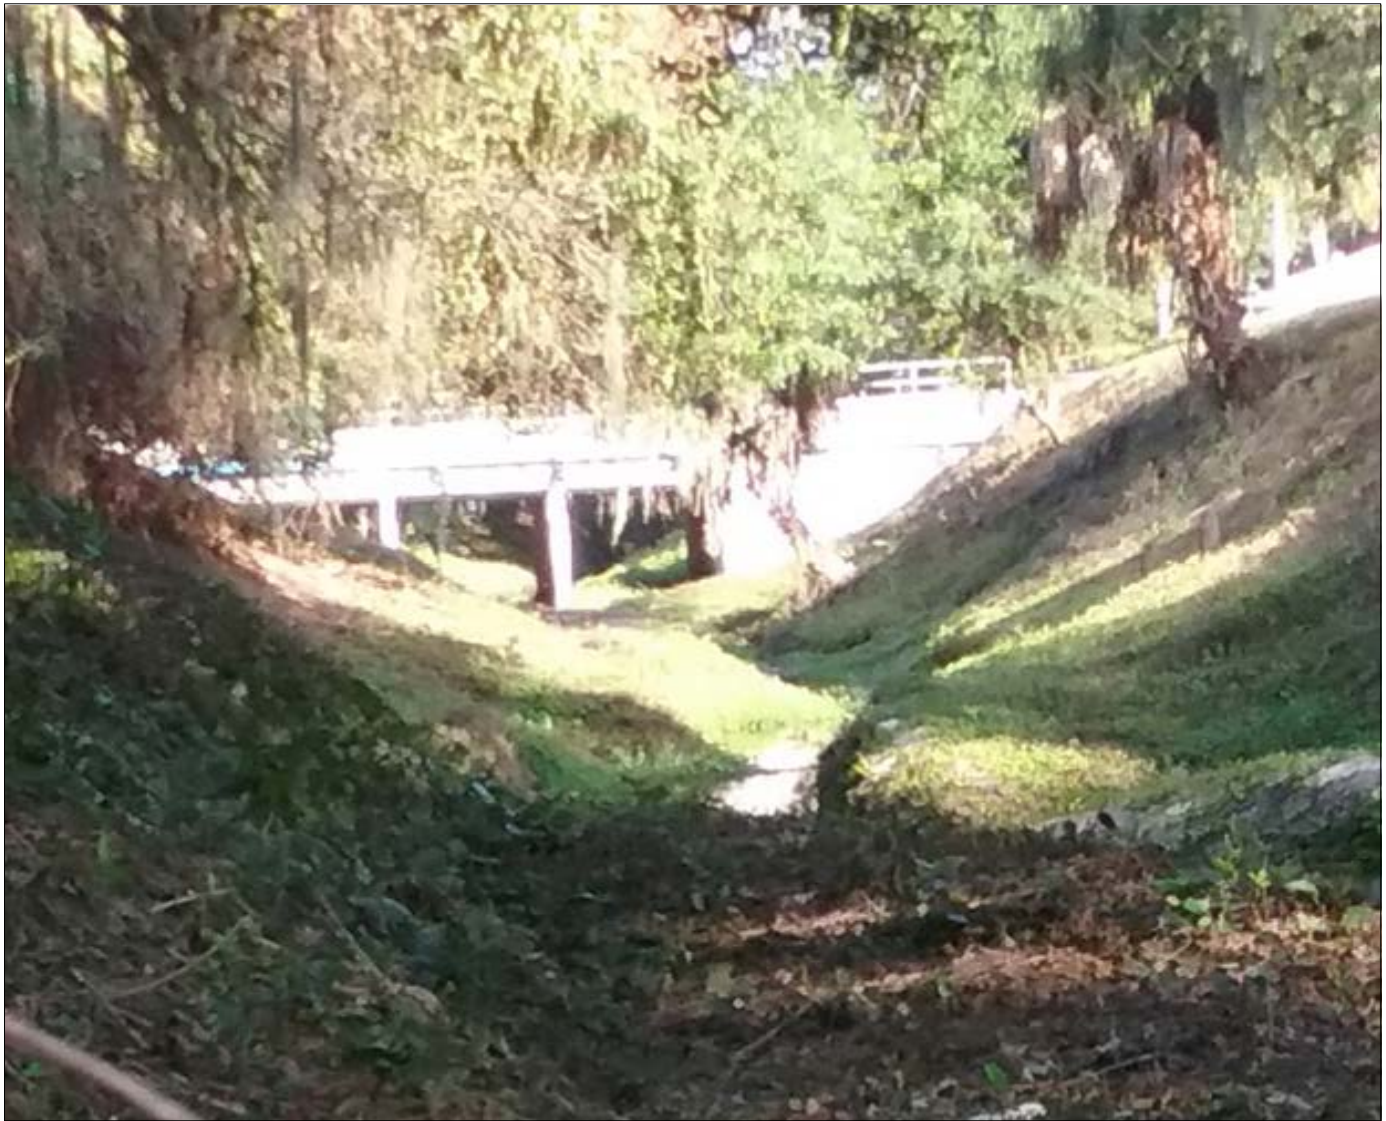
Inspector(s):	Date:	Photo Location	Photo Direction
K.O'Hara/M.Holland	12/15/2016	Bridge at Davis Blvd	North
Comments: Showing east and west banks of the canal. Recently cleared of vegetation. No pipes or potential point discharges were noted along this portion of the canal. Additionally, it appears that properties on the east side (right) of the canal have been graded to drain to the streets, not to the canal. This is not the case for some properties on the west side (left).
