Summary of Results

Walk the WBID Exercise for Philippi Creek
(WBID1937)

FINAL DRAFT

September 27, 2017

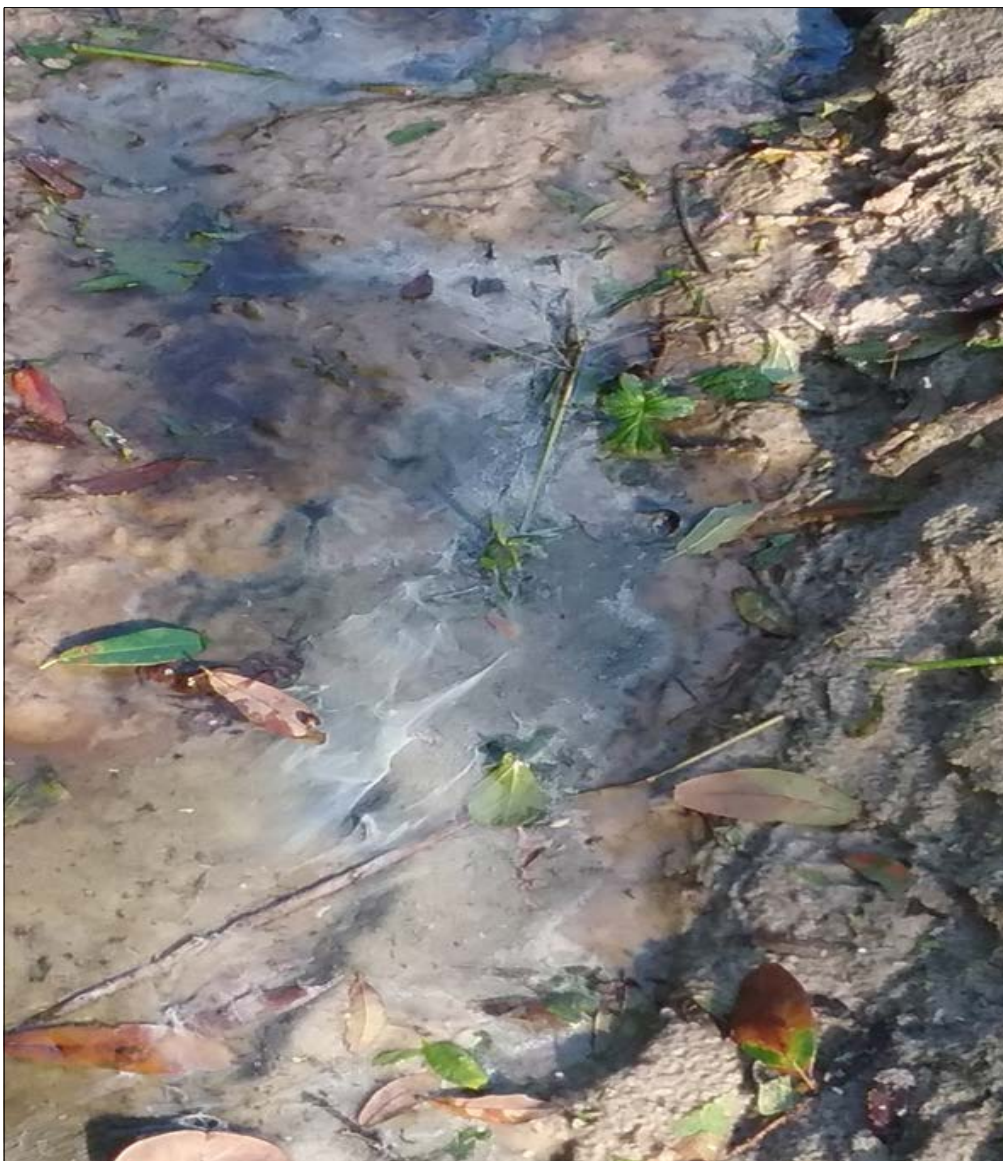
Inspector(s):	Date:	Photo Location	Photo Direction
K.O'Hara/M.Holland	12/15/2016	North of P4-40 Discharge	N/A
Comments: Once again, this white, stringy appearing substance was present. Similar situations have been seen in the presence of sulfur bacteria, however there was no odor of sulfur.

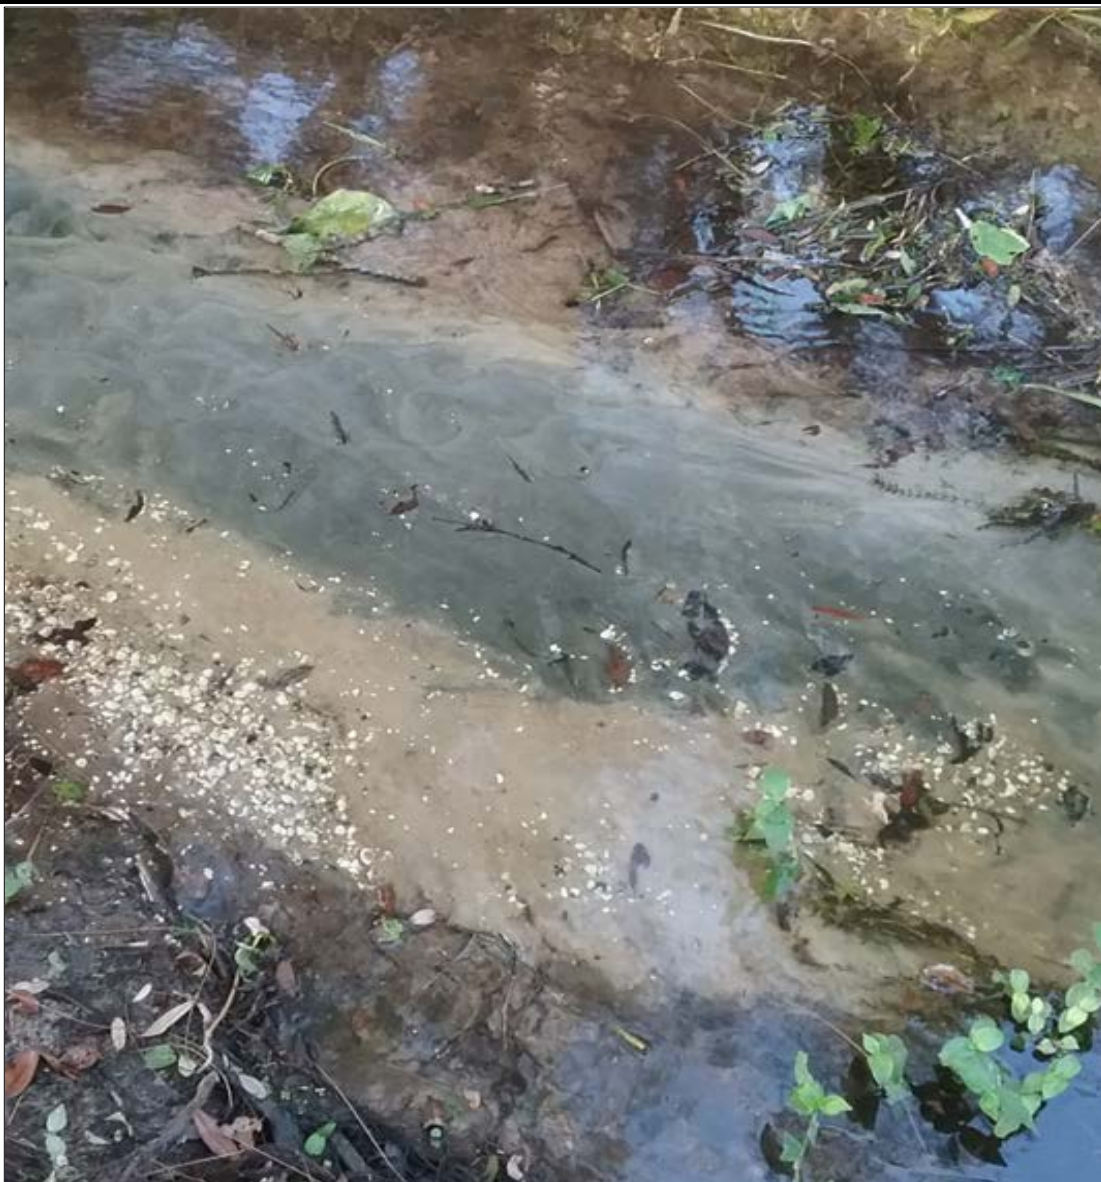
Inspector(s):	Date:	Photo Location	Photo Direction
K.O'Hara/M.Holland	12/15/2016	At outfall by Hawkeye Cir	SW
Comments: Showing white material on the sediment, as well as a fine greyish sediment as well. This is found on areas of the canal south of the outfall.

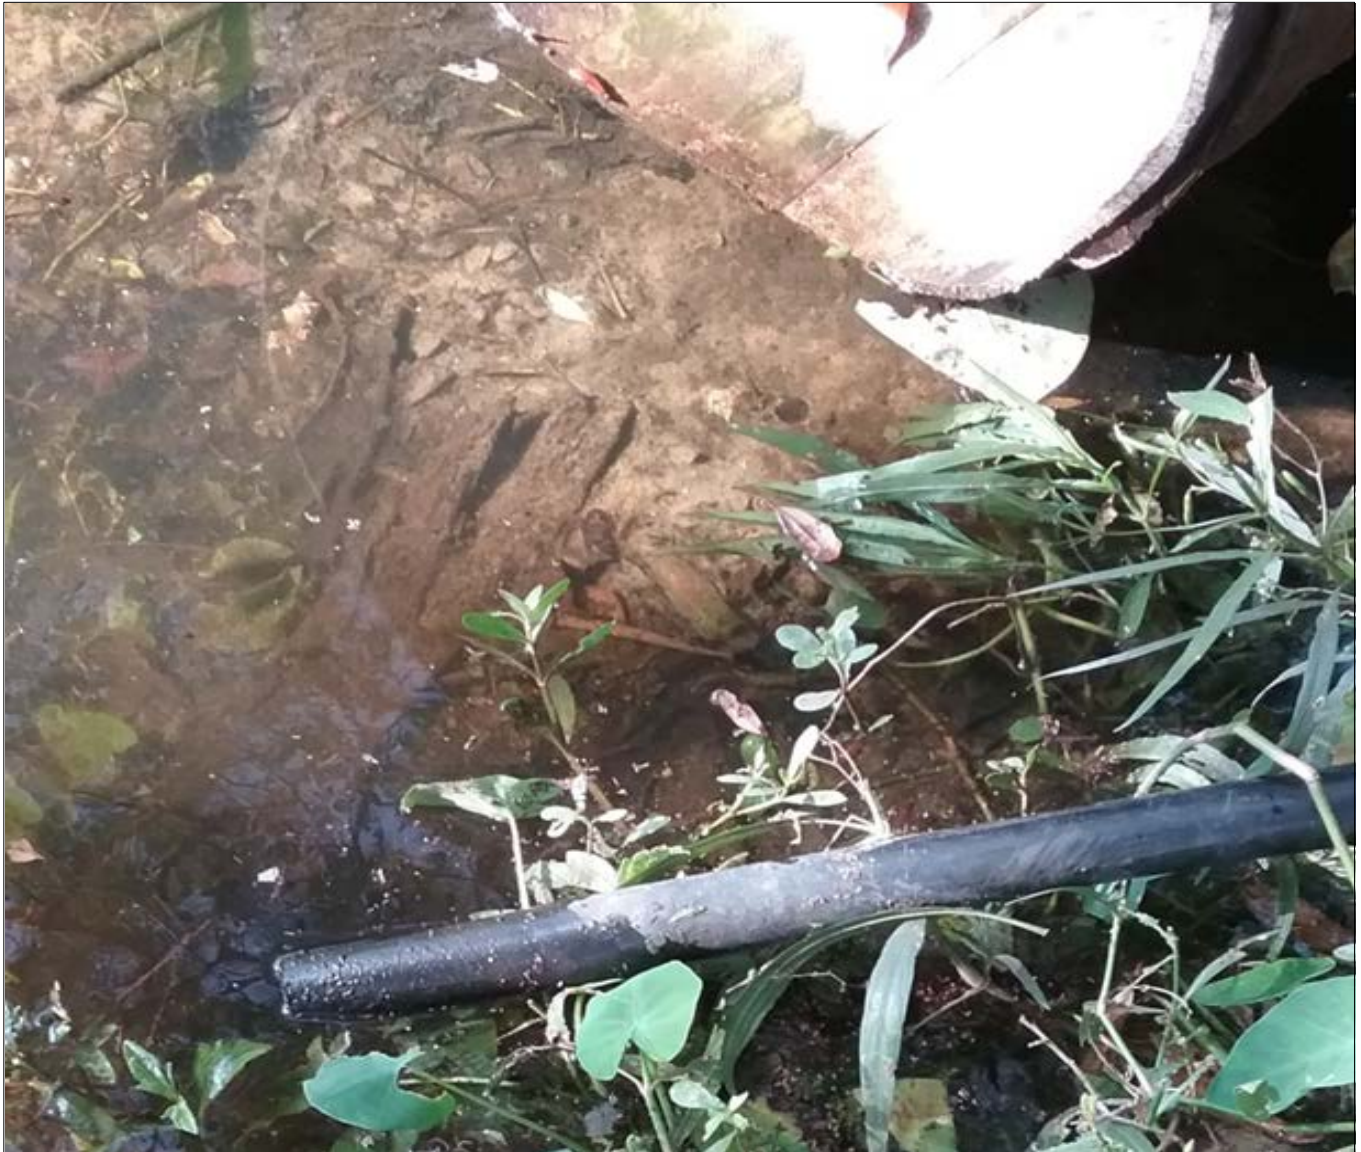
Inspector(s):	Date:	Photo Location	Photo Direction
K.O'Hara/M.Holland	12/15/2016	At the Hawkeye Cir outfall	SW
Comments: Not sure what function this pipe serves, if any. Pipes of this nature are usually attached to the washing machine and allows for greywater discharge. The pipe was reported to Air and Water Quality Staff for follow up.

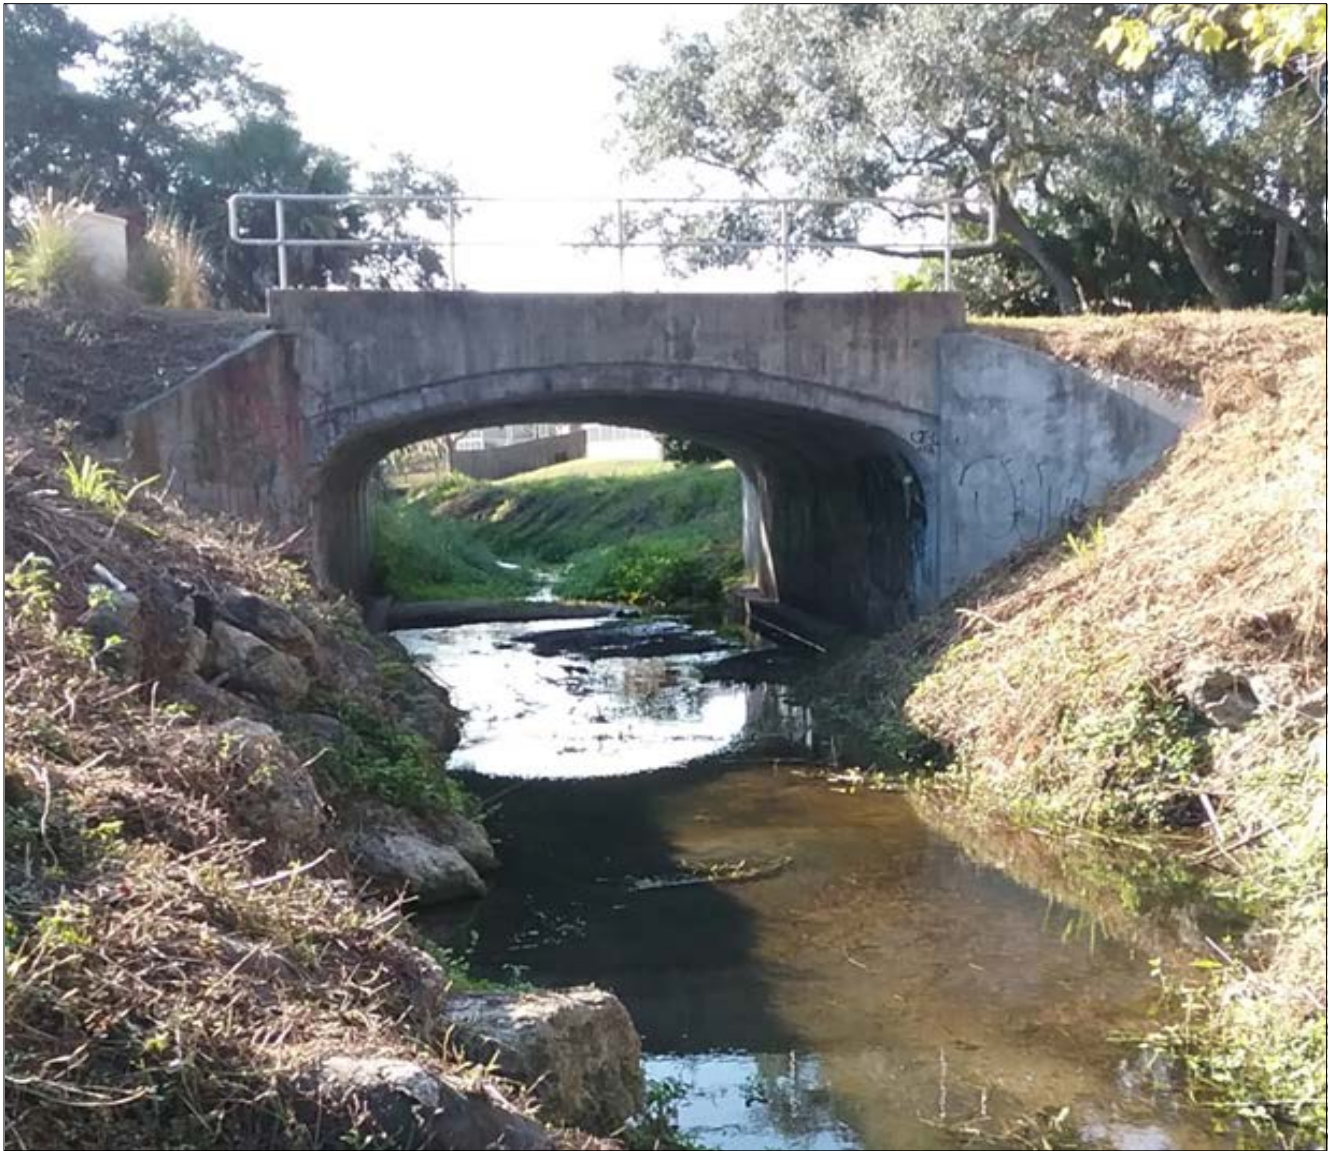
Inspector(s):	Date:	Photo Location	Photo Direction
K.O'Hara/M.Holland	12/15/2016	N of the Bridge at Woodview	South
Comments: Showing the bridge from the north. Monthly monitoring samples are taken on the south side of the bridge - in the foreground. Sand bar where the tracks and scat was visible under the bridge.

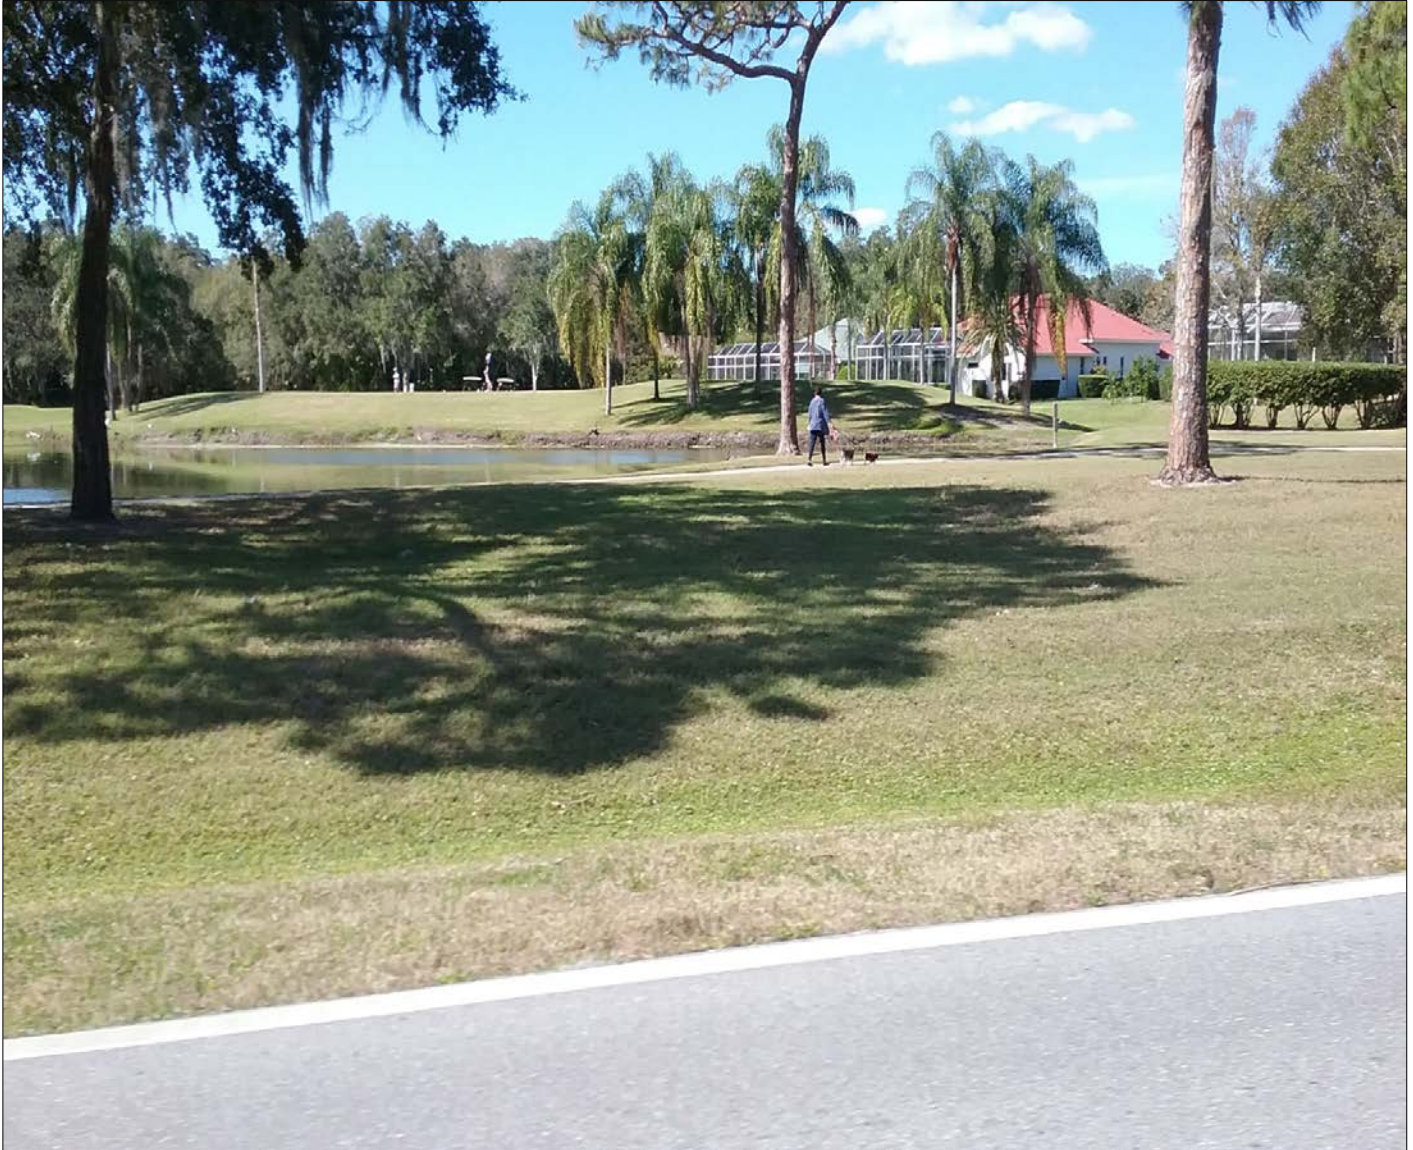
Inspector(s):	Date:	Photo Location	Photo Direction
M. Holland	1/31/2017	Londmeadow Drive	NE
Comments: (#2)The Meadows is a large residential community of mostly retirees. Shown here is common for the area, walking the dogs. It is unclear if they have outreach for picking up pet waste, and there was no obvious signage about picking up pet waste. They will be contacted in the future to assist them if they need a program.

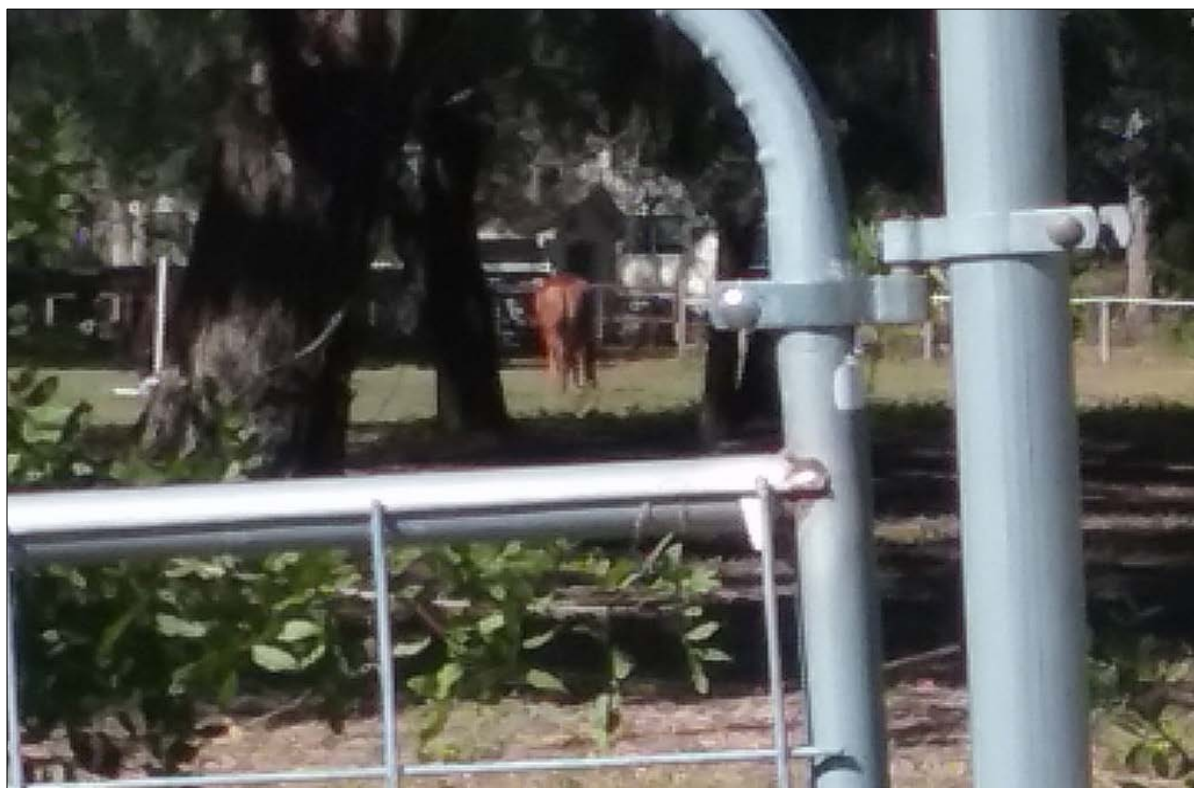
Inspector(s):	Date:	Photo Location	Photo Direction
M.Holland	1/31/2017	5167 Desoto Rd	North
Comments: (#4). Showing the second place where livestock was found. Owners have at least 2 horses on several acres. Unsure if there is a stable/paddock area where the animals congregate. There appears to be no direct connecton to major ditches and swales which convey to Phillippi Creek.

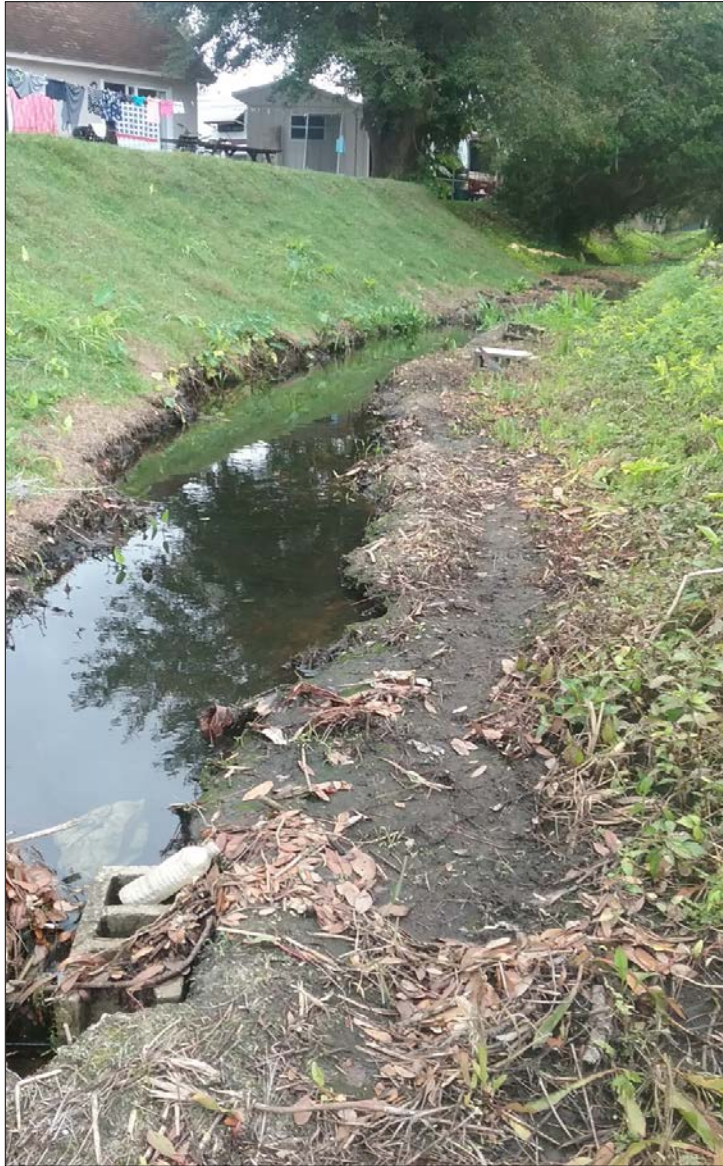
Inspector(s):	Date:	Photo Location	Photo Direction
M.Holland	2/23/2017	Seaview	North
Comments: (#2)Heading north in the ditch. Some trash in the ditch, decaying organic matter as well. There is a heavily travelled animal (probably raccoons) to the right of the flowing water. Water was still mostly clear, light brown in color. Bank to the left in the picture was recently re-sodded.

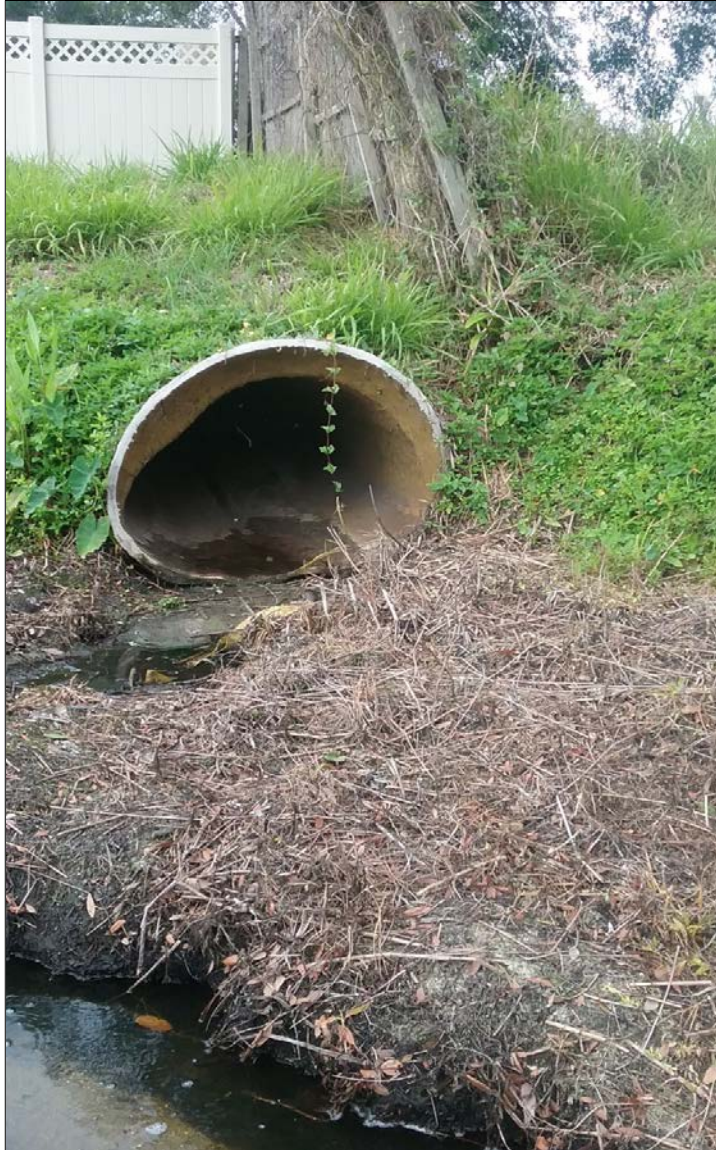
Inspector(s):	Date:	Photo Location	Photo Direction
M.Holland	2/23/2017	Bend in ditch at SV	West
Comments: (#3). Showing pipe that accepts runoff from road/property to the north (Kauffman Ave). Area in front and to the right of the pipe looks heavily travelled by animals.

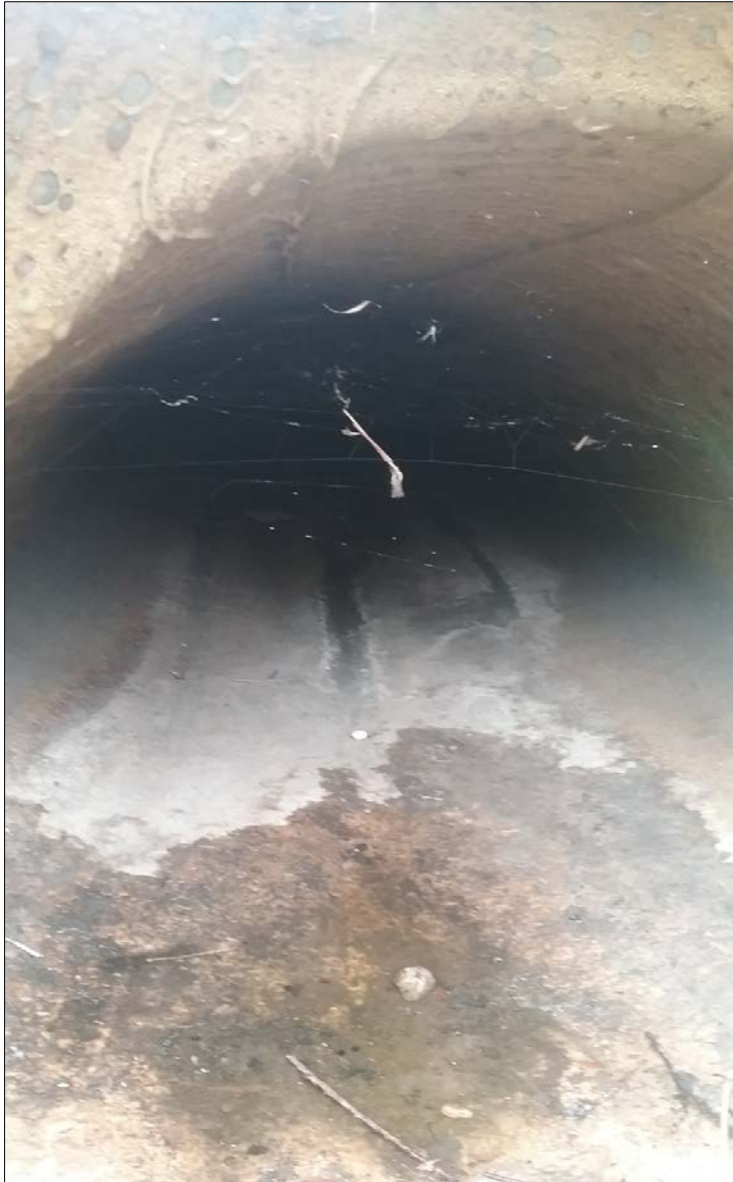
Inspector(s):	Date:	Photo Location	Photo Direction
M.Holland	2/23/2017	Same as above	inside pipe
Comments: (#3). Showing mouth of the pipe mentioned above. Stainlines indicate it conveys water at less than one quarter capacity. No odor in the pipe that would indicate animal denning. Light could been seen at the other end. Green arrow on the map - Page 1 - denotes the pipe.

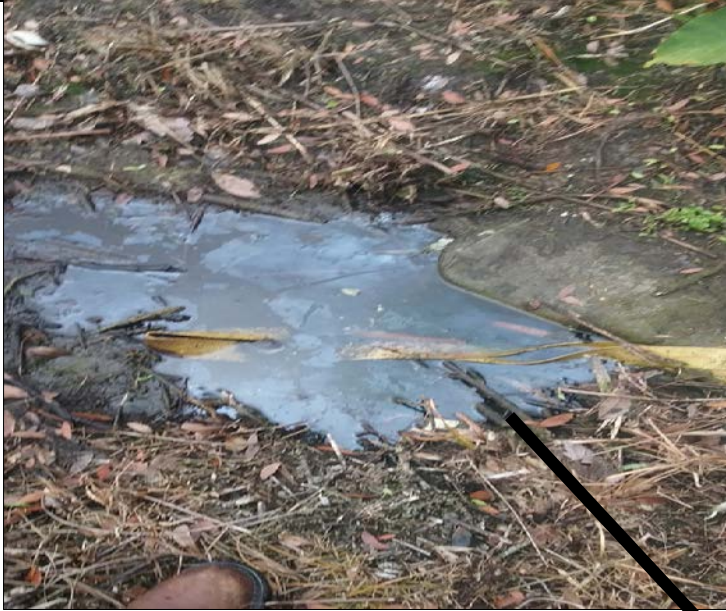
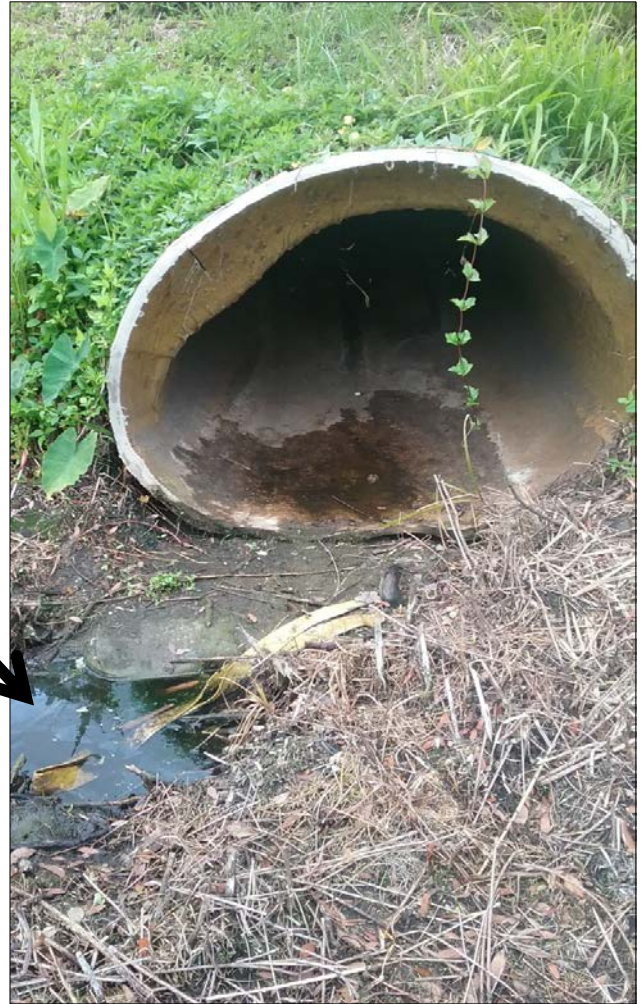
Inspector(s):	Date:	Photo Location	Photo Direction
M.Holland	2/23/2017	Mouth of the pipe	West
Comments: (#3). Showing well travelled area in from of the pipe - pipe collar begins at the concrete bag in the middle right of the picture. Plenty of raccoon tracks around this puddle.

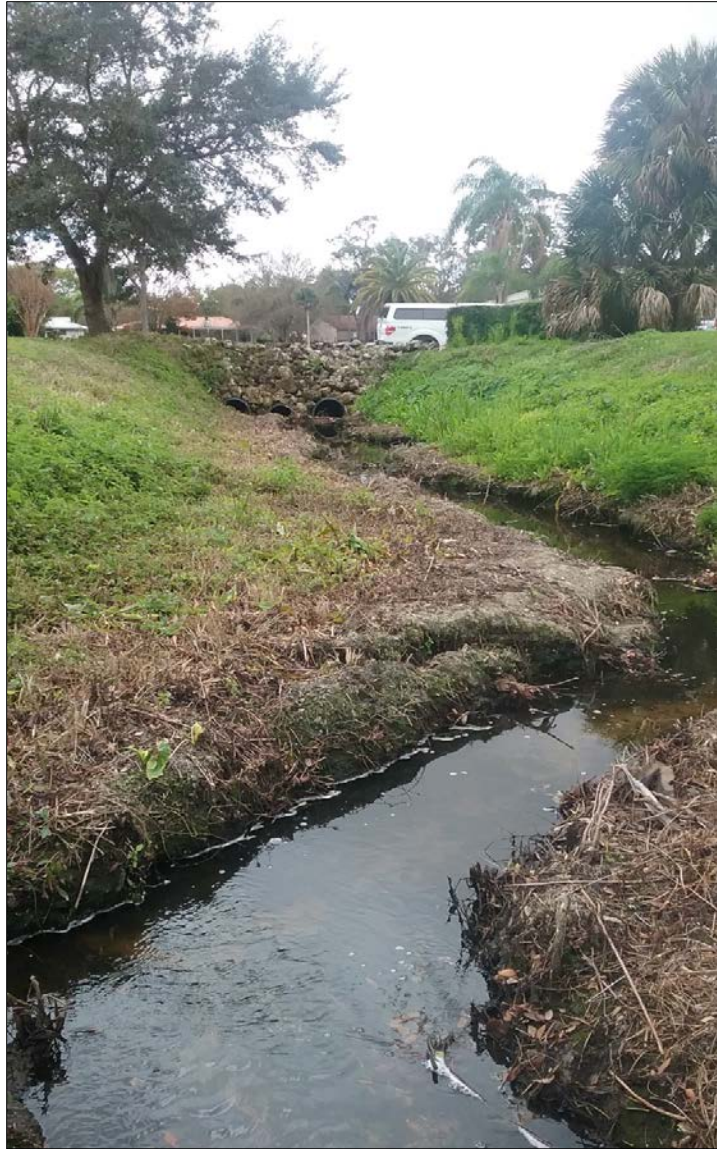
Inspector(s):	Date:	Photo Location	Photo Direction
M.Holland	2/23/2017	Looking at Seaview Dr	South
Comments: (#3). Showing the condition of the ditch heading south to Seaview. Recently maintained. Lots of decaying vegetation in the ditch, but not in the water currently. Flowing at the time of the site visit.

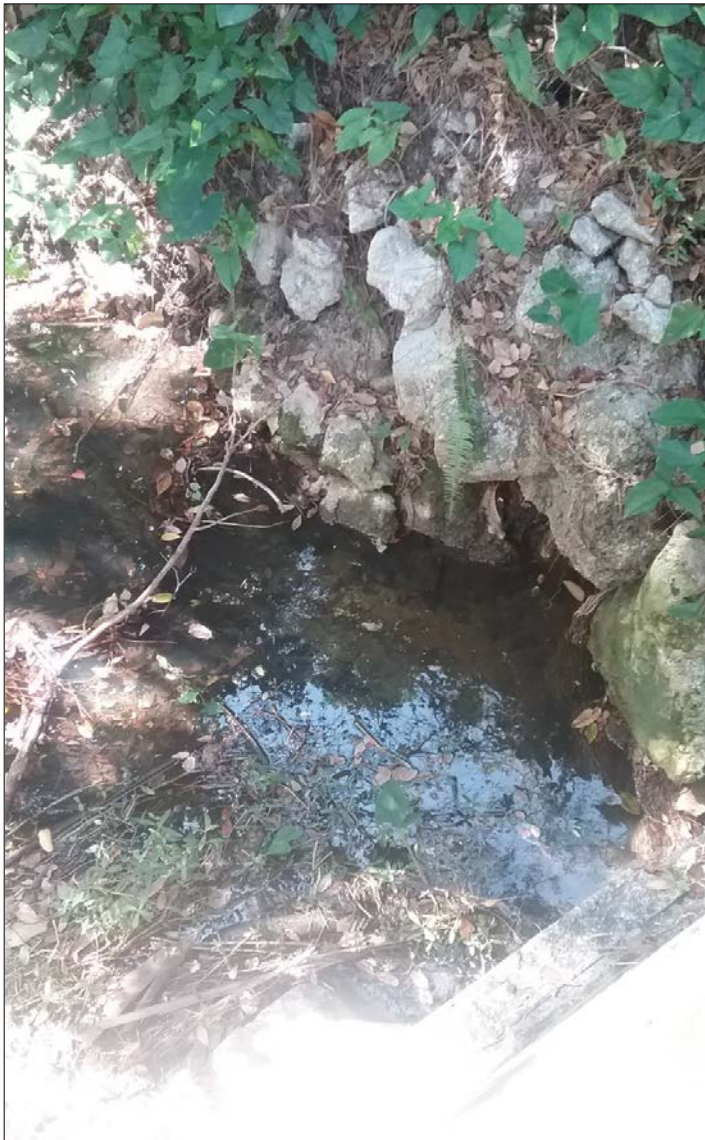
Inspector(s):	Date:	Photo Location	Photo Direction
M. Holland/J. Talbott/N.ladavia	3/1/2017	Nassau Street	North
Comments: (#1).Showing the slough as it passes under Nassau Street. The sample was taken here. Only one of the culverts was flowing, the other was blocked. Vegetation - intact and decaying - gets bottle necked in this area.

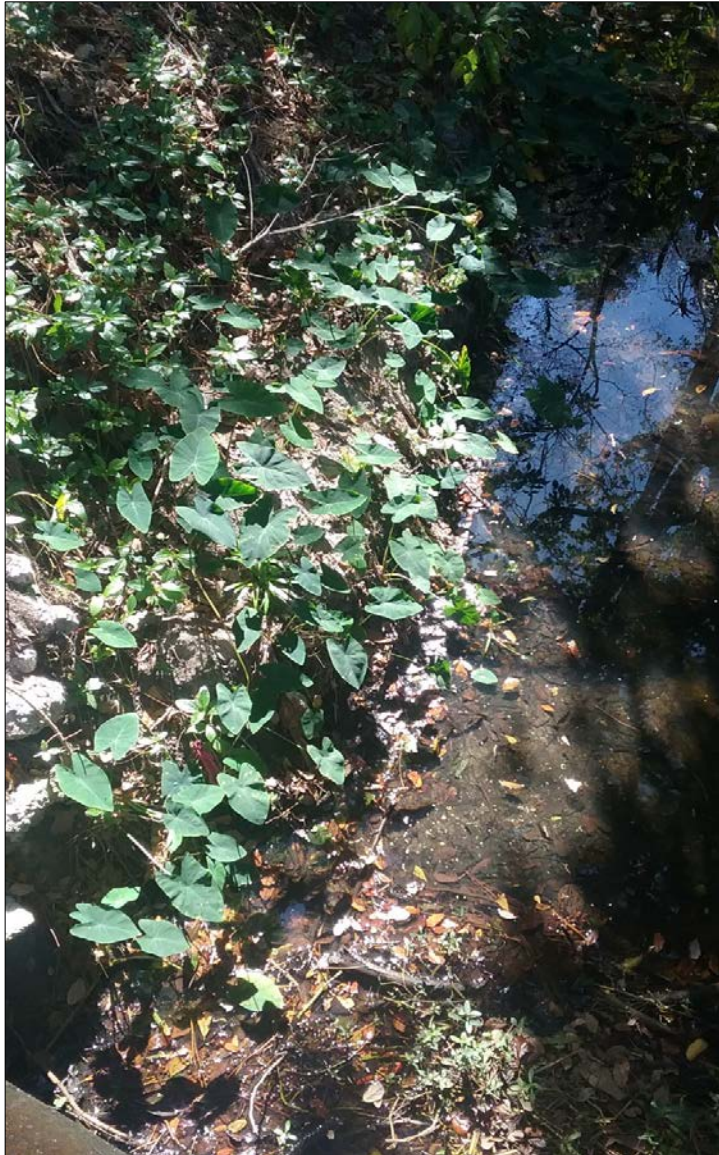
Inspector(s):	Date:	Photo Location	Photo Direction
M. Holland/J. Talbott/N.ladavia	3/1/2017	Same as above	South
Comments: (#1) Showing the eastern culvert. It is almost completely blocked, allowing for detritus to stack up here.

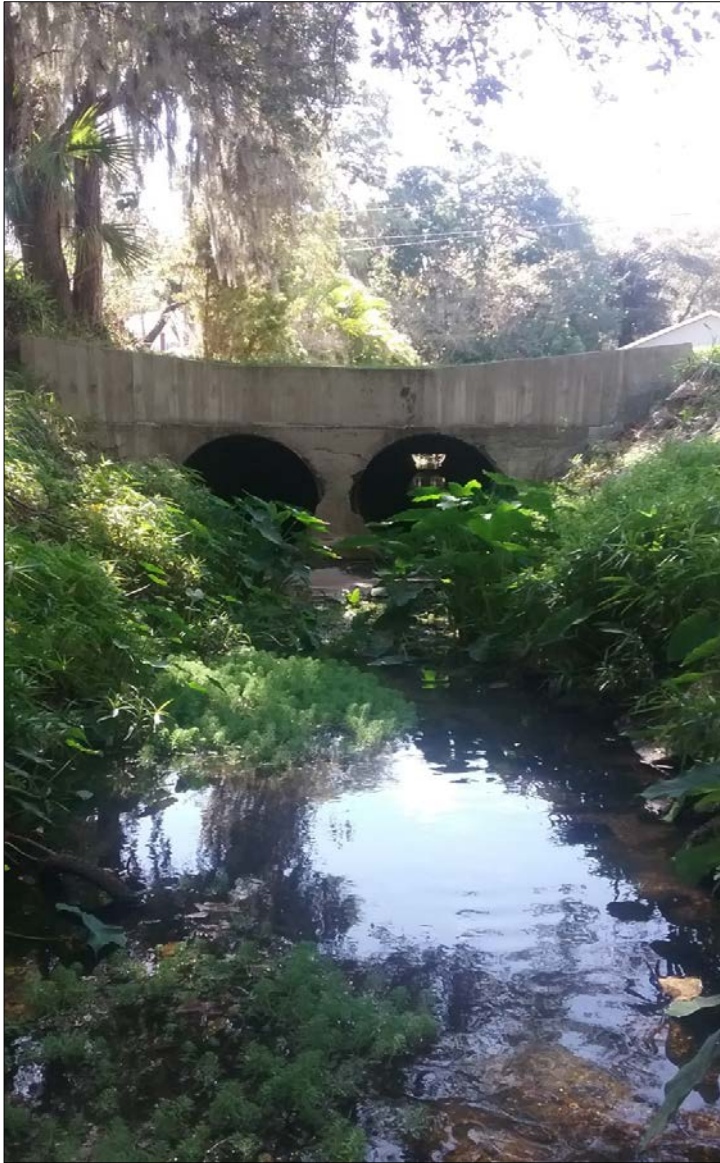
Inspector(s):	Date:	Photo Location	Photo Direction
M. Holland/J. Talbott/N.ladavia	3/1/2017	Nassau Street	South
Comments: (#2). Lookin at the downstream end of the box culverts at Nassau. Side slopes are mostly vegetated. Water is nearly completely shaded at this point of the Slough. Substrate is a mix of shell and decaying organic matter. Water is still clear, with a light brown color. Some emergent vegetation in this segment of the slough.

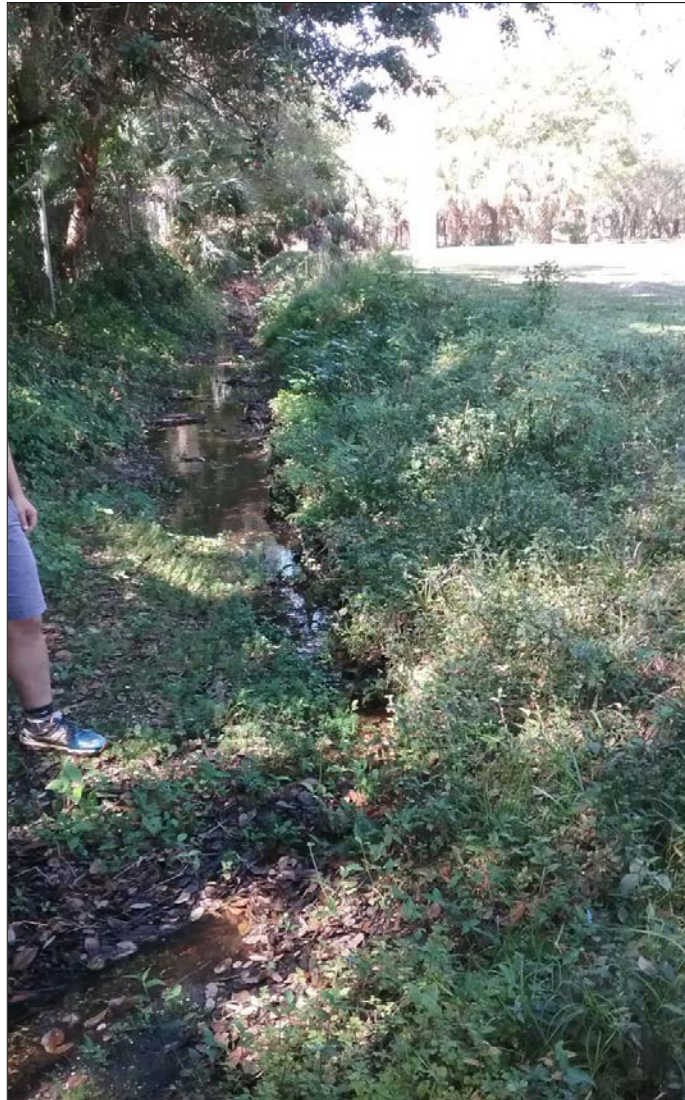
Inspector(s):	Date:	Photo Location	Photo Direction
M. Holland/J. Talbott/N.ladavia	3/1/2017	Same as above	West
Comments: (#3). In the ditch bottom showing the conditions. Water was moving, barely. All but the flow way is vegetated. Flow way is sandy/mucky with quite a bit of decaying leaves.

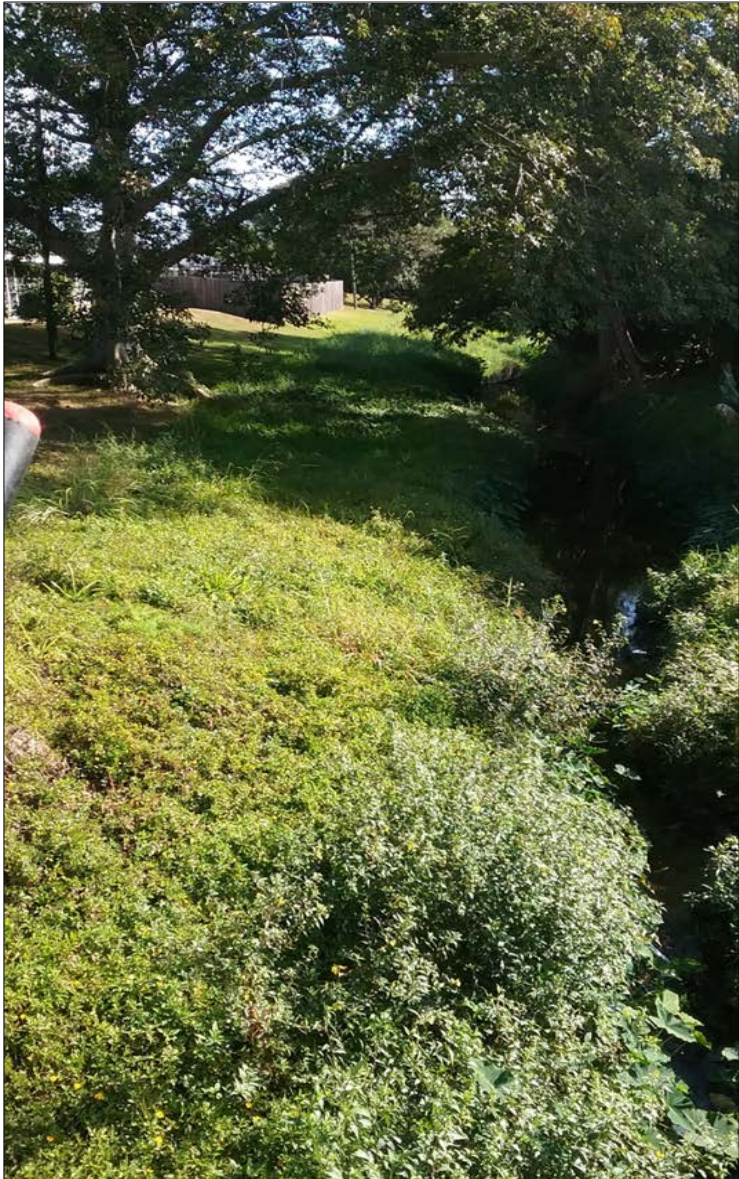
Inspector(s):	Date:	Photo Location	Photo Direction
M. Holland/A. Melton	11/29/2016	Same as above	East
Comments: Showing the overall condition of the north bank of the ditch. It appears the the back yards of homes on both the north and south banks are graded to drain to the ditch. Pet waste from the yards will end up in the ditch.

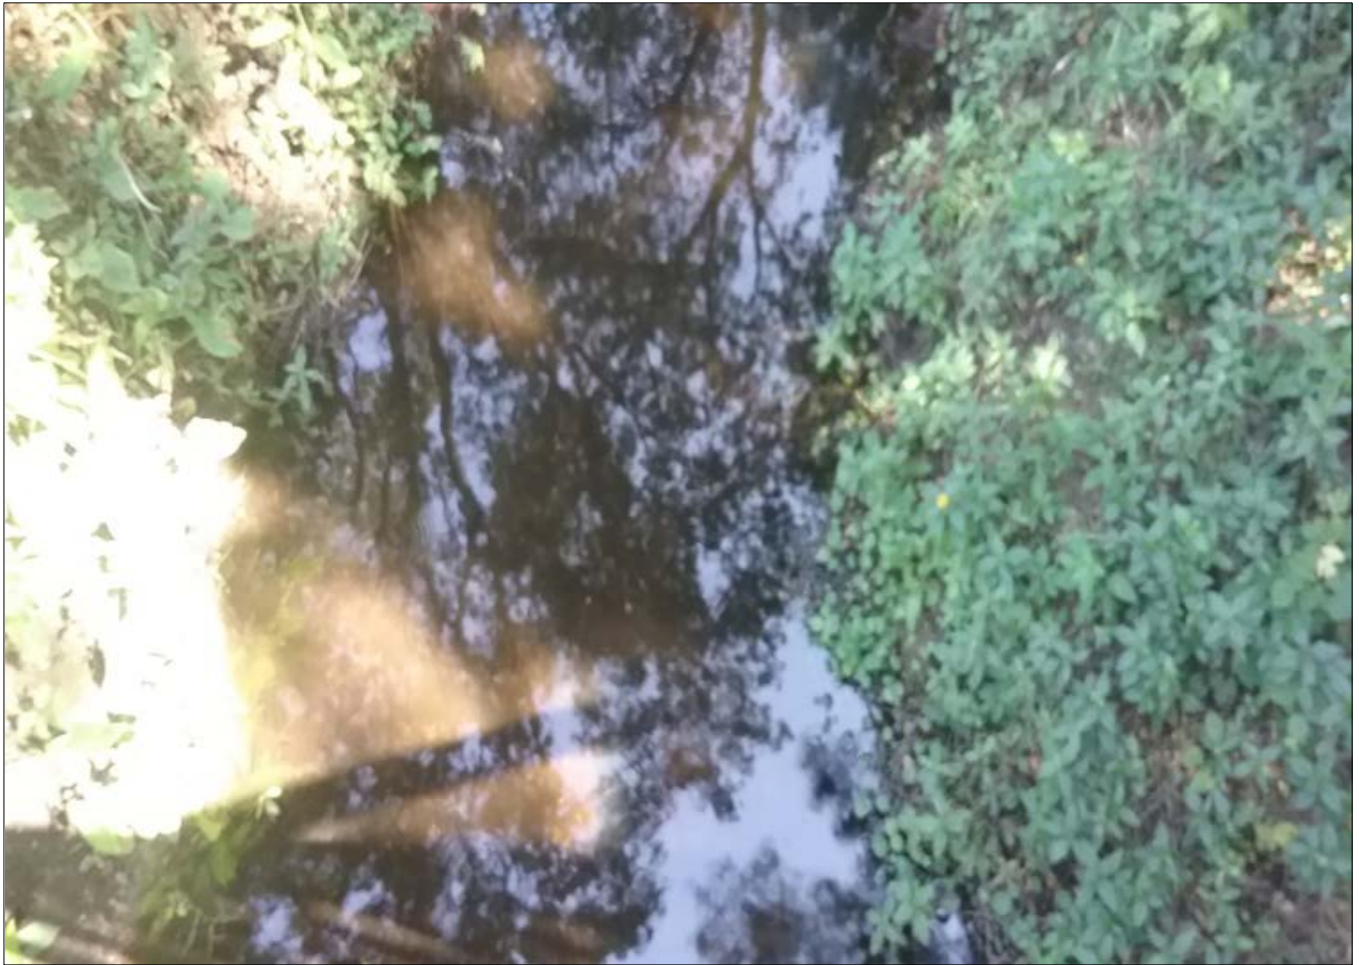
Inspector(s):	Date:	Photo Location	Photo Direction
A.Melton/M.Holland	11/16/2016	Same as above	East
Comments: Showing the overall appearance of the water in the canal. Bottom was sandy/shell with a slight layer of decaying organic matter. Water had a slight musty smell. There was a minimal flow in the ditch.
