SARASOTA COUNTY

ENVIRONMENTAL PROTECTION DIVISION MANGROVE TRIMMING AND PRESERVATION AFTER-THE-FACT PERMIT

PERMIT NO. 17-105188 RR

LOCATION: Southern shoreline of 217 Lychee Road on a canal leading to Blackburn Bay, Nokomis, Florida 34275. PID: 0161-15-0027

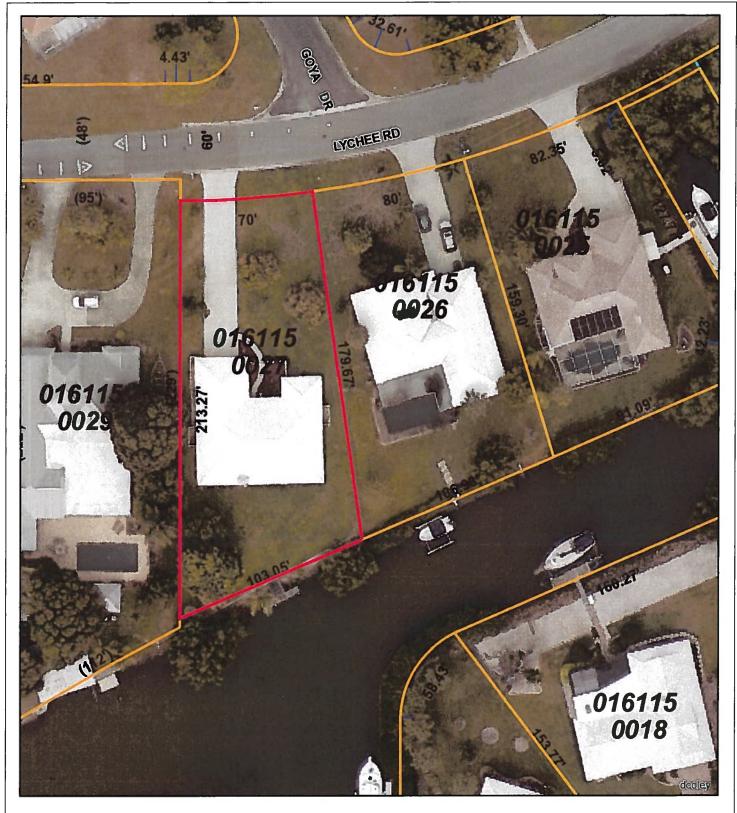
217 Lychee Road

On January 19, 2017 EPD staff identified unauthorized trimming at the subject property during an inspection for WNCA authorization. Two large clusters of mangroves to the east and west of the existing dock, approximately 35 ft. by 30 ft. were trimmed to an overall height of 5 ft. from a pre-trimmed height of 20+ ft. During a follow-up inspection on February 1, 2017, regrowth was witnessed on the trimmed portions of the mangroves. Staff also identified an area of shoreline,

The property shoreline consists of a hardened rip-rap shoreline containing red mangroves (*Rhizophora mangle*) and white mangroves (*Laguncularia racemosa*) trimmed to an overall average height of 5 feet from the substrate. The trimming was conducted without authorization by an unqualified trimmer. Review of aerial photos indicates that the mangroves present had a pre-trimmed height of at least 20 feet. EPD staff found during a site inspection that significant regrowth was occurring on improperly trimmed trees. EPD staff also identified an area of 18 linear feet east of the existing dock containing untrimmed mangrove seedlings less than 2 feet in overall height. EPD Staff identified one intact carrotwood (*Cupaniopsis anacardioides*) and one brazilian pepper (*Schinus terebinthifolius*) that had been previously cut to the root and was exhibiting signs of regrowth.

approximately 18 linear ft., which contained untrimmed mangrove seedlings of an average height less than 2 ft. As mitigation for the unauthorized trimming it is required that all untrimmed mangrove seedlings remain in place and intact. It is also required that all mangroves currently trimmed at an average overall height of five feet be allowed to regrow to a height greater than 6 ft. in average overall height. In order to assess the regrowth of the mangrove fringe and the continued growth of mangrove seedlings a follow-up mitigation inspection will be required 6 months after the issuance of this After-the-Fact permit.
