Wetland Restoration Plan

**PARCEL NUMBER 0487-12-0005
ENGLEWOOD, FLORIDA**

**ENVIRONMENTAL NARRATIVE IN SUPPORT OF A
WETLAND RESTORATION PLAN
FOR LEMON BAY**

October 2018

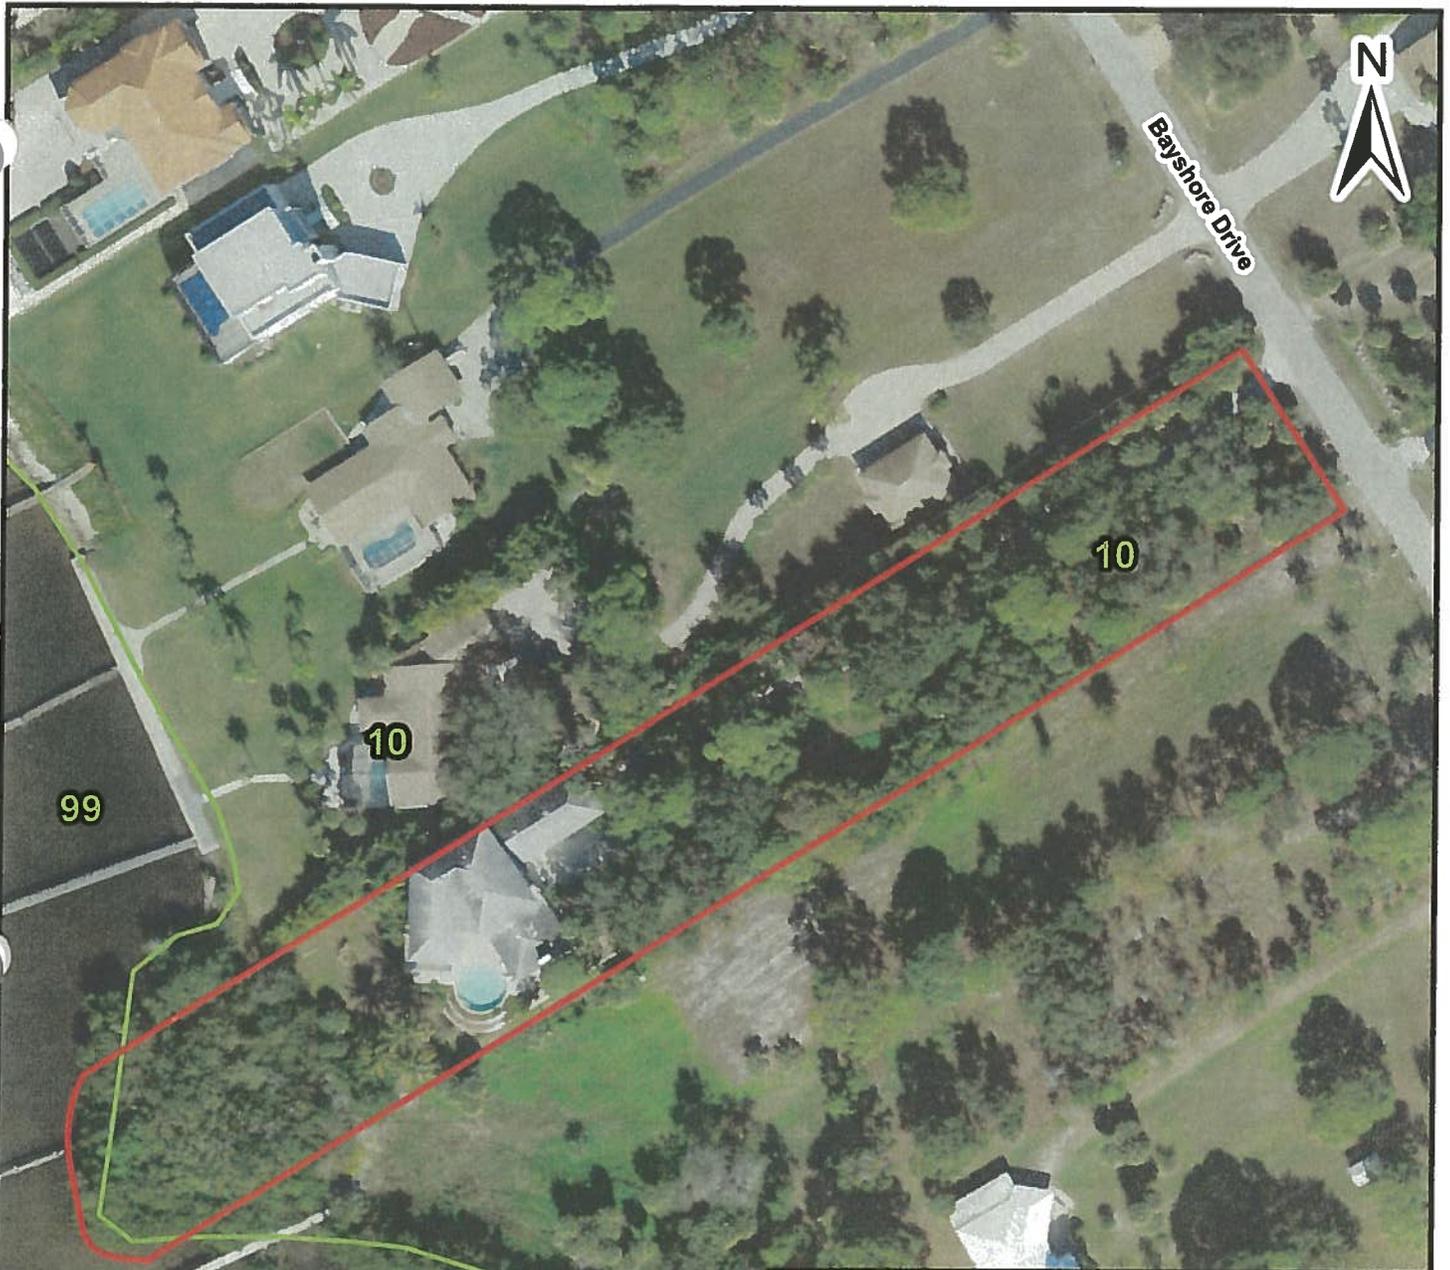
NRCS SOILS MAP
MANGROVE TRIM VIOLATION
 1850 BAYSHORE DRIVE, ENGLEWOOD, FL. 34223
 SARASOTA COUNTY, FLORIDA

10, EauGallie and Myakka fine sands, 1.66 ac.

99, Water, 0.05 ac.

The Natural Resource Conservation Service (NRCS) did not map the mangrove portion of this parcel as a separate soil type; however, adjacent mangrove habitats found along Lemon Bay are mapped Kesson and Wulfert mucks (Exhibit 5). Based on a soil sample taken within the parcel's mangrove habitats, the NRCS' descriptions for the Kesson and Wulfert mucks better defines the soils found within the parcel's mangrove habitats. In their natural unaltered condition, these soils are nearly level, very poorly drained soils located in tidal marshes and tidal swamps adjacent to coastal islands and estuaries. The Kesson and Wulfert components do not occur in a regular percentage or pattern and maybe entirely Kesson and similar soils or entirely Wulfert and similar soils. Under normal conditions, these soils are flooded during normal high tides, with a high fertility for salt water plants. Typical native wetland vegetation includes red mangrove (*Rhizophora mangle*), white mangrove (*Laguncularia racemosa*), black mangrove (*Avicennia germinans*), saltwort (*Batis maritima*), glasswort (*Salicornia bigelovii*), seashore salt grass (*Distichlis spicata*), and seashore paspalum (*Paspalum vaginatum*).

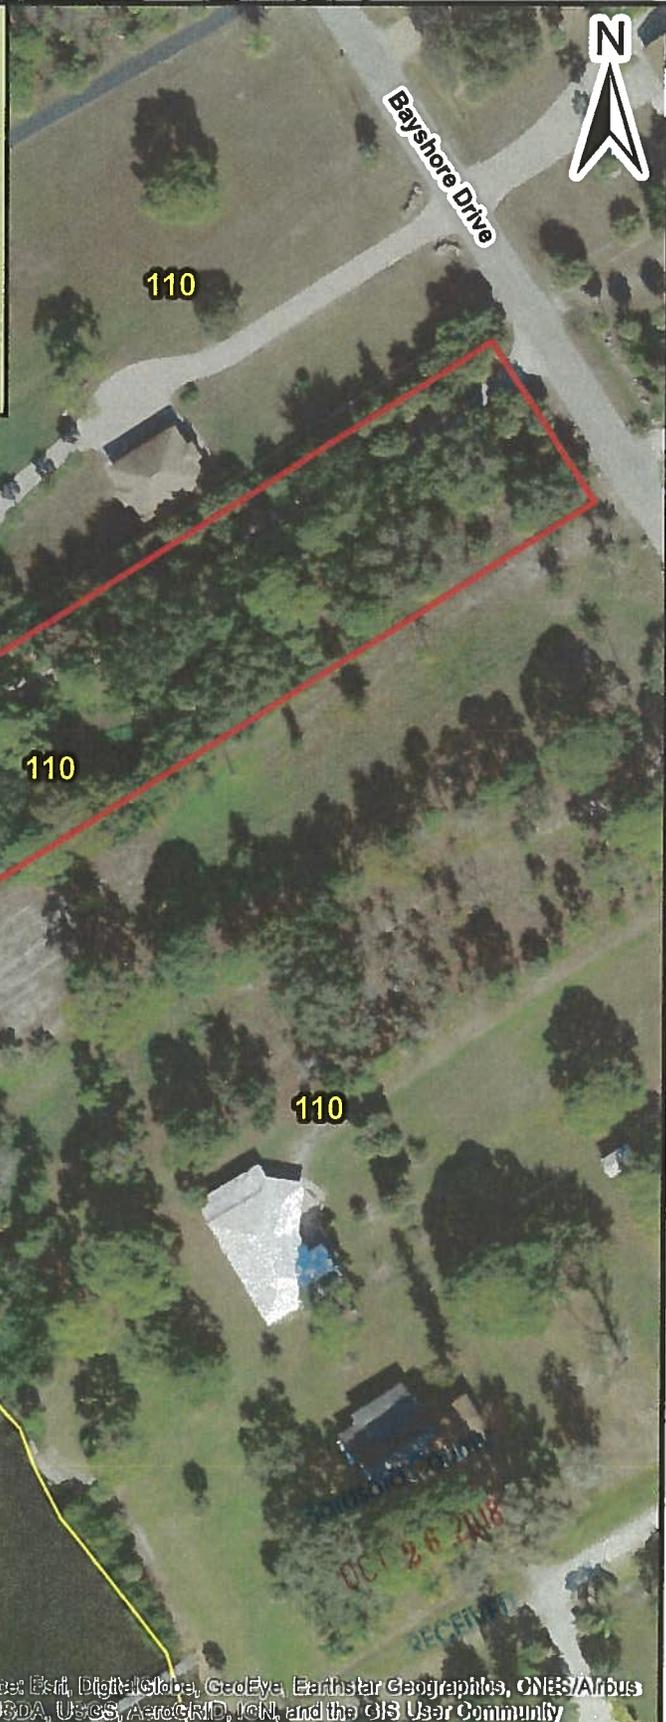
FLUCFCS MAP
MANGROVE TRIM VIOLATION
1850 BAYSHORE DRIVE, ENGLEWOOD, FL. 34223
SARASOTA COUNTY, FLORIDA

110, RESIDENTIAL LOW DENSITY < 2 DWELLING UNITS, 1.37 ac.

540, BAYS AND ESTUARIES, 0.01 ac.

612, MANGROVE SWAMPS, 0.33 ac.

The specific parcel and surrounding upland land covers were mapped in 2011 by the Southwest Florida Water Management District, using designations from the *Florida Land Use, Cover and Forms Classification System* (FLUCFCS), Florida Department of Transportation, 1999 (Exhibit 6). The SWFWMD identified land use type is described with only a single land use type FLUCFCS 110 (Residential, Low Density < 2 Dwelling Units Per Acre).

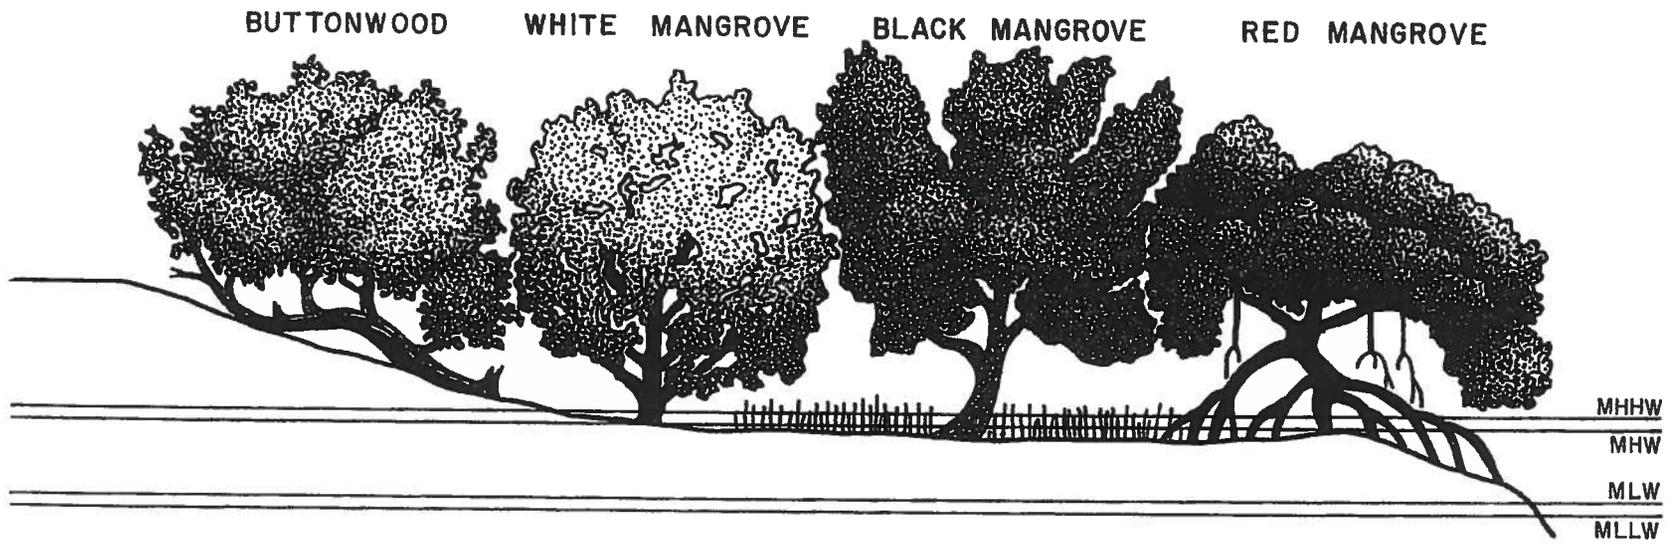
Typical Florida Fringe Mangrove Showing the Commonly Recognized Zonation Pattern.
Source: Barnettt, Michael R. and David W. Crewz. (1983). Florida Sea Grant Report No. 97.

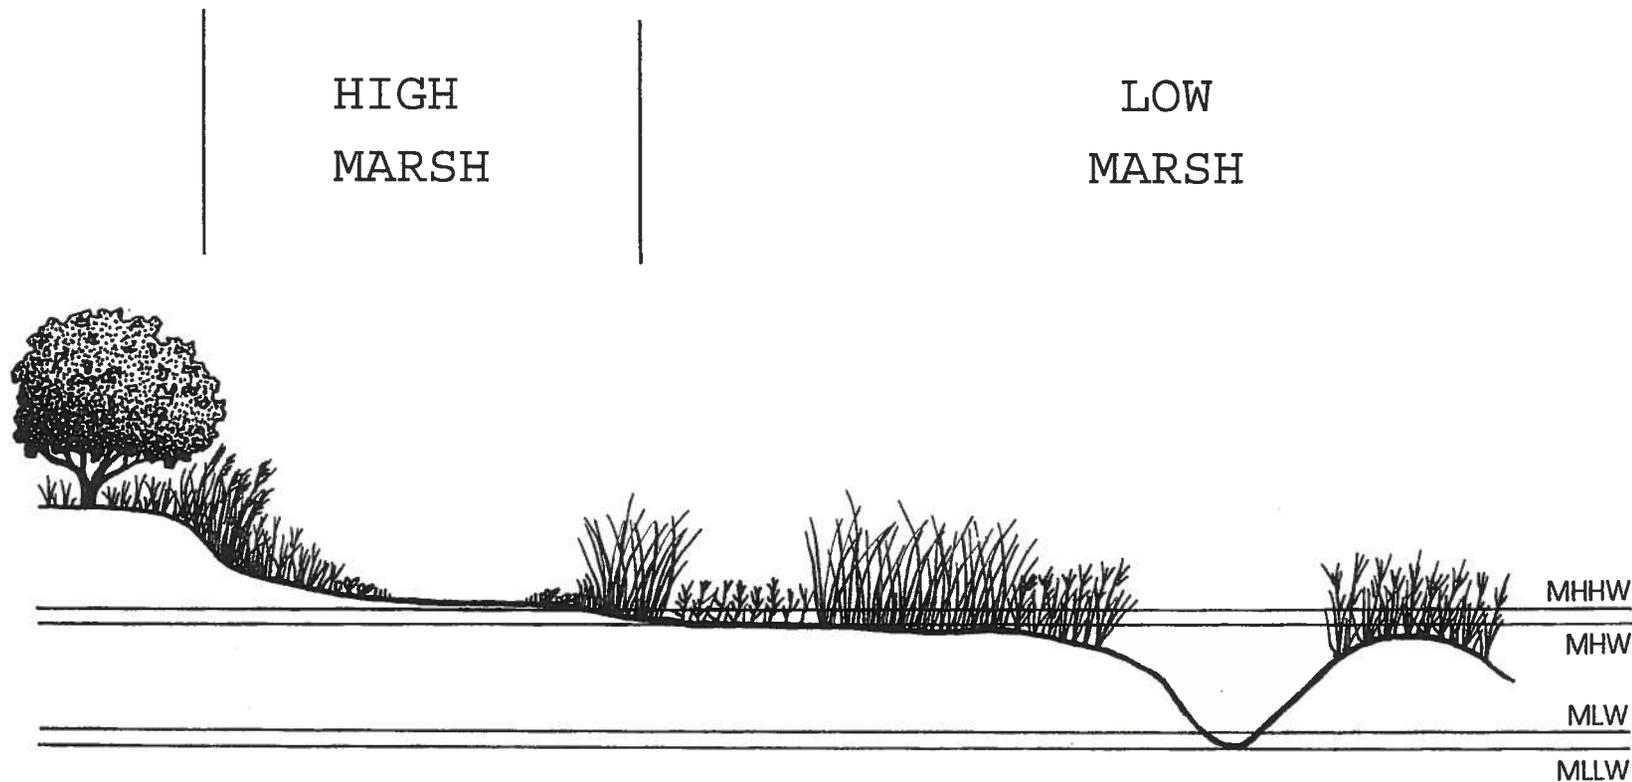
Typical Florida Salt Marsh. Mangroves Displace Marsh Vegetation at Lower Elevations in Southern Regions.

This natural recruitment of mangrove seedlings can significantly exceed densities of planted seedlings in wetland creation/restoration areas and is a cost-effective way to restore mangrove ecosystems through natural colonization by volunteer mangroves endemic to the specific ecosystem being restored. In addition, most mangrove zonation patterns in Florida include a tidal marsh component dominated by such species as black needle rush (*Juncus roemerianus*), saltgrass (*Distichlis spicata*), marsh-elder (*Iva frutescens*), and sea-purslane (*Eluvium potulacastrum*) that adds plant diversity and facilitates access for wading birds (Exhibits 8 and 9).
