DONA BAY WATERSHED MANAGEMENT PLAN MODEL UPDATE

Sarasota County | May 2024

Jones Edmunds Project No.: 19006-073-01

May 2024

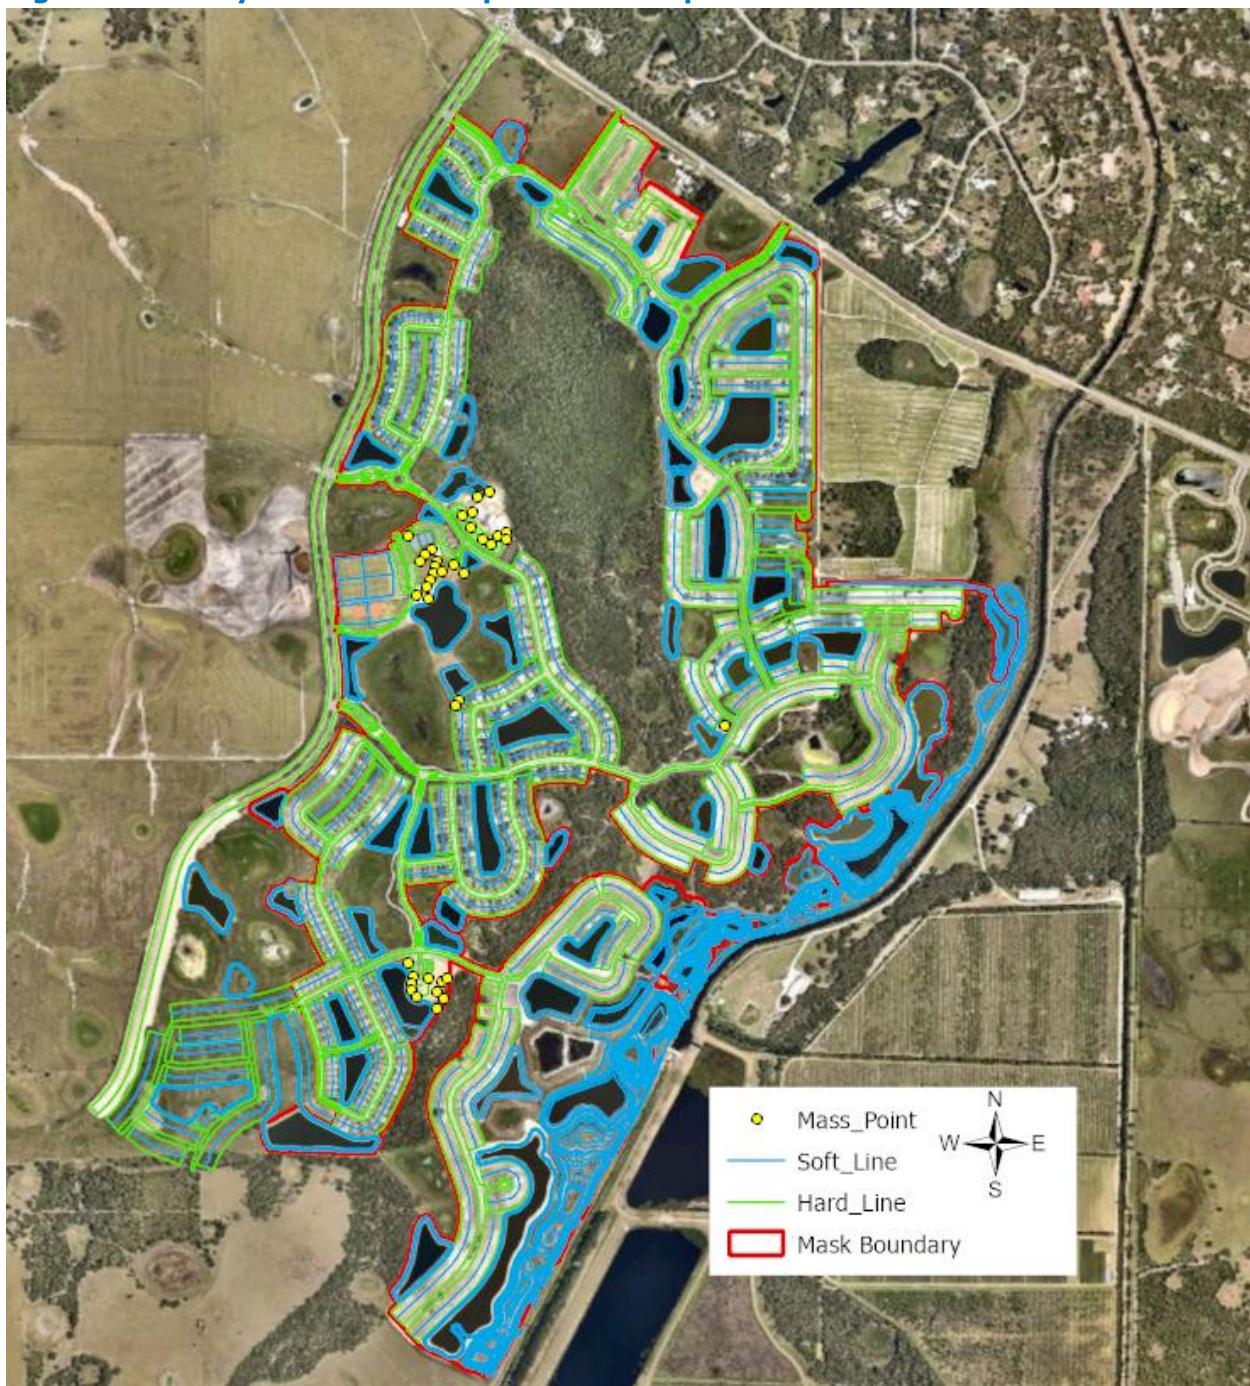
Figure 2 Skye Ranch Development DEM Update Features

For each area, Jones Edmunds georeferenced the applicable design drawings in a geographic information system (GIS). These drawings were used to digitize the ponds, building pads, parking lots, ditches, and other features that would assist in updating the terrain. Figure 2 illustrates the topographic features used to update the terrain for the Skye Ranch development. Figure 3 shows the before and after DEM for the Skye Ranch development.

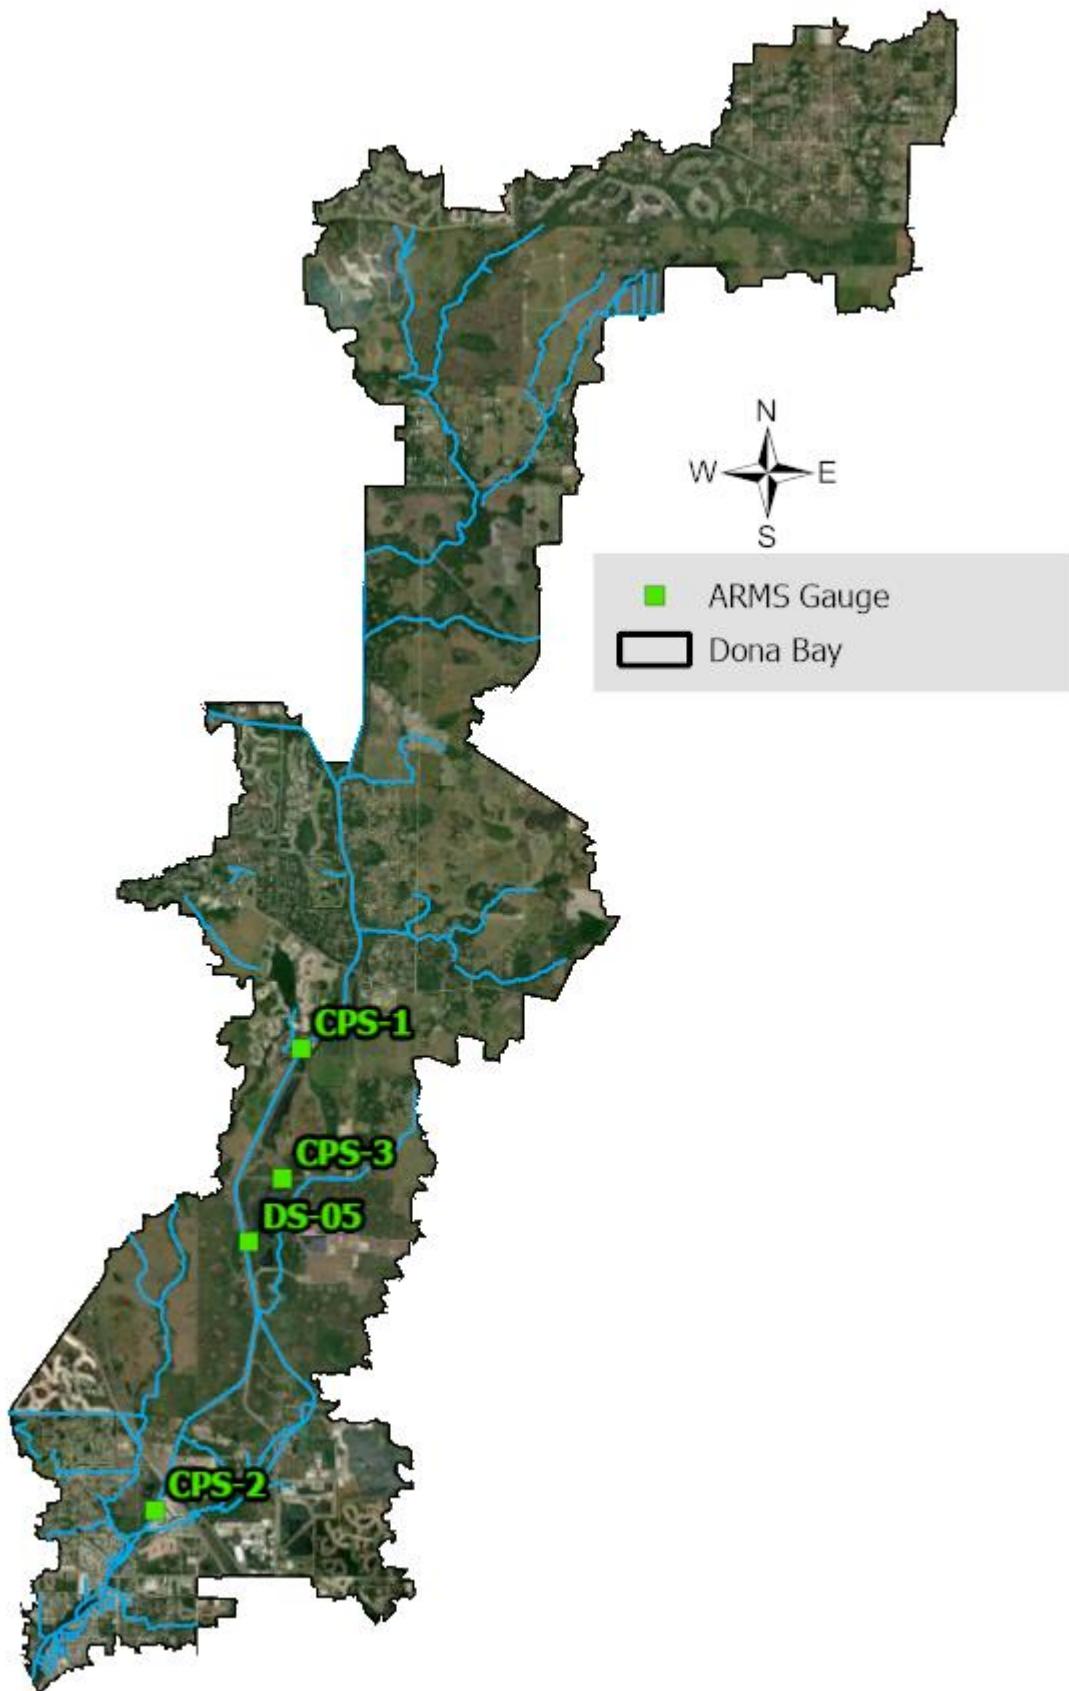
Figure 4 Sarasota County ARMS Gauge Locations – Dona Bay Watershed

The Sarasota County Automated Rainfall Monitoring System (ARMS) program is equipped with a network of remote monitoring stations throughout the County that record rainfall and water-level information. Four gauging stations are within the Dona Bay Watershed. Table 4 summarizes the ARMS gauge sites with the suitability of their usage for the verification process. Figure 4 shows the locations of the ARMS gauge sites.

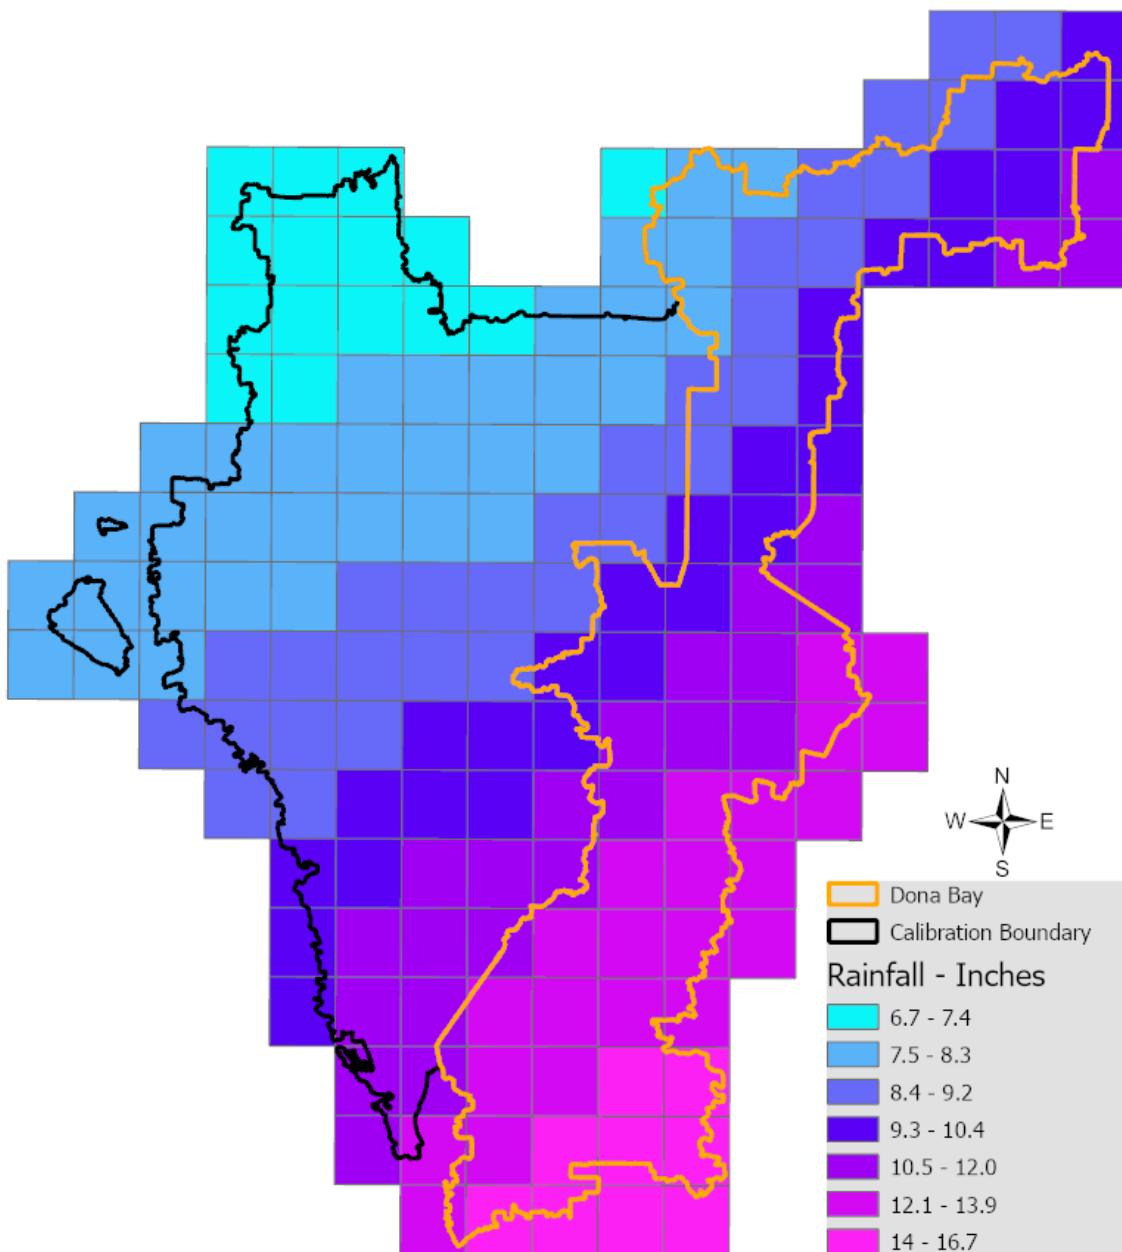
Figure 5 Hurricane Ian Modeled Calibration Rainfall Totals

Jones Edmunds obtained the Next Generation Weather Radar (NEXRAD) rainfall data from SWFWMD. The data are quantified through a 2-kilometer (km) grid with each cell containing rainfall-depth distributions at 15-minute intervals. The rainfall distribution grid was intersected with the model subbasins, and each subbasin received the rainfall distribution (and depth) for the grid cell that contained the centroid of the subbasin polygon. Figure 5 depicts the NEXRAD grid cells used for Dona Bay and the surrounding watersheds, showing the range of rainfall depth totals for cells used in the model calibration event. NEXRAD rainfall totals were also compared to the ARMS-recorded rainfall data totals to verify the accuracy of the NEXRAD data. Overall, the data compared within reasonable limits with no discrepancies to warrant any rainfall data changes.

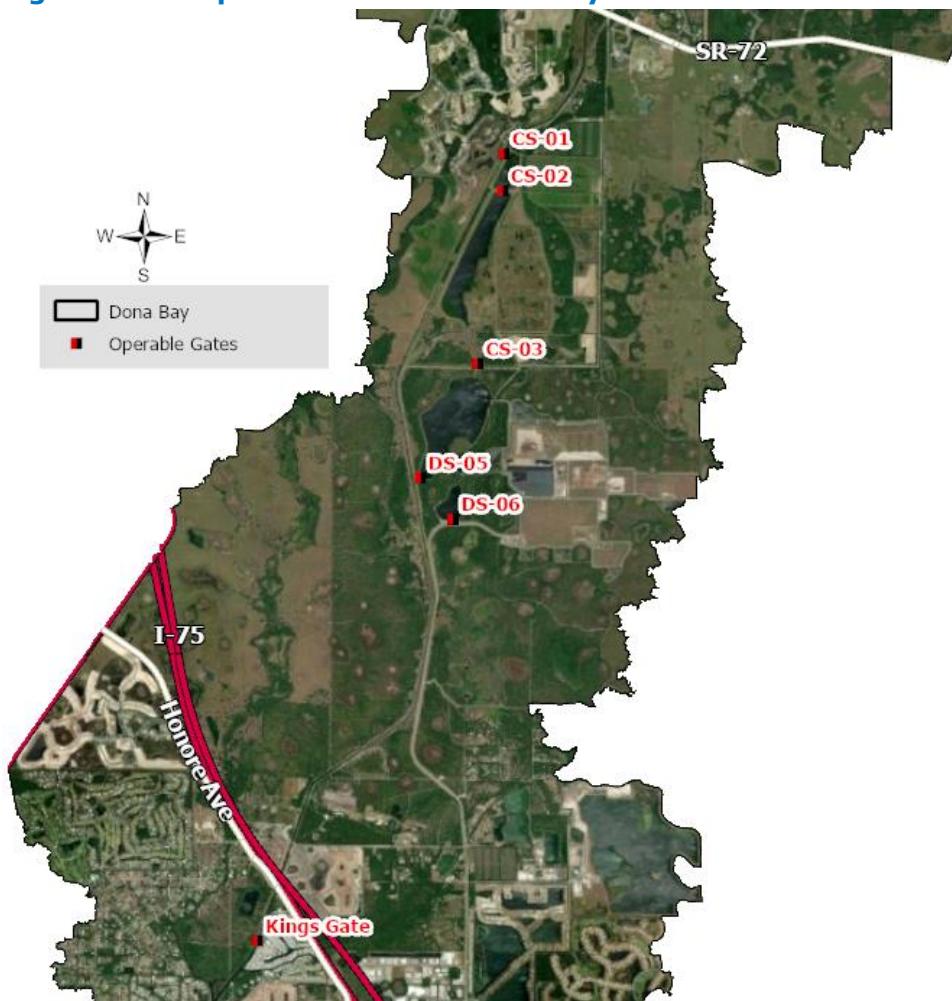
Figure 6 Operable Gates – Dona Bay Watershed

The Dona Bay Watershed contains six operable water-control structures within its drainage area. All operable structures are part of the Dona Bay Restoration Project except for the Kings Gate weir. The Dona Bay Restoration Project was designed to reduce freshwater flows to the downstream estuary, enhance the level of flood protection, and improve water quality, wetland rehydration, and conveyances to Salt Creek. The system diverts flow from Cow Pen Slough through a treatment train system consisting of the North Pinelands stormwater management facility, the Central Pinelands stormwater management facility, and a wetland rehydration area. The operable gates control the stages and outflows from each treatment facility. Figure 6 illustrates these structure locations.

The structures have an SOP for the wet and dry seasons. The general operation rules are described in Sarasota County's *Standard Operating Procedures* and in *Maintenance Guidelines for Dona Bay Water Quality Project Phase I* (Kimley-Horn and Associates, Inc., 2014). The structure operations for the calibration and verification simulations were simulated using the wet-season SOPs. Table 5 shows the wet-season structures operation table from the Kimley-Horn operation manual.

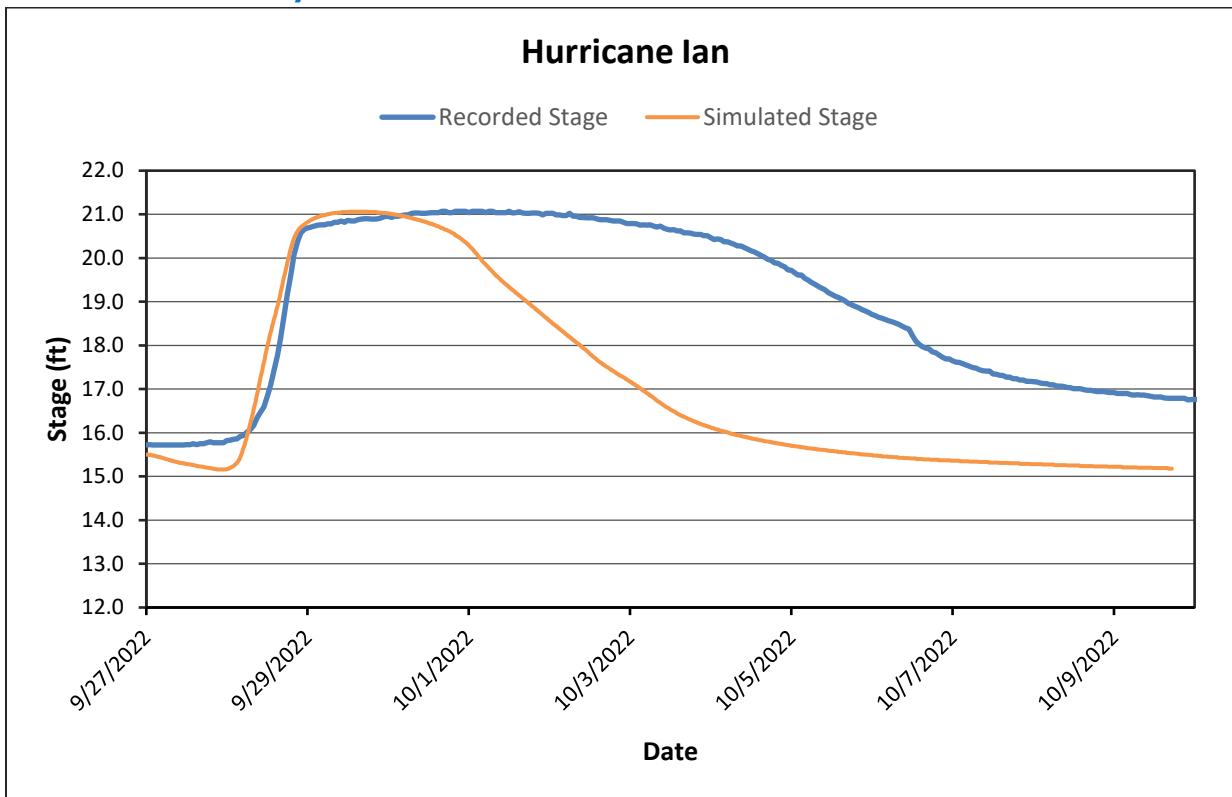
Figure 7 Calibration Stage Hydrograph Comparison – CPS-1 at Clark Road Battery

The Operations staff told us that detailed structure operations were not available for the Hurricane Ian event. However, we did discover that a flow blockage occurred at Clark Road that was not cleared until a month after the storm had passed. This could be why the recession limb on the observed stage hydrographs stays elevated for so long. We also reviewed the verification results, which do not show a prolonged stage recession (discussed more in subsequent sections). We determined that the disparities in the calibration hydrographs were attributed to abnormal structure operations or flow blockage. Based on these reasons, no additional changes were made to the calibration model.

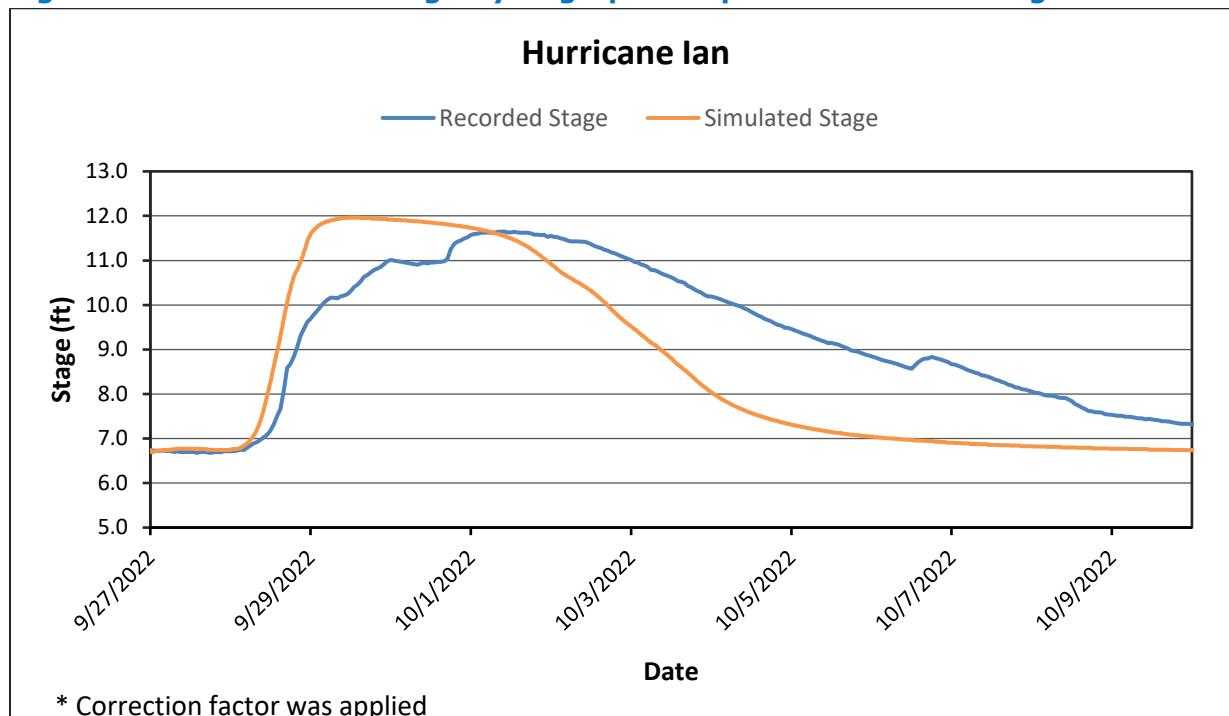
Figure 9 Calibration Stage Hydrograph Comparison at CPS-2 Kings Gate

The observed stage at Kings Gate was given a correction factor based on a field visit of the gauge. When we visited the gauge, the ARMS system recorded the stage at elevation 6.6 feet NAVD88. However, we measured the depth of water over the weir at 2 inches with the model weir elevation at 5.92 feet NAVD88. Therefore, the recorded stage was recording higher than the observed stage by approximately 0.5 foot.

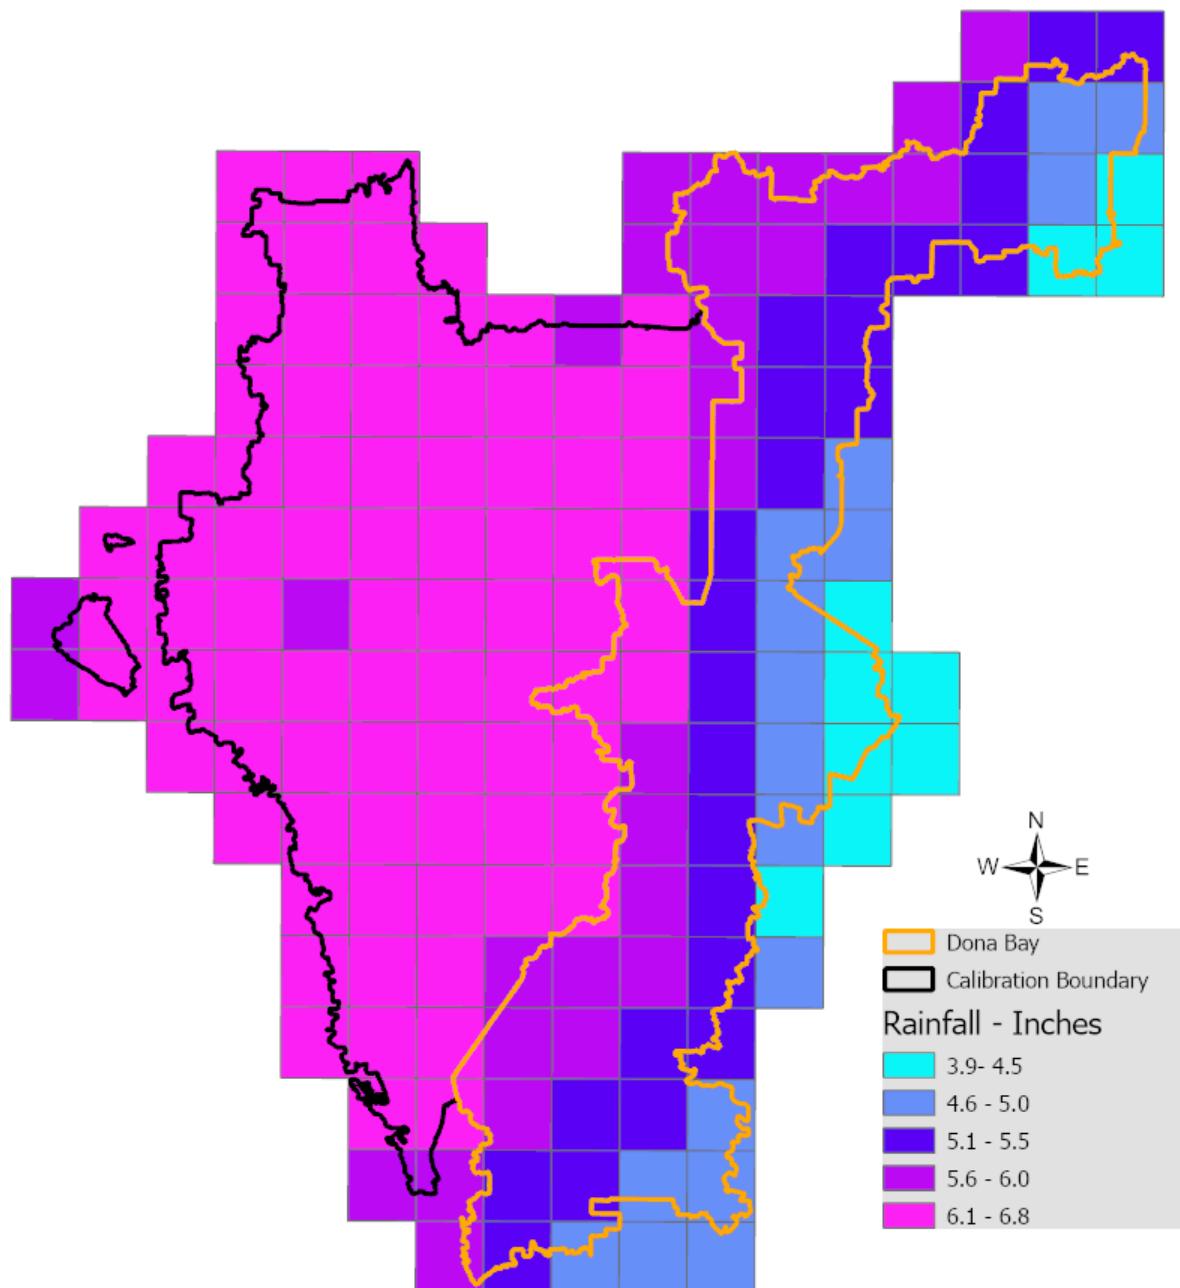
Figure 10 Rainfall Verification Map – TS Eta Rainfall Totals

TS Eta began to impact southwest Florida on November 8, 2020. Although much of the rainfall occurred on November 11, the model was simulated from November 10 through November 21. During this period, rainfall ranged from 4 to 7 inches across all of the Dona Bay Watershed. Figure 10 shows the model verification event rainfall depths for the entire combined model, including the Dona Bay Watershed. As with the calibration storm, NEXRAD rainfall distributions were applied to each basin based on the intersection of the subbasin's centroid with the NEXRAD grid cells.

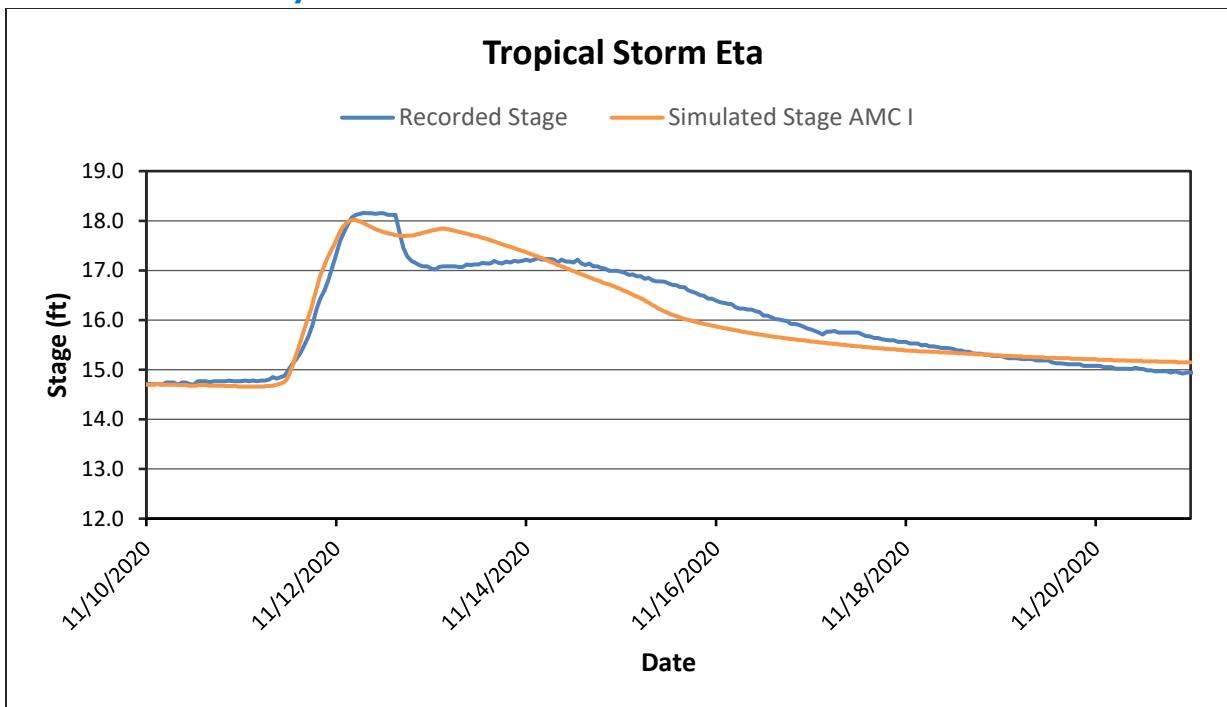
Figure 11 Verification Stage Hydrograph Comparison – CPS-1 Clark Road Battery

Figures 11 through 15 present stage hydrograph comparisons for the gauge locations with viable data (Table 4). Although verification event data were available for the DS-05 gauge, these data were missing from the calibration period. The model verification figures show that the model stage hydrographs match reasonably well in peak stage and timing with the recorded gauge data for the AMC I model simulation. Figure 11 shows that the elevation at CPS-1 drops sharply from 18.12 to 17.28 feet between 3 PM and 6 PM on November 12, 2020. We contacted the Stormwater Operations Department staff to confirm the operation schedule and were told that the stop logs were removed at this time; however, no work order was in the system for confirmation. This removal would explain the sharp drop in the observed stage at the CPS-1 gauge and correspondingly explain the second peak at the

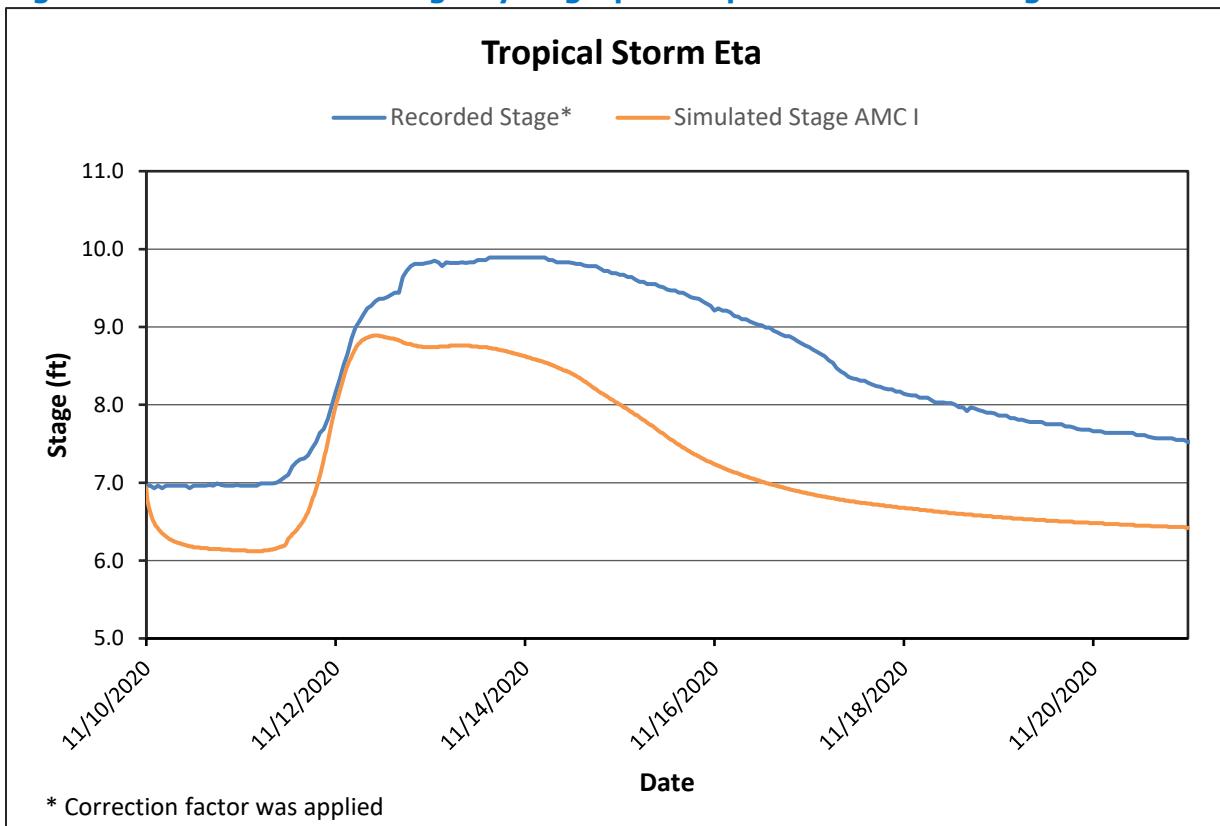
Figure 14 Verification Stage Hydrograph Comparison – CPS-2 Kings Gate

Kings Gate gauge shown in Figure 14. Figure 15 shows the timing correlation from the stop log being removed at CPS-1, which likely impacted the second peak of the observed data at Kings Gate.

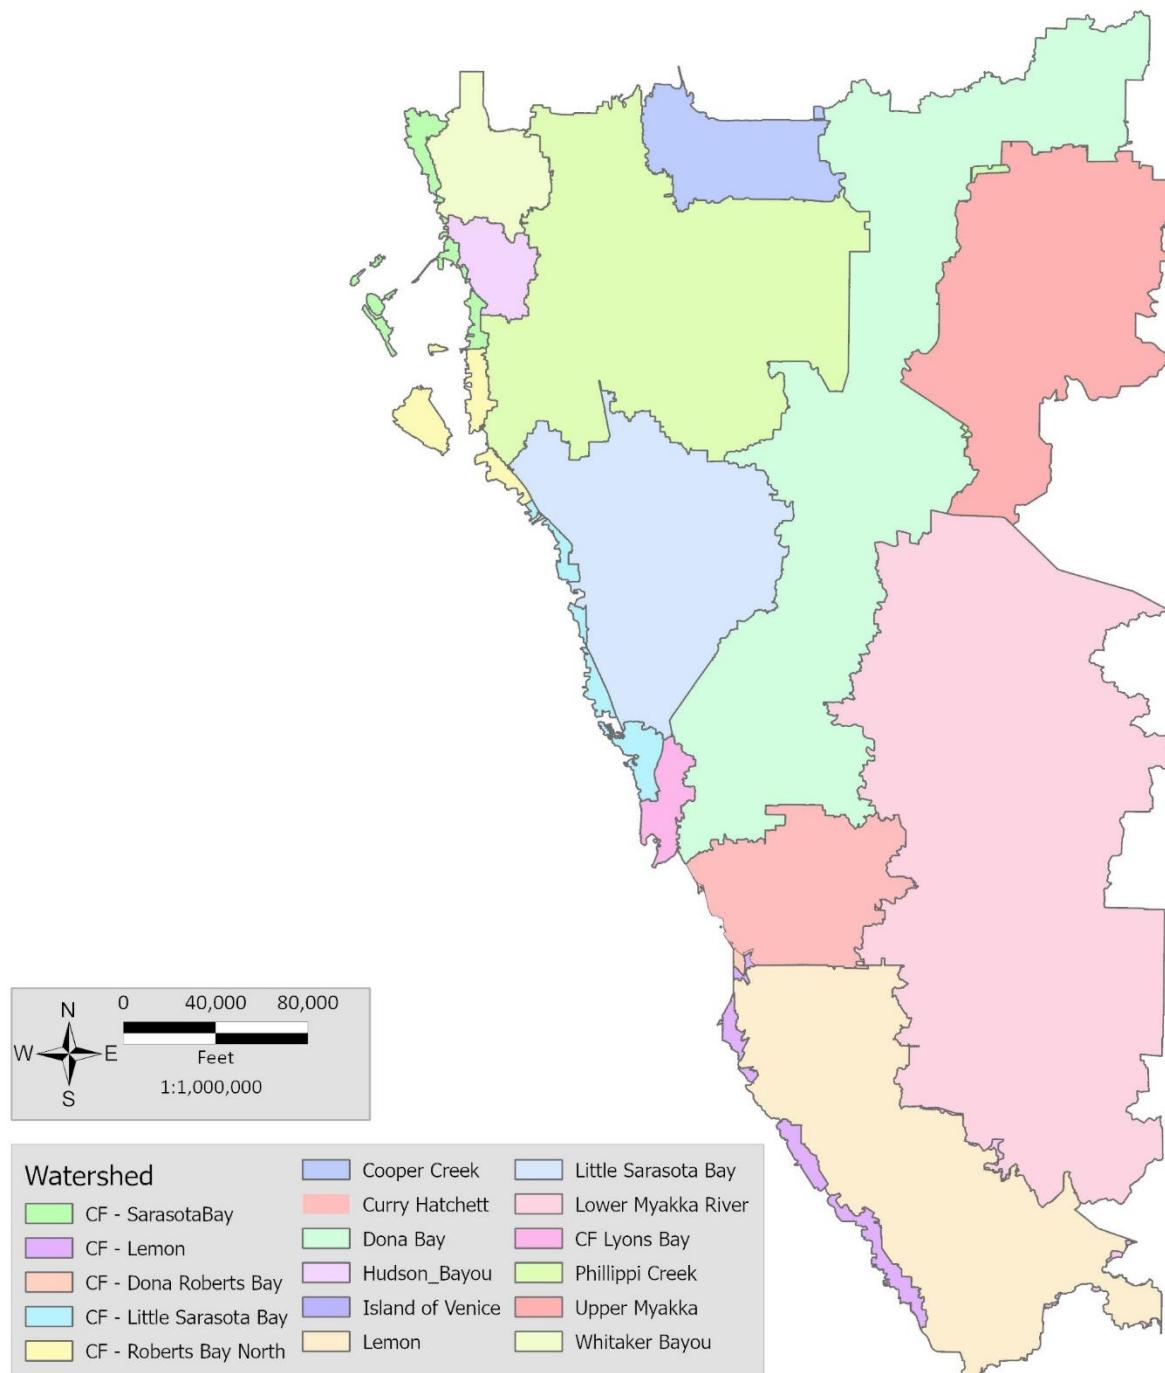
Figure 16 Sarasota County's Watershed Model Boundaries

The County maintains 16 models; six models are coastal models that were developed with the intent to be merged with the adjacent riverine watersheds. Under the County's guidance, Jones Edmunds combined the coastal basins into the appropriate watershed. Figure 17 illustrates the resulting 10 watershed boundaries.

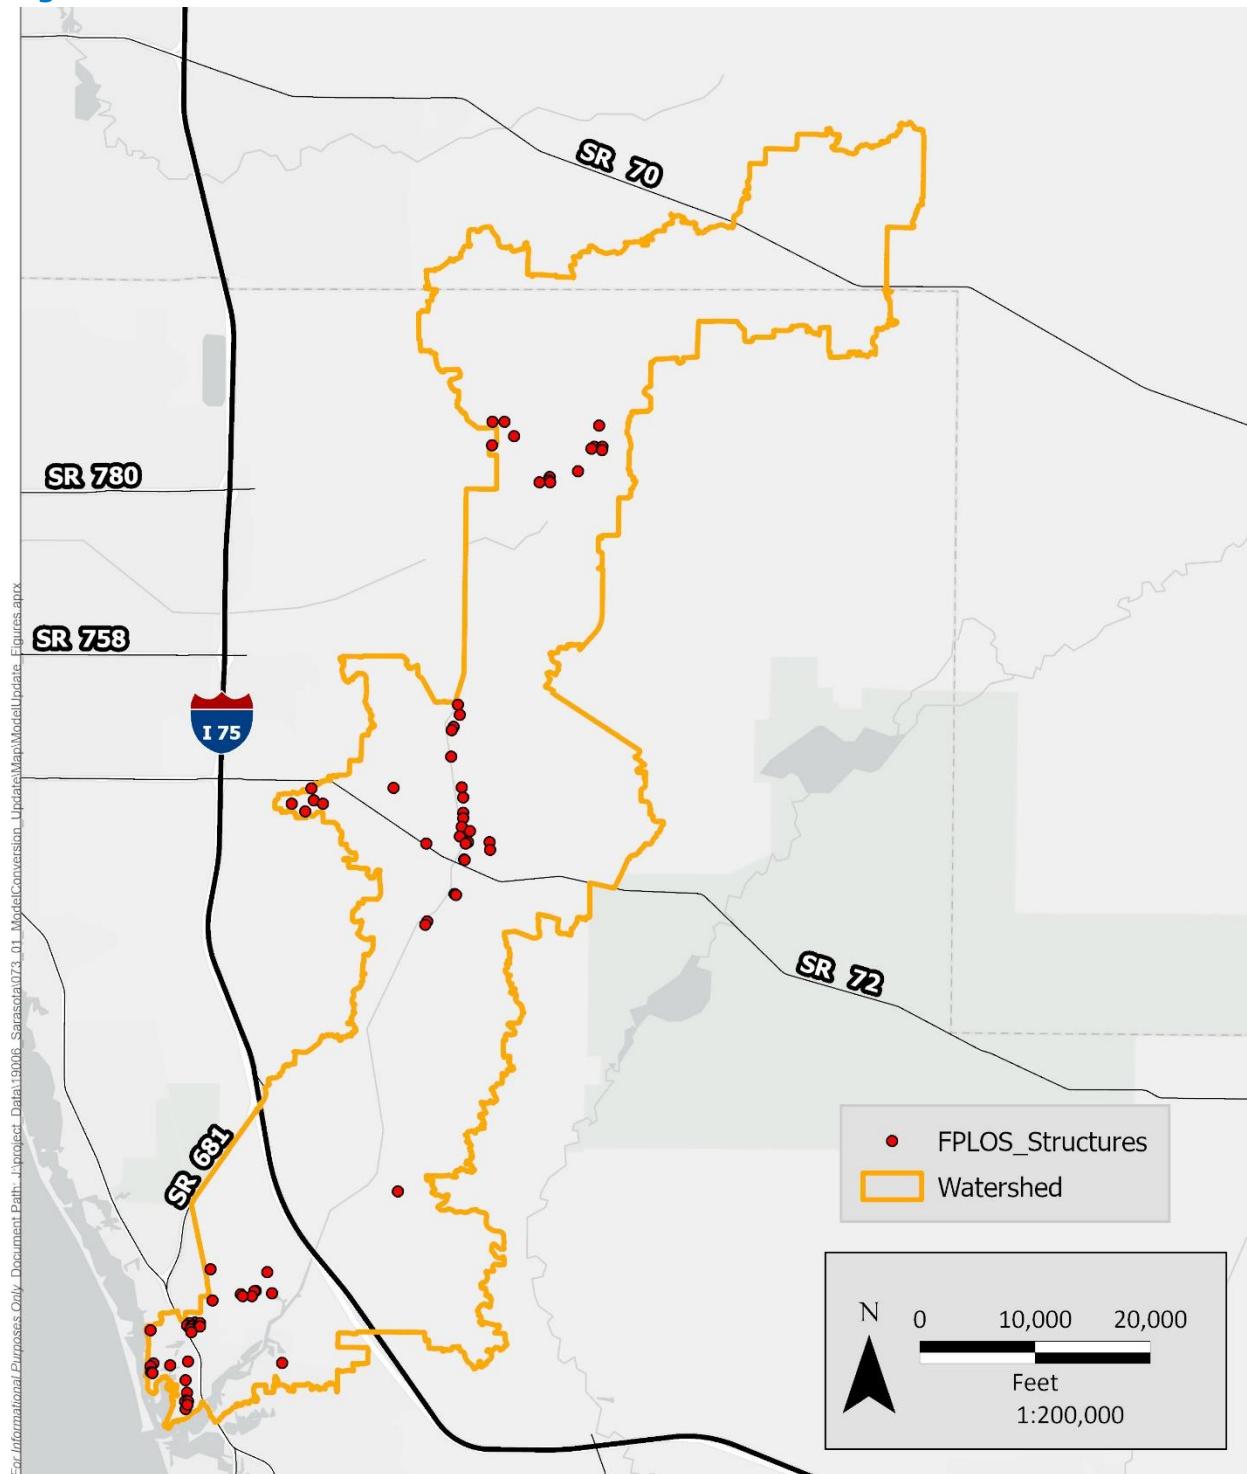
Figure 18 FPLOS-Deficient Structures Locations within the Watershed

The Dona Bay Watershed contains 83 deficient structures for the 100-year/24-hour design storm. Figure 18 and Table 12 highlight the locations of the structures within the watershed that did not meet the FPLOS conditions for Category I.

The above approach was compared with available survey data for reasonableness. FFE values were then compared to the flood-depth grid to determine whether the building meets the FPLOS conditions for Category I. Non-habitable structures were removed from the list of deficient structures.

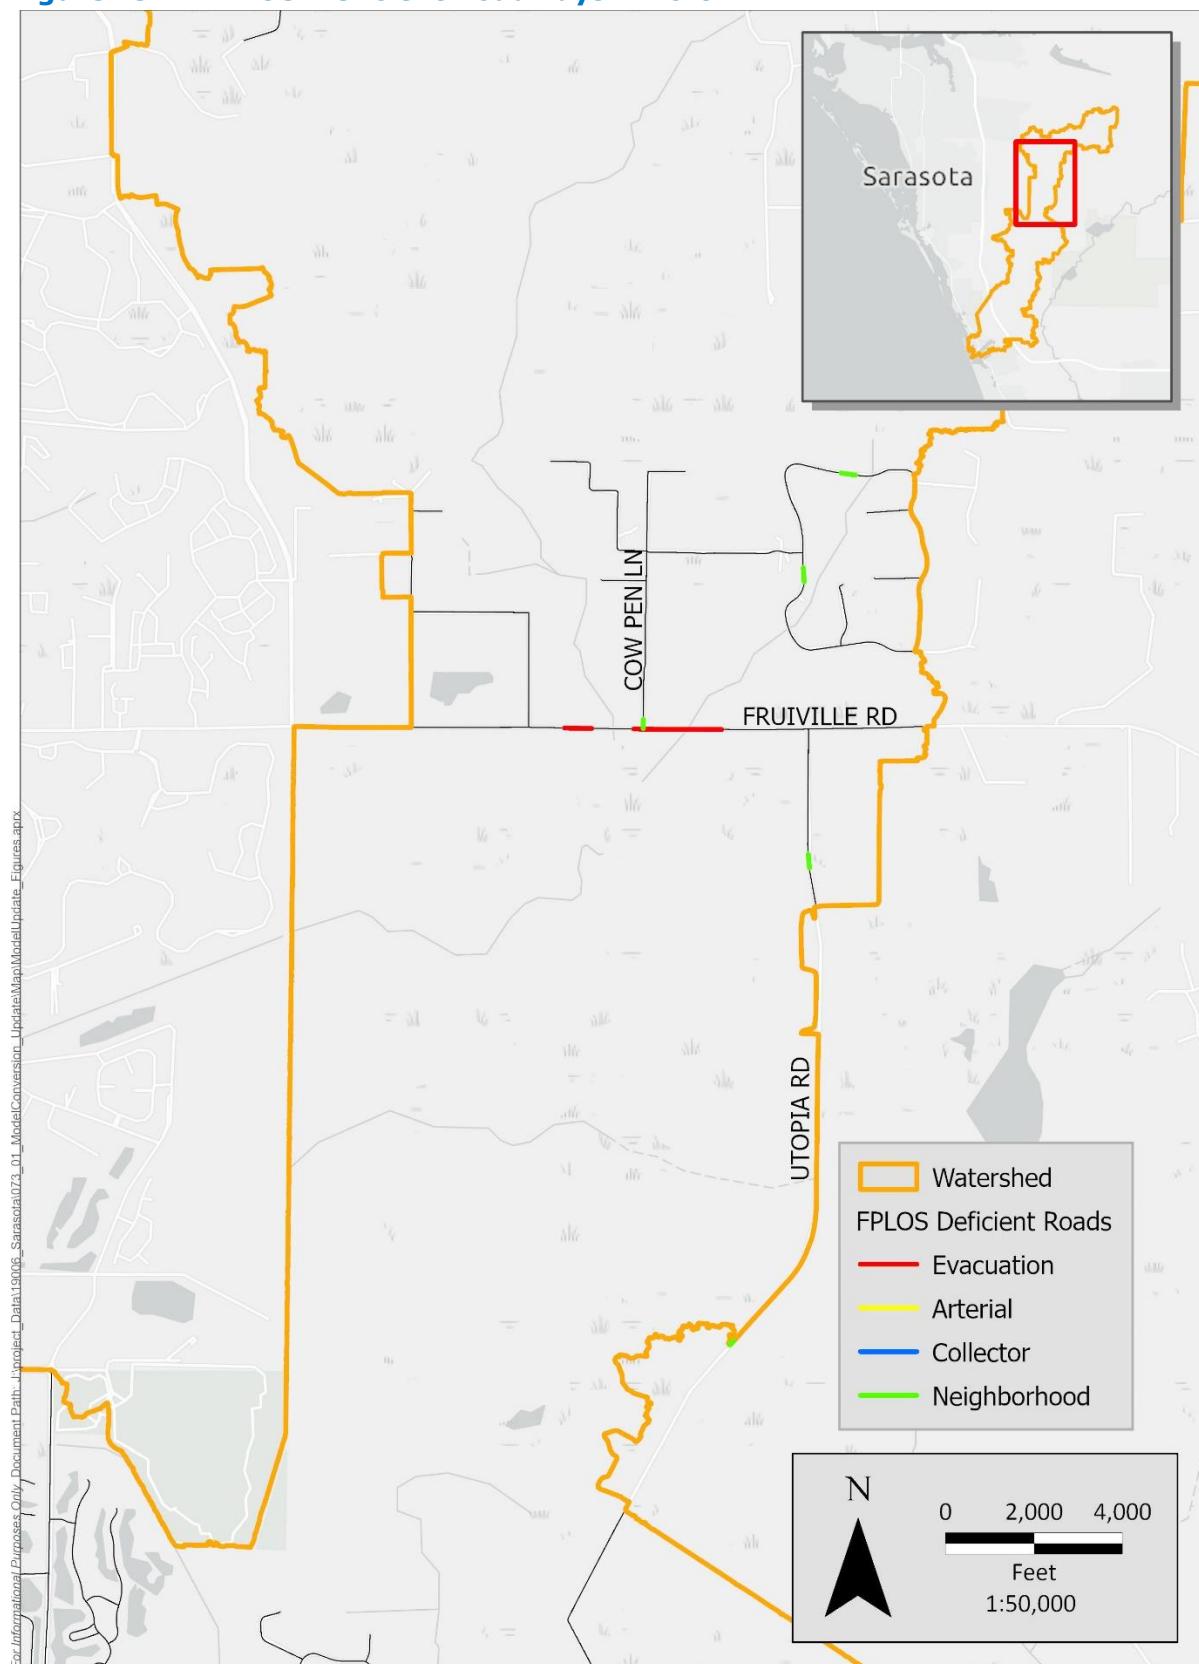
Figure 19 FPLOS-Deficient Roadways – North

The allowable flood depth for all roadway classifications is 6 inches except for Evacuation Road. No flooding is allowed for an evacuation road. Jones Edmunds assumed that the edge-of-pavement (EOP) is 3 inches lower than the road center line (i.e., the crown of the road), which corresponds to the average roadway width of 24 feet with a 2-percent cross-slope from the crown of the road. This assumption is for the initial identification of FPLOS-deficient roadway segments.

depth for each road classification. The duration of the flooding was calculated using the assumed EOP and model results. The deficient roadways were also visually checked for the reasonableness of results. Isolated deficient segments of streets less than 25 feet were not considered FPLOS deficient. Figures 19 and 20 show that the FPLOS-deficient roadways are concentrated in two areas. Table 14 summarizes the results from the street FPLOS evaluation by roadway class. Table 15 presents the roadway segments not meeting FPLOS design criteria. In summary, approximately 3.9 percent of evacuation routes and 0.9 percent of neighborhood roads did not meet the FPLOS conditions for Category II.
