Summary of Results

Walk the WBID Exercise for Philippi Creek (WBID1937)

FINAL DRAFT

September 27, 2017

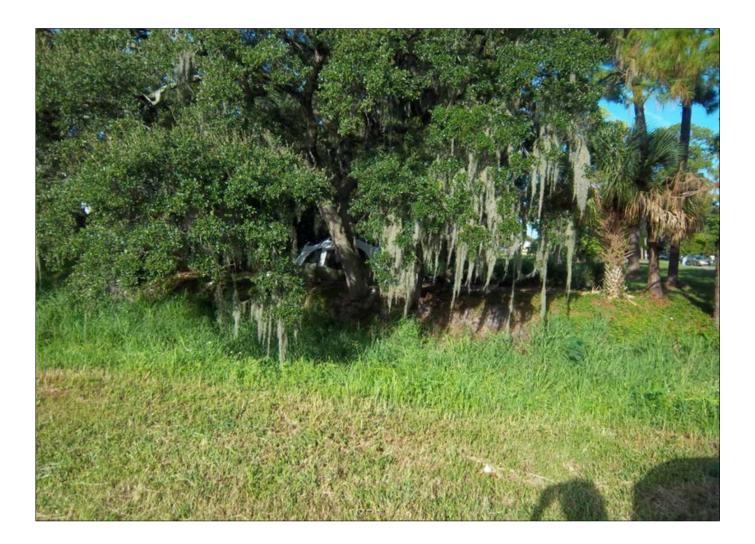
Inspector(s):	Date:	Photo Location	Photo Direction
M.Holland/R.Wells/J. Pate	8/26/2016	McDonalds on Fruitville	West

Comments: (a)Appears to be a homeless camp on vacant property west of McDonalds and directly adjacent to the creek. This encampment is upstream from the established sampling site.

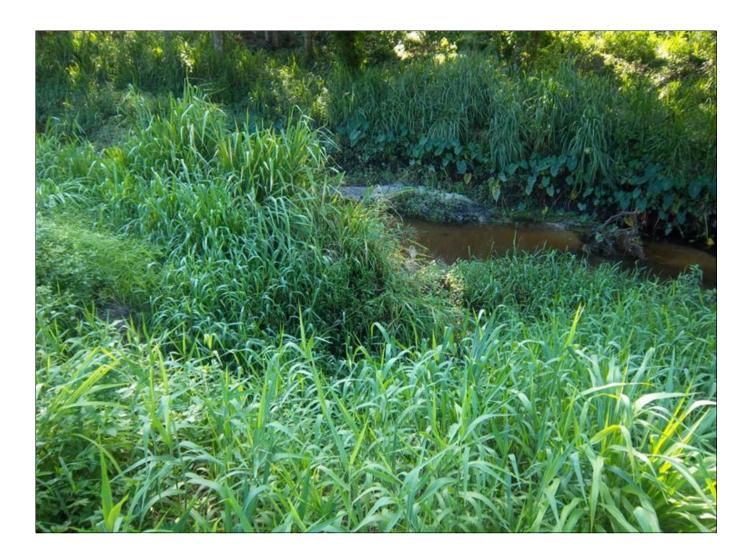
Inspector(s):	Date:	Photo Location	Photo Direction
M.Holland/R.Wells/J. Pate	8/26/2016	Phillippi Creek at Circus Blvd	NW

Comments: (b)Phillippi Creek at Circus Blvd, just east of the fire dept training area. The creek here is heavily vegetated.There is also areas of bank erosion and sloughing in of the banks. No evidence of dog walkers along this linear "park".

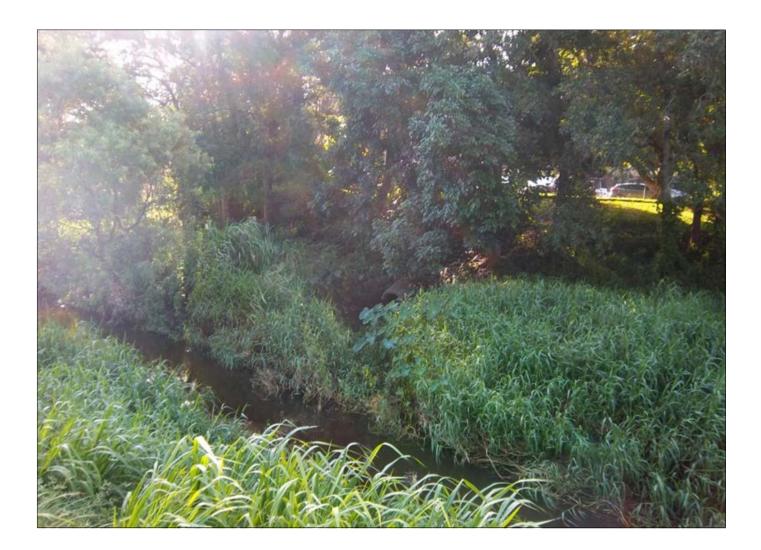
Inspector(s):	Date:	Photo Location	Photo Direction
M.Holland/R.Wells/J. Pate	8/26/2016	Phillippi Creek	NE

Comments: (c)Outfall from Amherst Street (the southern one) . Runoff comes from a apartment complex, which is on City Sewer. Lat/long is 27.3398/82.4948 of this pipe. There is no on site treatment for the stormwater for this apartment complex.

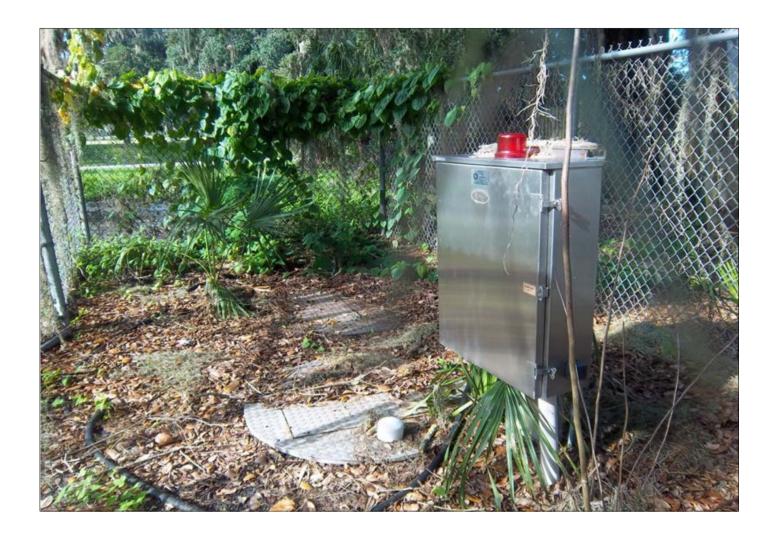
Inspector(s):	Date:	Photo Location	Photo Direction
M.Holland/R.Wells/J. Pate	8/26/2016	N end of Azinger Way	South

Comments: (e)City Lift station. The maintenance entity for this lift station is the contractor that maintains the golf course. The site was secure at the time of the investigation. There is a history of problems at this station, but no issues recently.

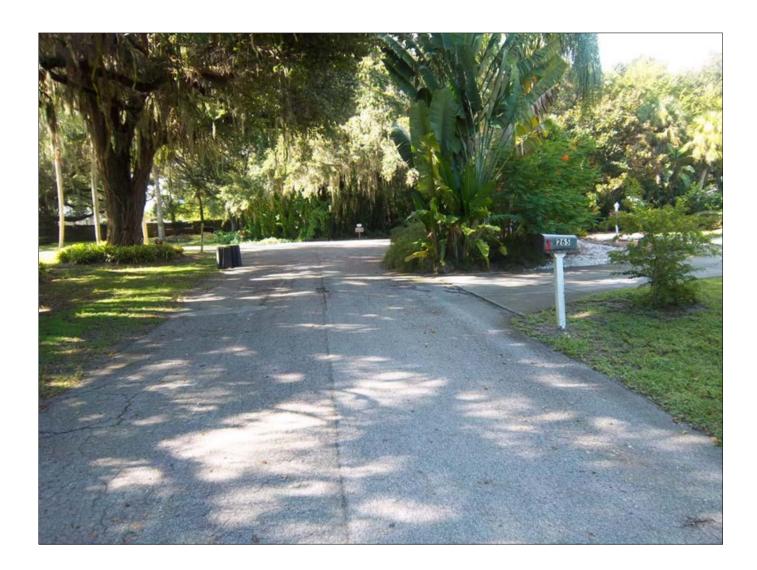
Inspector(s):	Date:	Photo Location	Photo Direction			
M.Holland/R.Wells/J. Pate	8/26/2016	End of Bearded Oaks Drive	South			
Comments: (f)Residential commun	Comments: (f)Residential community South of Fruitville Rd and adjacent to 4-37 canal and north of BBB-WV hotspot					
for Fecal Coliform. This subdivision is not on City sewer.

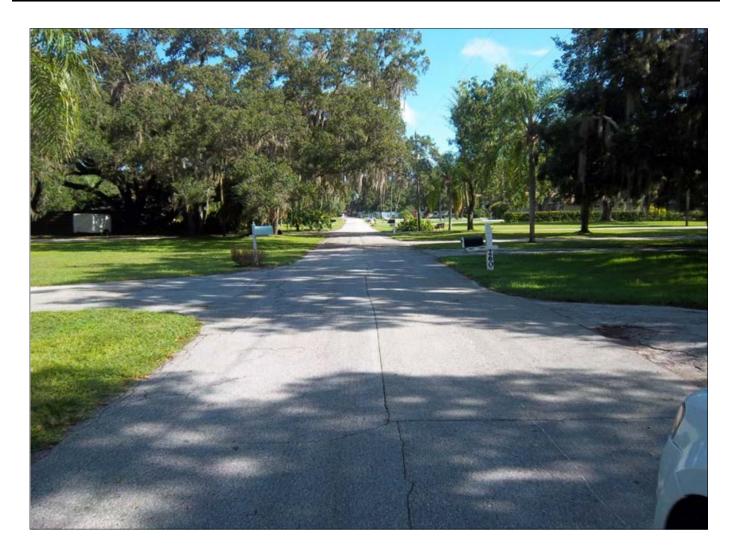
Inspector(s):	Date:	Photo Location	Photo Direction		
M.Holland/R.Wells/J. Pate	8/26/2016	Same as Above	North		
Comments: (f)Same as above, but looking towards Fruitville Rd. There are no obvious signs of septic failure in the					
front yards. Houses and lots are large and well taken care of. The lots of the left (west of this road - Bearded Oaks					
Drive) back up to the canal shown later, Canal 4-37.3. This is the last sight visited with Rich and John from the City

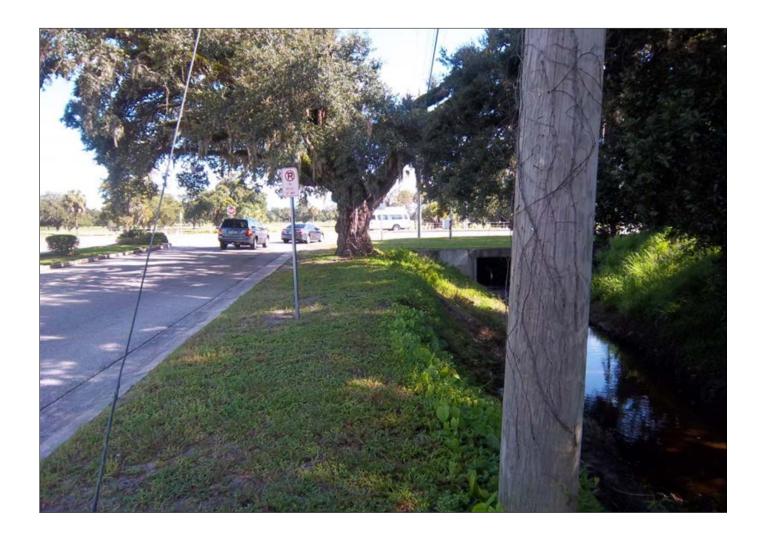
Inspector(s):	Date:	Photo Location	Photo Direction
M. Holland	8/26/2016	Same as Above	North
Comments:(g) Looking towards Fr	uitville Rd. 4-37.3 i	is to the right.

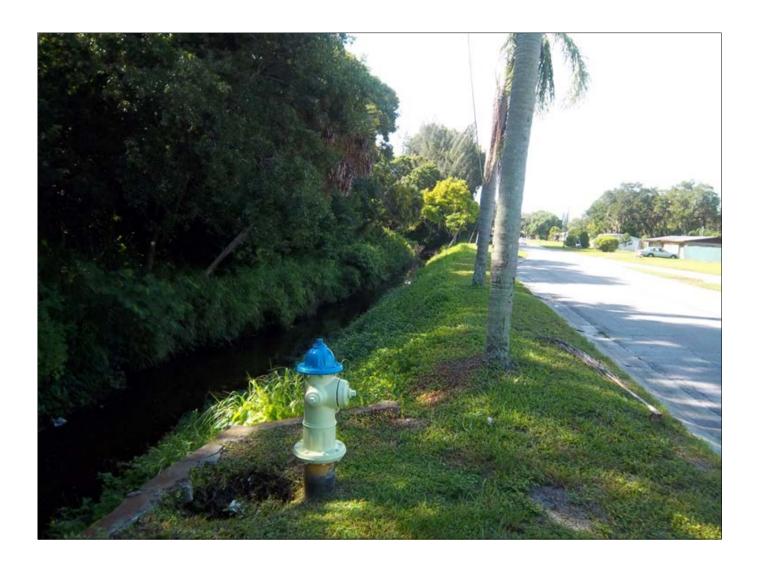
Inspector(s):	Date:	Photo Location	Photo Direction
M. Holland	8/26/2016	Same as Above	South
Comments: (g)Looking south along	g 4-37.3. The side l	banks on the west side of the canal (sa	ame side as the fire
hydrant) are very steep and are er	oding in some are	as. The east side is heavily vegetated.

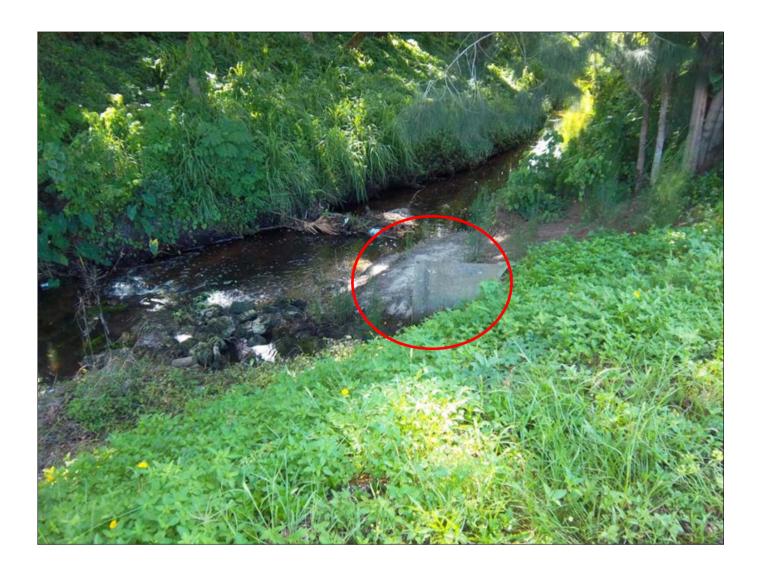
Inspector(s):	Date:	Photo Location	Photo Direction
M. Holland	8/26/2016	Canal 4-37	SE

Comments: (h)Stormwater pipe that collects from Wolverine and Midwest Pkwy. Pipe was discharging minimally at the time of the site visit in to Canal 4-37.3.

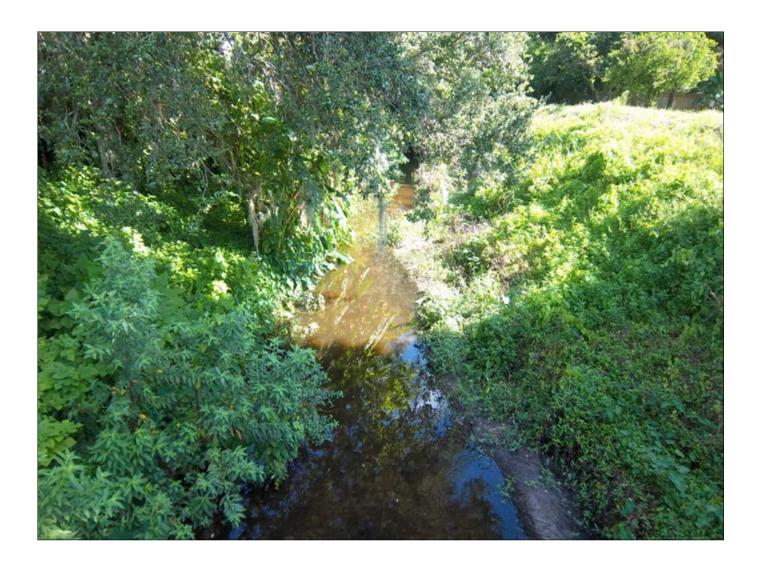
Inspector(s):	Date:	Photo Location	Photo Direction
M. Holland	8/26/2016	Bridge over Canal 4-37 @ Davis	North

Comments: (j)Showing canal 4-37.3 at the bridge. Bottom is mostly sandy with some shell. Banks are heavily vegetation, water is still clear, but cloudier than upstream. Since this is residential, there are dogs throughout (could hear barking), but there was no obvious signs of pet waste in the neighborhood.

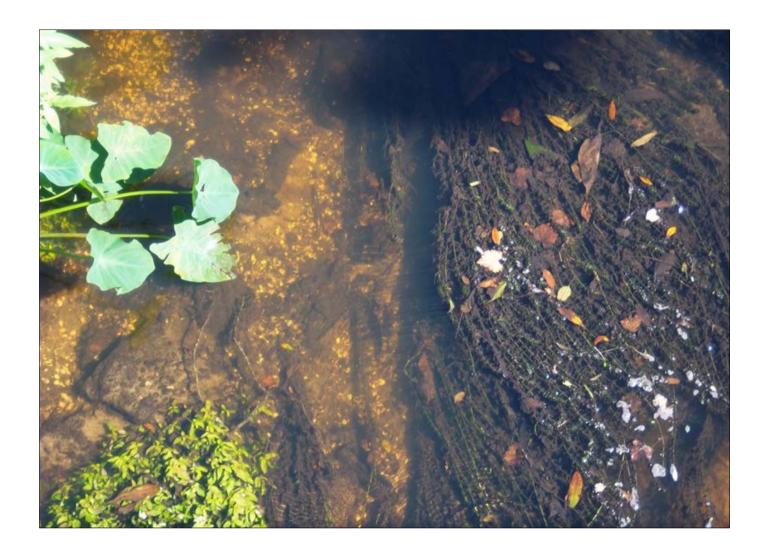
Inspector(s):	Date:	Photo Location	Photo Direction
M. Holland	8/26/2016	Same as Above	North

Comments: (j)Showing the water before it passes under the bridge. Water is a bit cloudier than upstream. Aquatic vegetion is present. Banks are heavily vegetated as well.

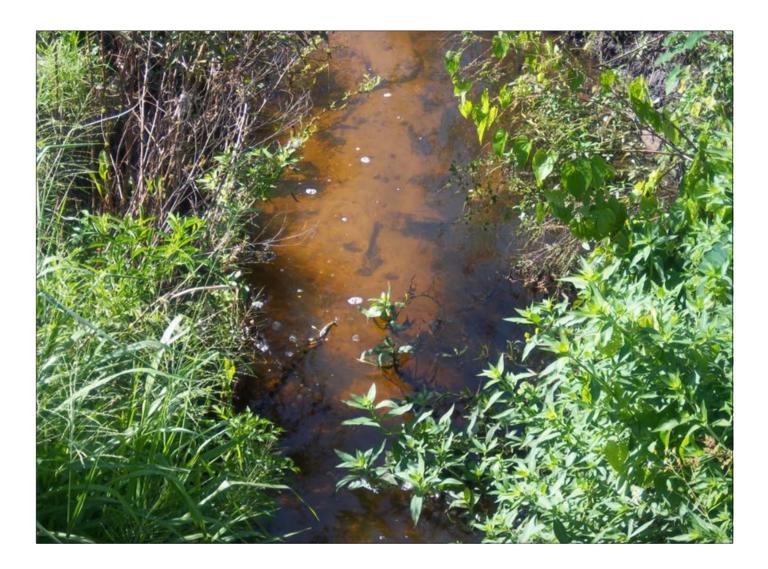
Comments: (j) Looking at 4-37 on the south side of the bridge. Banks are heavily vegetated, aquatic vegetation present as well. Bottom is sandy.

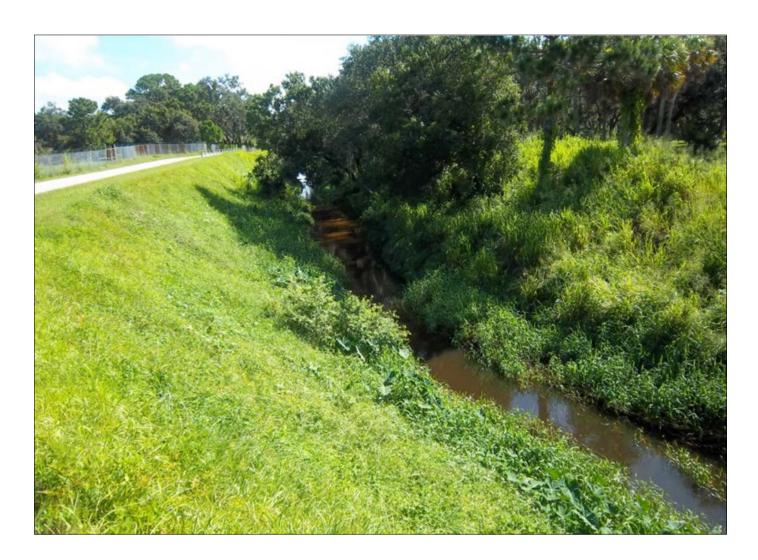
Inspector(s):	Date:	Photo Location	Photo Direction
M. Holland	8/26/2016	Linear Park north of Fruitville	North

Comments: (k)Following the linear park north of Fruitville and to the west of Fruitville Park. Canal is known as 4-14 in this area. Shoreline is very steep, with some areas of major erosion (older and now vegetated). Entire length is heavily vegetated.

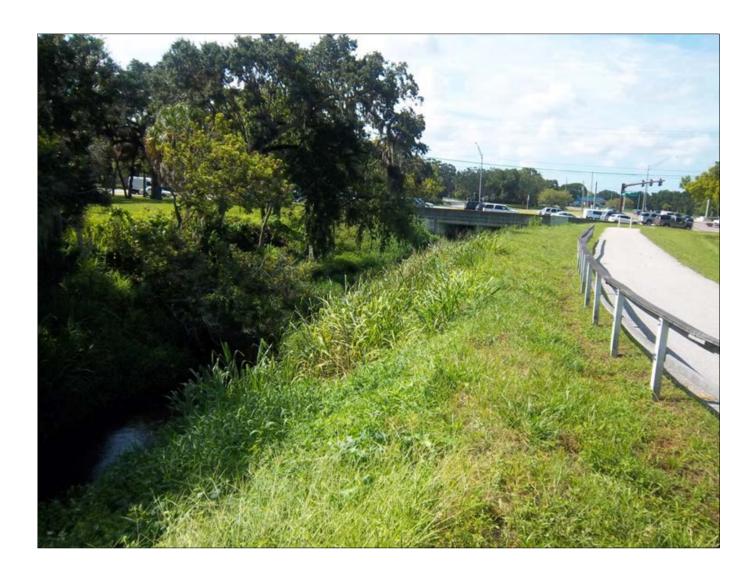
Comments: (k)Showing the canal looking south towards Fruitville Rd. No evidence of dog walking along this linear park. There are no heavily traveled critter trails along the creek.

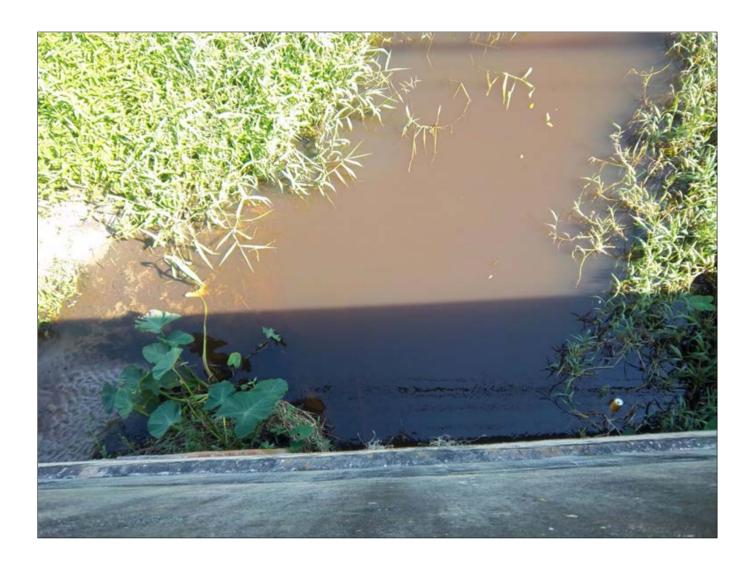
Inspector(s):	Date:	Photo Location	Photo Direction
M. Holland	8/26/2016	At Fruitville and 4-14	North

Comments: (I)Showing water as it flows south. Water is somewhat cloudy, flowing. It appears the bottom is sandy throughout.

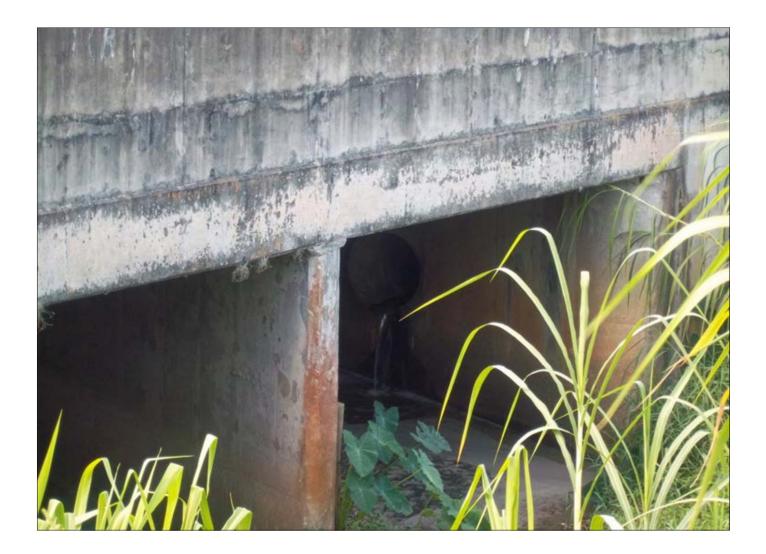
Comments: (I)Showing the discharge point of a stormwater pipe that collects water along Beneva Road north of Fruitville. The regularly sampled point is upstream of this.

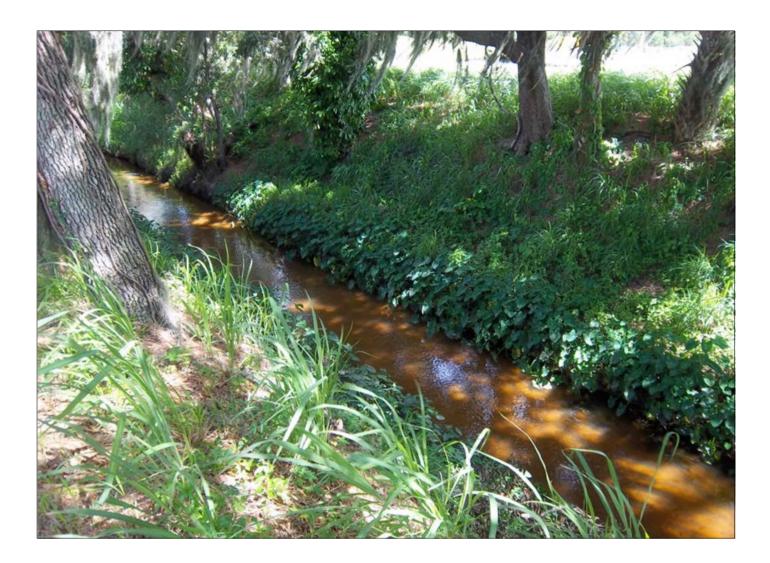
Inspector(s):	Date:	Photo Location	Photo Direction
M. Holland	8/26/2016	4-14 South of 17th Street	NE
Comments: (m)Showing the canal	just south of 17th	Street. Sandy bottom, no aquatic veg	etation, shoreline is
heavily vegetated and mostly shad	ded.

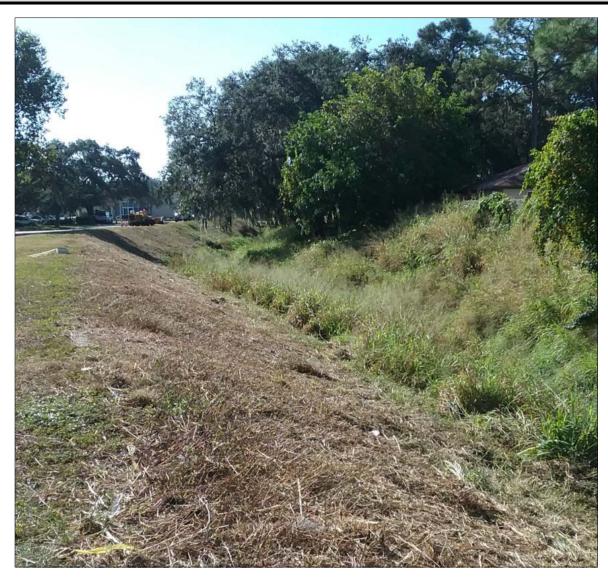
Inspector(s):	Date:	Photo Location	Photo Direction
A. Melton, J. Talbott, M. Holland	11/10/2016	Same as above	South

Comments: (#1)Showing the upstream of the sample site. The east side had been recently maintained, but not to the water's edge. Land use is commercial on the east side of the ditch, residential on the west side.

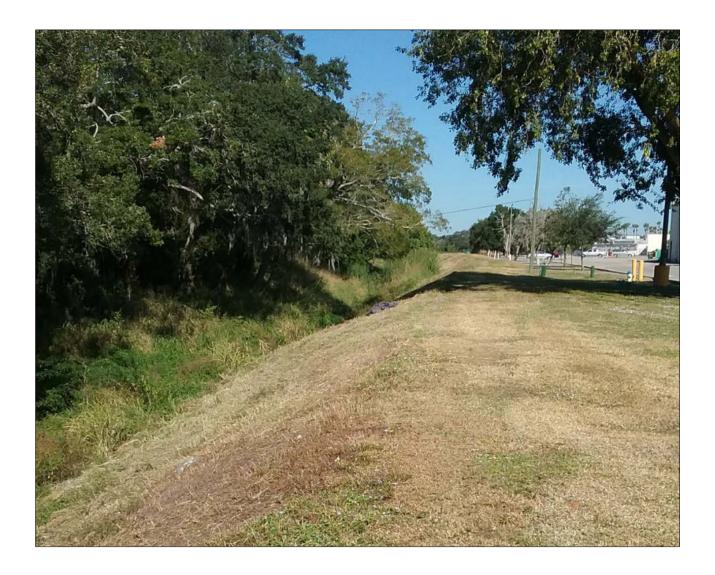
Inspector(s):	Date:	Photo Location	Photo Direction
A. Melton, J. Talbott, M. Holland	11/10/2016	Same as above	North

Comments: (#1) Showing the upstream side of the sample location. Commercal use is to the right, residential to the left. No signs of homeless encampments in this particular area.

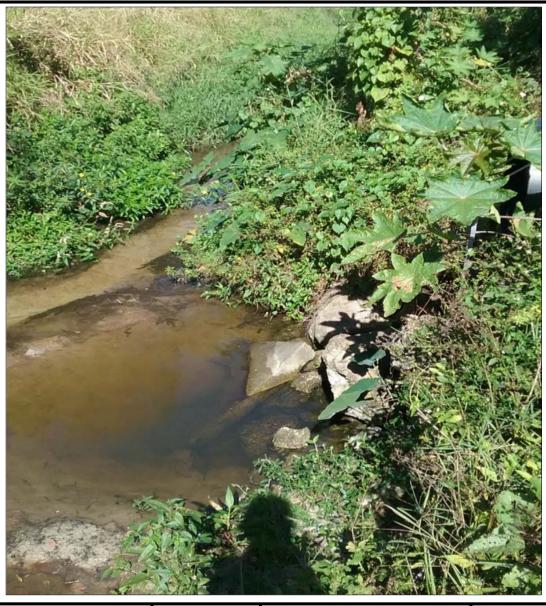
Inspector(s):	Date:	Photo Location	Photo Direction
A. Melton, J. Talbott, M. Holland	11/10/2016	Upstream of Sample site	NW

Comments: (#2)At the outfall of one of the retention ponds for the shopping center. The pond is heavily wooded and appears to be used intermittantly as a homeless encampment. The bottom sediment was sand, there was wildlife tracks as well.

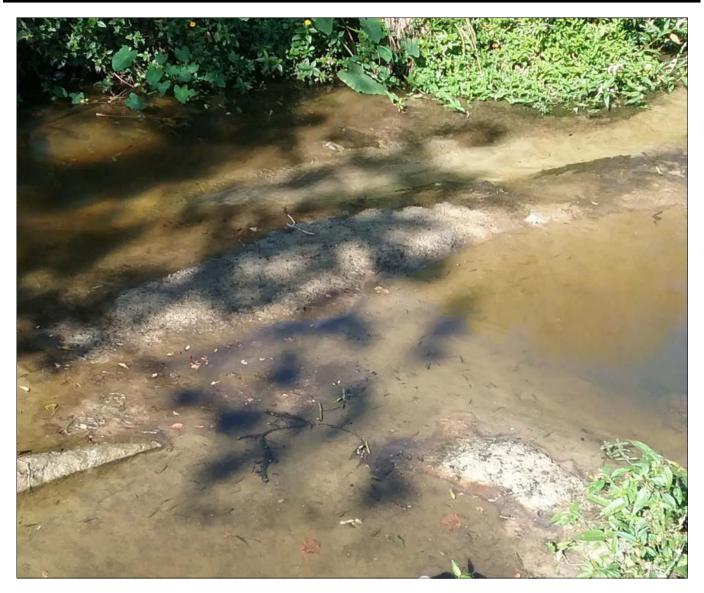
Inspector(s):	Date:	Photo Location	Photo Direction
A. Melton, J. Talbott, M. Holland	11/10/2016	Same as Above	NW

Comments:(#2) Showing the bottom sediment and the wildlife tracks. Flow was present, but not from the outfall pipe.

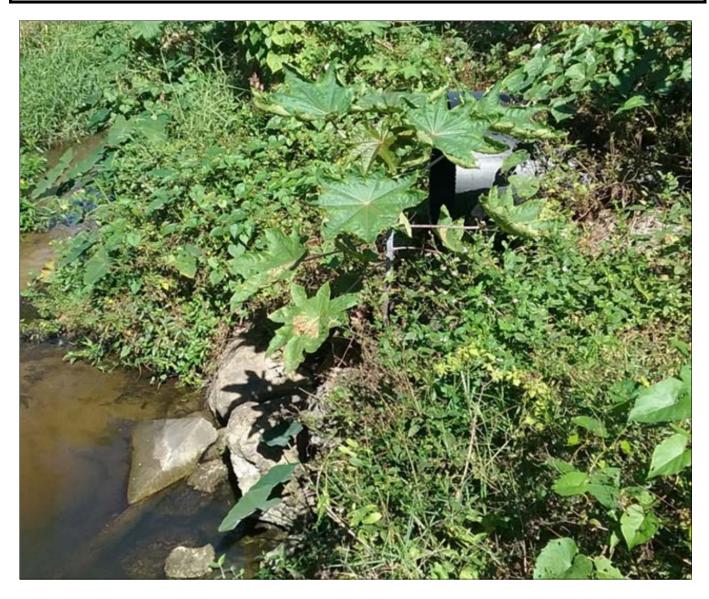
Inspector(s):	Date:	Photo Location	Photo Direction
A. Melton, J. Talbott, M. Holland	11/10/2016	Same as above	North

Comments: (#2) Showing the outfall pipe from the detention area.

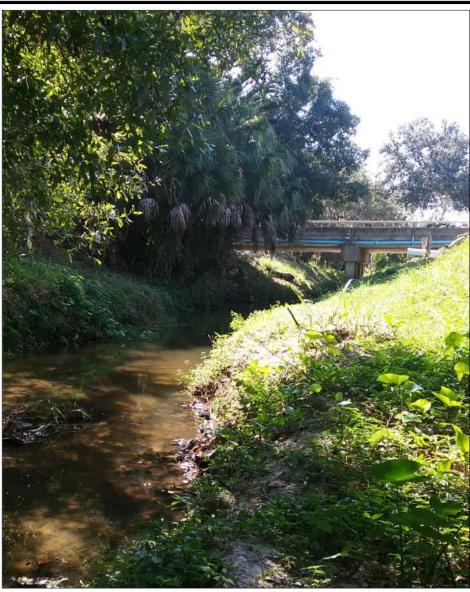
Inspector(s):	Date:	Photo Location	Photo Direction
A. Melton, J. Talbott, M. Holland	11/10/2016	N of Main B - Fruitville	South
Comments: (#4)Showing the entrance	e to Bobby Jones	Golf Course, which is about 50 yds o	downstream.

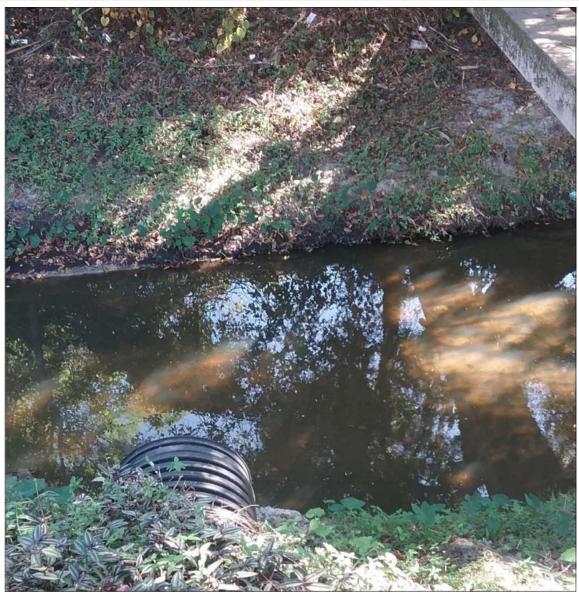
Inspector(s):	Date:	Photo Location	Photo Direction
A. Melton, J. Talbott, M. Holland	11/10/2016	Same as above	SE

Comments: (#4). Showing the sample area. A sample was taken just to the right of the outfall pipe. The bottom sediment was sand, the canal was flowing south (left to right). No flow from the outfall pipe, which accepts stormwater from the adjacent Circus Blvd. Some erosion in the canal bottom from discharge from the pipe, but riprap has been added for energy dissipation.

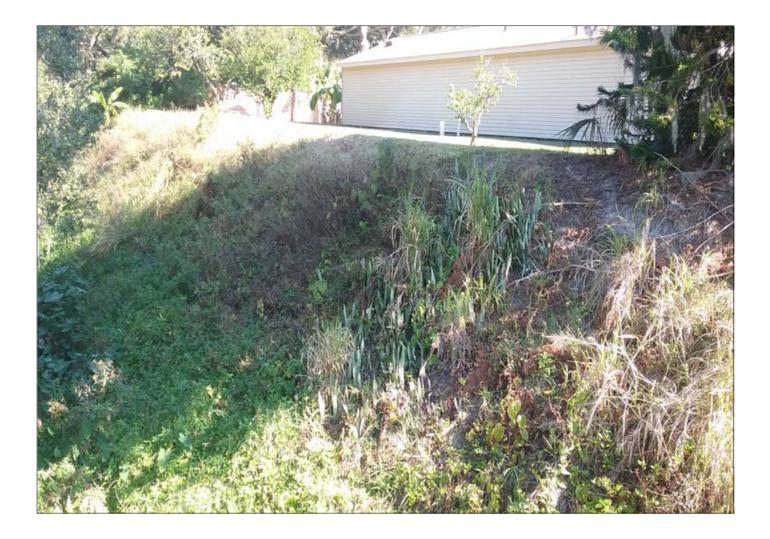
Inspector(s):	Date:	Photo Location	Photo Direction
A.Melton/M.Holland	11/16/2016	Davis Blvd.	West

Comment(s): (#2)Showing residental on east of the canal. It appears there is no direct discharge, at least from this residence, as there is a berm between the lot and the canal. Unsure of what occurs in the back of the residence in the rear of the picture.

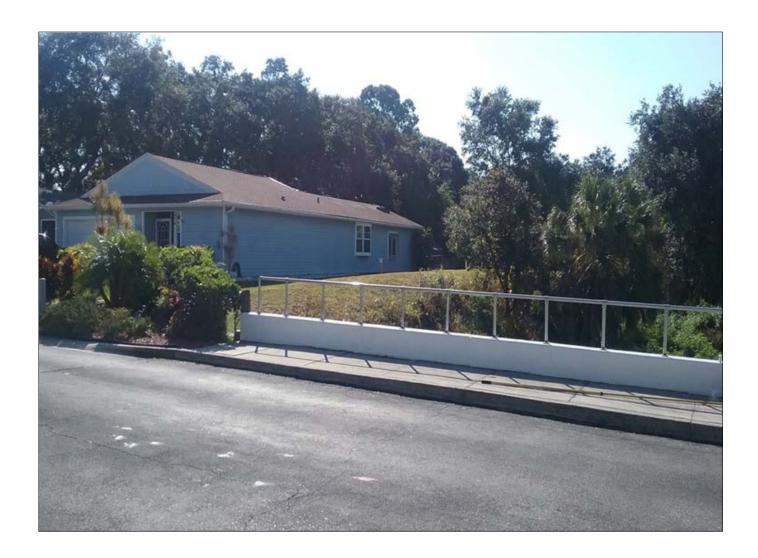
Inspector(s):	Date:	Photo Location	Photo Direction	
A.Melton/M.Holland	11/16/2016	East side of Davis Blvd.	East	
Comment: (#1*)Showing residence	e on the East side	of the canal, south side of the	bridge. Once again, there does	
not appear to be direct discharge	to the canal, ast le	ast from the visible portion of	f the lot.

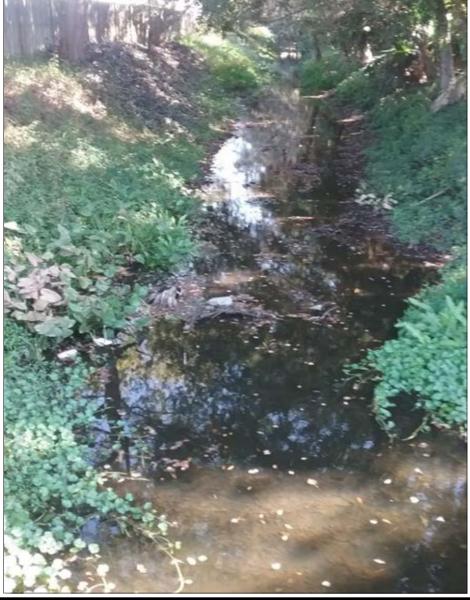
Inspector(s):	Date:	Photo Location	Photo Direction
A.Melton/M.Holland	11/16/2016	Beneva south of Bahia Vista	East

Comments: (#1*) South of Beneva Square Shopping Center. Looking east at the canal that passes under Beneva and flows west towards Phillippi Creek. Canal appears heavily shaded along this section. Heavy detritus in the bottom of the canal, bottom appears mucky. Turtles were seen upstream. This area is about 1,500 ft upstream of a known hot spot for bacteria at Seaview Drive.

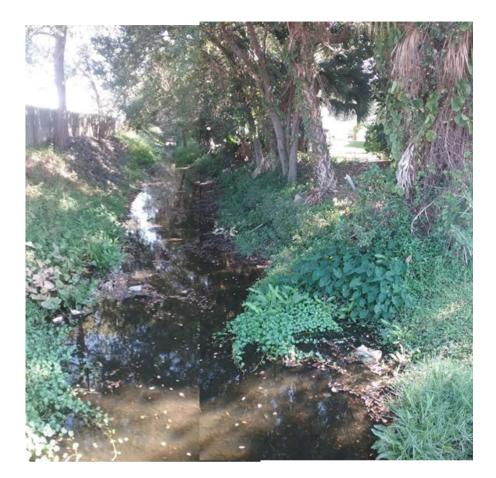
Inspector(s):	Date:	Photo Location	Photo Direction
A.Melton/M.Holland	11/16/2016	Same as above	NE

Comments: Showing a composite of the north and south banks of the canal. Slopes are relatively shallow and heavily vegetated. Beneva Shopping Center is on the left (north) of the canal, residential is on the right (south) of the canal. Stormwater from the shopping center discharges via stormwater pond to the canal. Dumpsters for this center were in good shape.

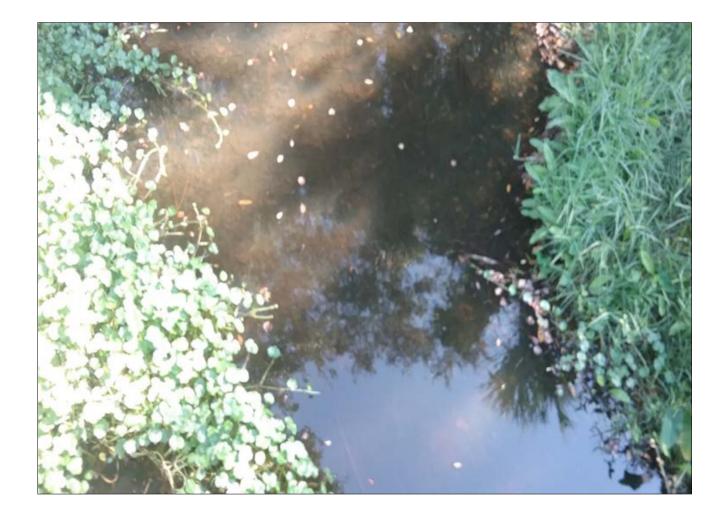
Inspector(s):	Date:	Photo Location	Photo Direction
A.Melton/M.Holland	11/16/2016	Same as above	NE
Comments: Showing water clarity	in the canal.

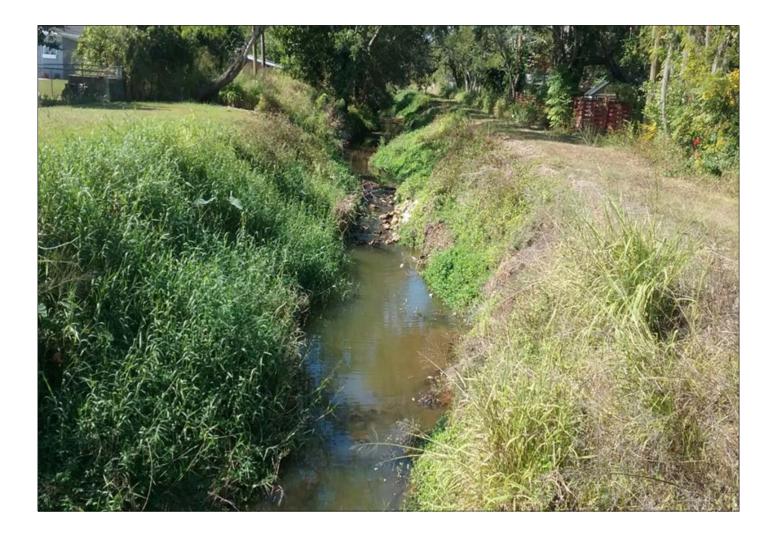
Inspector(s):		Date:	Photo Location	Photo Direction
A.Melton/M.Holl	and	11/16/2016	Brookmead and Lokai	West

Comments: (#1*)Showing canal as it flows under Lokai Pl. Water is running east (coming towards the bridge). Slopes are steep and vegetated, but showing evidence of erosion/sloughing.

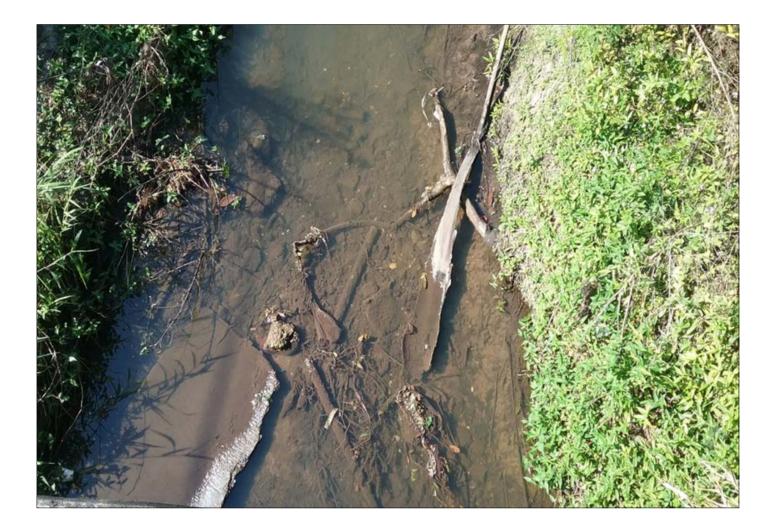
Inspector(s):	Date:	Photo Location	Photo Direction
A.Melton/M.Holland	11/16/2016	Same as above	West

Comments:(#1*) Showing the canal as it flows under Lokai. Water was light brown (a bit tannic) and somewhat cloudy. Bottom was mucky. Evidence of wildlife in the area (tracks in the mud). A sample was taken here for further testing. Shallow muddy areas such as these can promote the growth of bacteria.

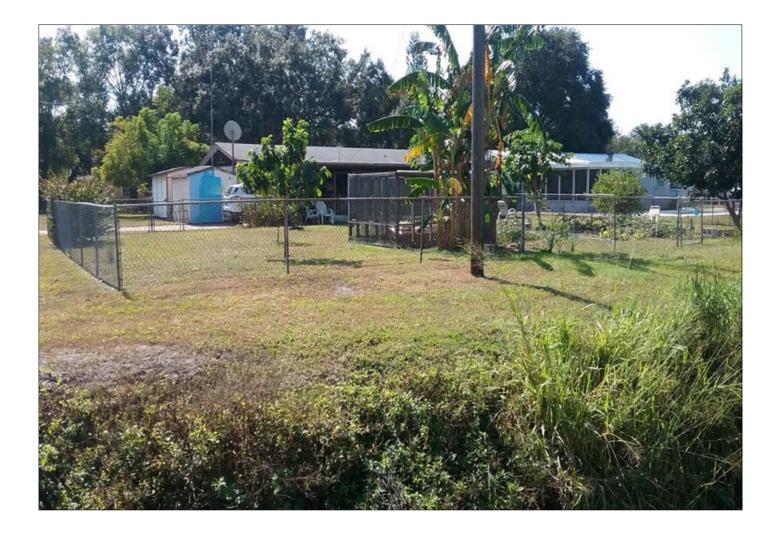
Inspector(s):	Date:	Photo Location	Photo Direction
A.Melton/M.Holland	11/16/2016	Same as above	SW

Comments: (#1*)Showing typical residential land use upstream of the sample sight. Potential for sheet flow from the homes to the canal. This home is at the NW corner of Bell Meade Drive and Lokai Place.

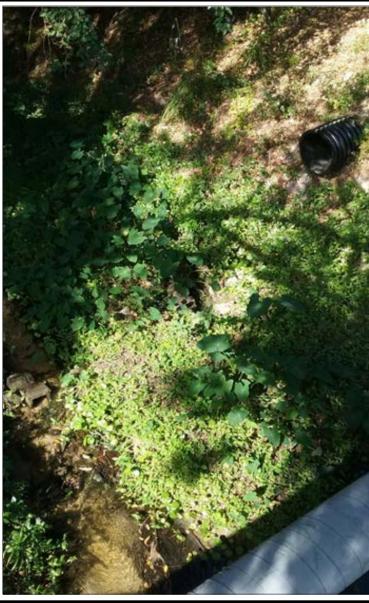
Inspector(s):	Date:	Photo Location	Photo Direction
A. Melton, M. Holland	11/29/2016	West side of South Shade	NE

Comments: (#1)Showing the canal on the west side of South Shade. This area is several blocks upstream of the hotspot located on Brink.

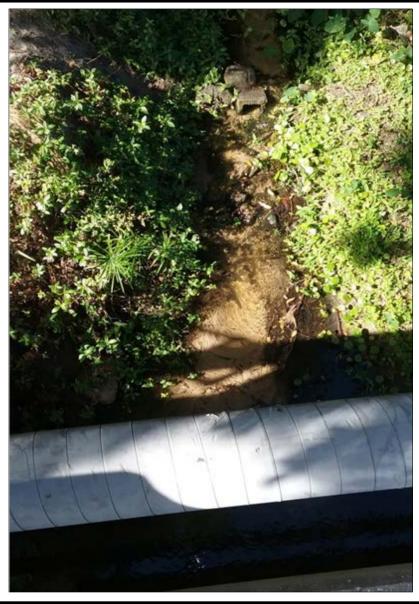
Inspector(s):	Date:	Photo Location	Photo Direction
A. Melton, M. Holland	11/29/2016	S. Shade	West

Comments: (#1)Showing the canal bottom. Sandy, mostly shade. This area is heavily travelled by animals. Game trails are evident, as well as tracks.

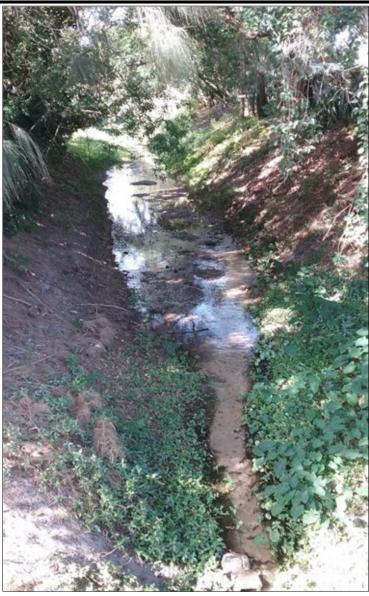
Inspector(s):	Date:	Photo Location	Photo Direction
A. Melton, M. Holland	11/29/2016	Same as Above	West

Comments: (#1*) Showing upstream from the sampling location. Banks are mostly vegetated. Residental on both sides.

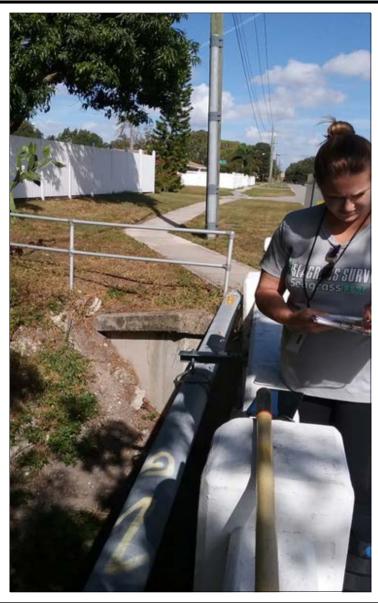
Inspector(s):	Date:	Photo Location	Photo Direction
A. Melton, M. Holland	11/29/2016	West side of South Shade	North

Comments: (#1)Showing Ashley entering in information in the sampling tablet. Just to her left is a game trail that leads from the roadside down to the ditch.

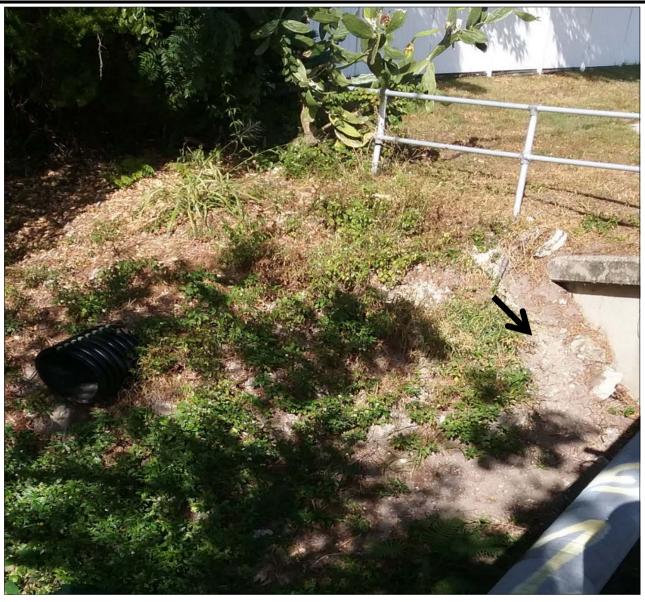
Inspector(s):	Date:	Photo Location	Photo Direction
A. Melton, M. Holland	11/29/2016	Same as Above	NW

Comments: Showing the north bank with the heavily traveled trail on the right side of the photo.

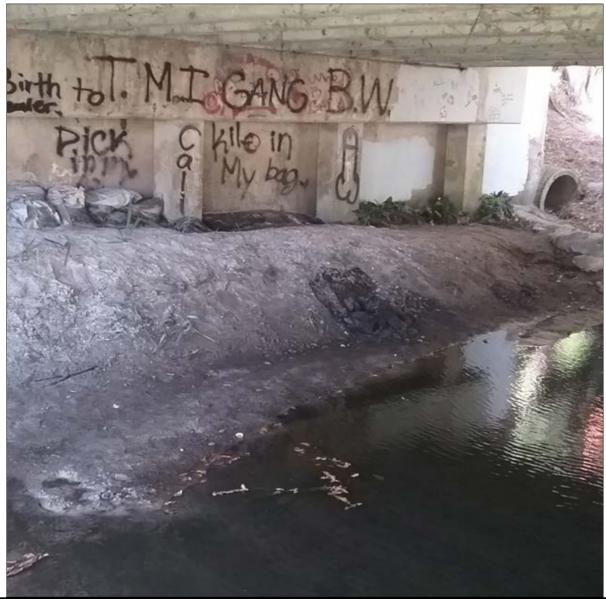
Inspector(s):	Date:	Photo Location	Photo Direction
A. Melton, M. Holland	11/29/2016	Same as Above	SW

Comments: Showing the south shore of the canal under the bridge. Lots of animal tracks, some human.

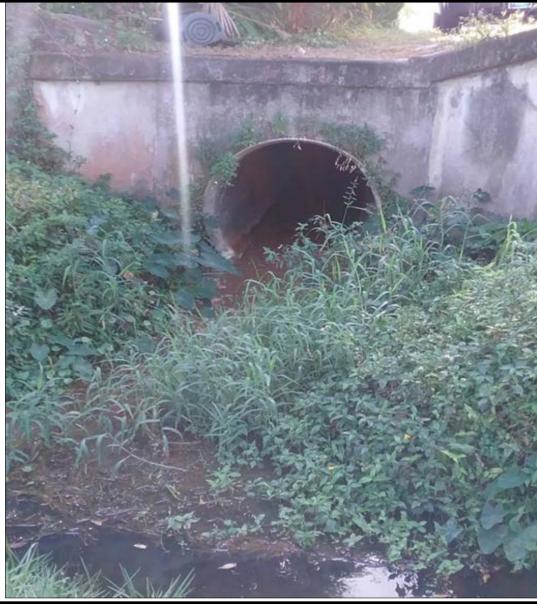
Inspector(s):	Date:	Photo Location	Photo Direction
A. Melton, M. Holland	11/29/2016	West side of S. Shade	South

Comments: Showing a pipe currently discharging discolored water into the canal. Unsure the beginning of the pipe - where it is.

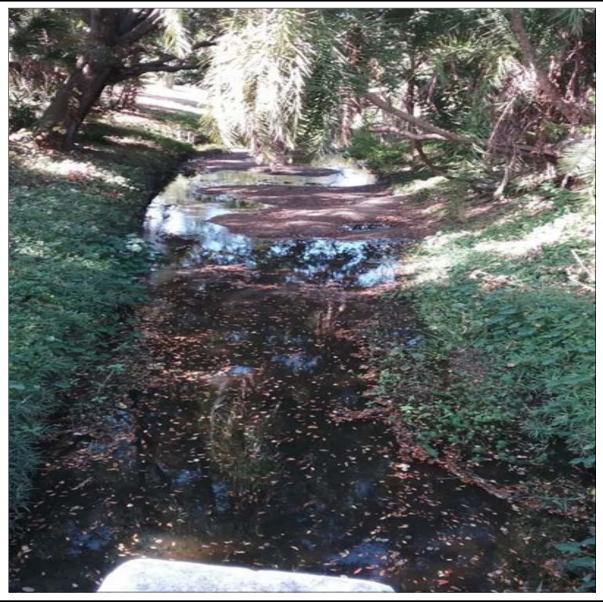
Inspector(s):	Date:	Photo Location	Photo Direction
A. Melton/M.Holland	11/29/2016	Brink Ave	West

Comments: (#1)Looking west of the bridge on Brink . The canal is a mix of sun and shade, heavily vegetated on both sides. Sand bar in the background is typically the area where the neighbor to the south (on the left) that feeds birds with fish/meat scraps (reportedly). Wildlife tracks are everywhere.

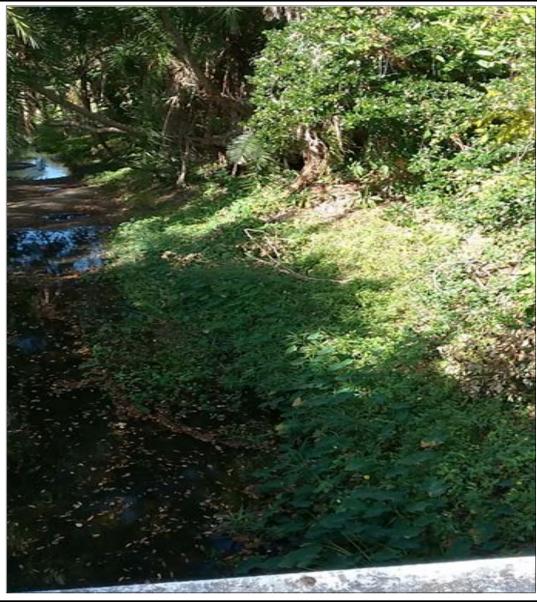
Inspector(s):	Date:	Photo Location	Photo Direction
A. Melton and M. Holland	11/29/2016	Same as above	West

Comments: Showing the nothern ditch. Residential land use on both sides, along the entire length. There was a strong smell of urine/musty animal smell in this area. The sand bar in the background was covered in animal tracks. The property on the right of the photo has fruit trees (bananas) adjacent to the creek.

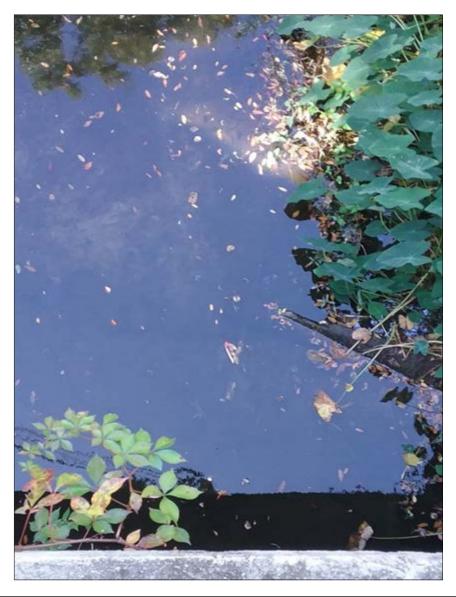
Inspector(s):	Date:	Photo Location	Photo Direction
A. Melton/M.Holland	11/29/2016	Same as above	West side of Bridge

Comments: Looking down from the bridge on the west side. The water was clear and flowing. Water depth was less than 7-8 inches deep. No odor to the water. The sample was taken here, about halfwater between the banks in the flow line.

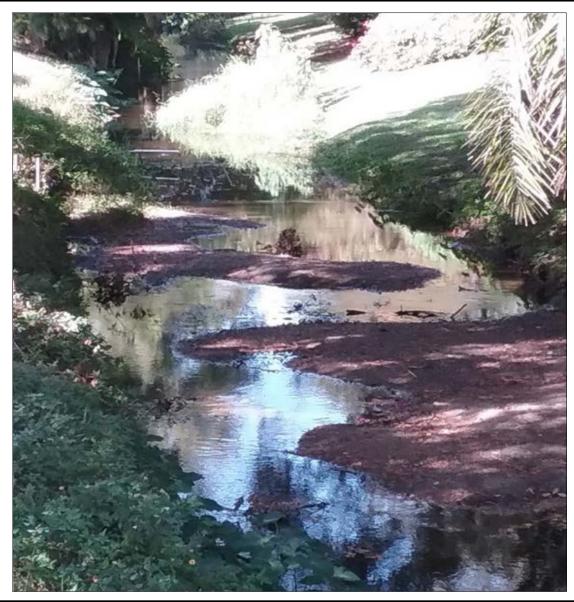
Inspector(s):	Date:	Photo Location	Photo Direction
A. Melton /M. Holland	11/29/2016	Same as above	West

Comments: Showing the other side of the sand bar (above). You can see the canal is still flowing. The slope are gentle, and covered with vegetation. As previously mentioned, the sandy areas are covered with wildlife tracts.

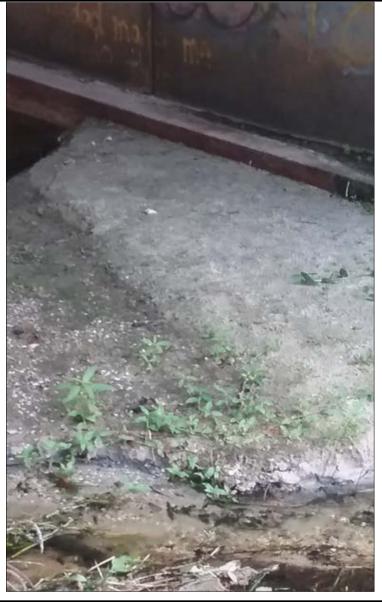
Inspector(s):	Date:	Photo Location	Photo Direction
K.O'Hara/M.Holland	12/15/2016	Under bridge at Woodview	SW

Comments: Looking at area under bridge downstream of the sample site. Sandy area is covered with animal tracks (raccoon). This is canal 4-27.

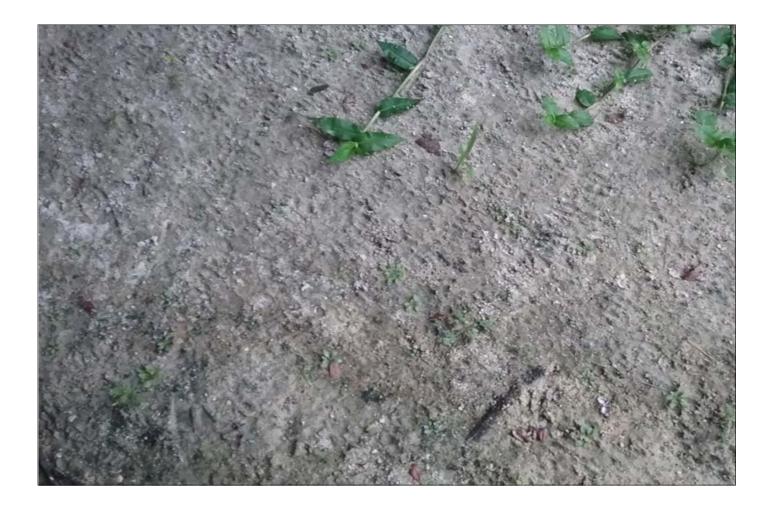
Inspector(s):	Date:	Photo Location	Photo Direction
K.O'Hara/M.Holland	12/15/2016	Same as above	SW
Comments: Showing the many ani	mal tracks in the s	and at the sandy area.

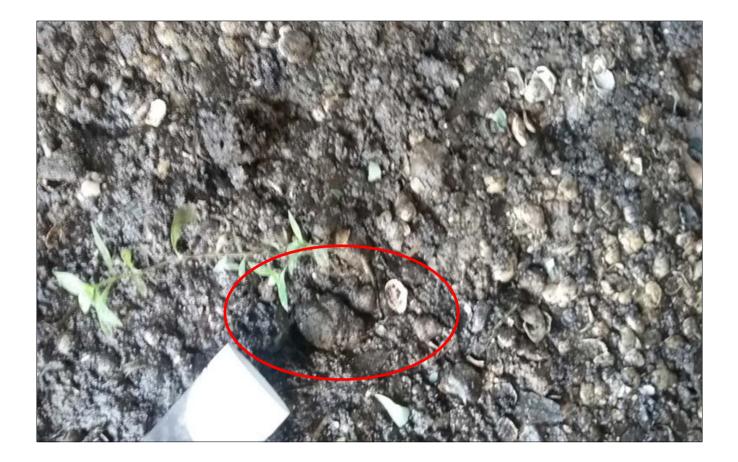
Inspector(s):	Date:	Photo Location	Photo Direction
K.O'Hara/M.Holland	12/15/2016	Same as above	N/A

Comments: Showing animal scat (just to the right of the white pole) on the sand bar, along with dozens of opened bivalves. This is upstream of the sample area.

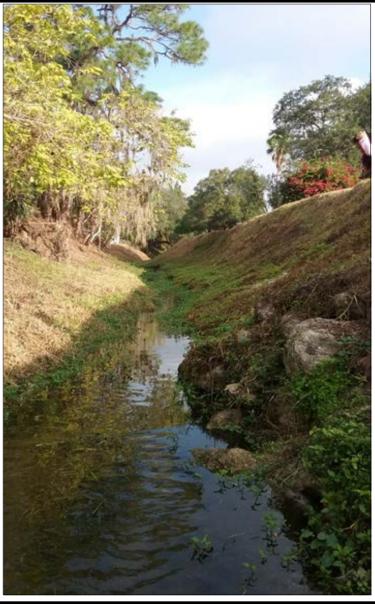
Inspector(s):	Date:	Photo Location	Photo Direction
K.O'Hara/M.Holland	12/15/2016	Same as above	North

Comments: Showing the canal to be inspected. Banks on each side are usually heavily vegetated, but there was a recent maintenance event. Slopes are steep and heavily vegetated.

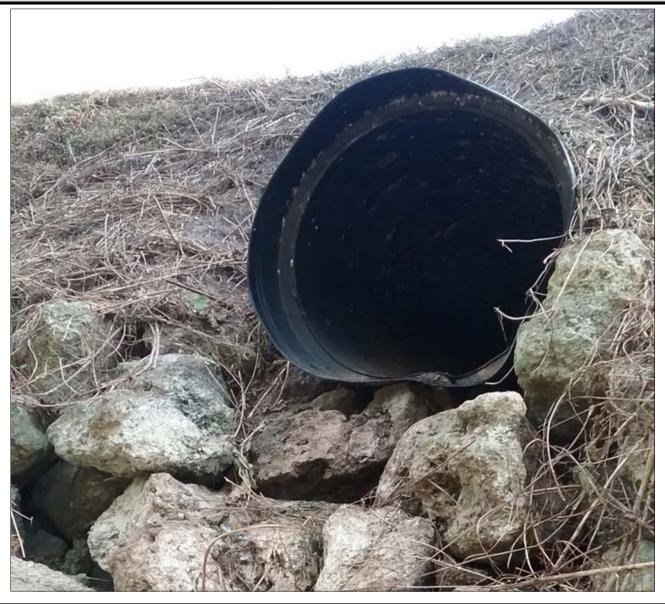
Inspector(s):	Date:	Photo Location	Photo Direction
K.O'Hara/M.Holland	12/15/2016	outfall of upstream pond	NE

Comments: Outfall for privately maintained pond P4-43. Pond was not discharging at the time of the site visit. Pond P4-43 receives stormwater runoff from the adjacent subdivision, which may contain pet waste from dog walking and yards. There was also wildlife (turtles) seen in the pond - another potential contributer.

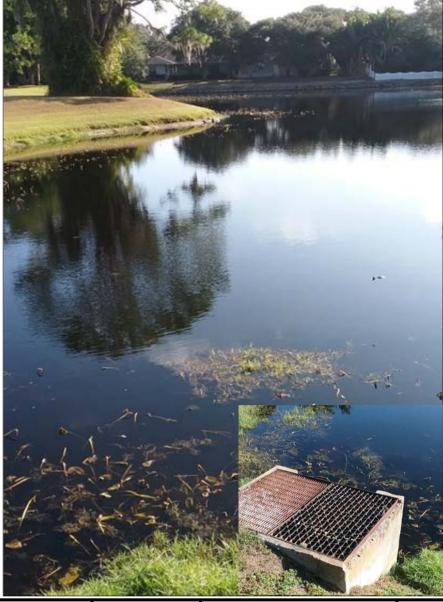
Inspector(s):	Date:	Photo Location	Photo Direction
K.O'Hara/M.Holland	12/15/2016	Pond P4-43	NE

Comments: Showing pond P4-43 and the outfall . Pond is well maintained with some vegetation at the outfall. Turtles were the only wildlife seen at the time of the site visit.

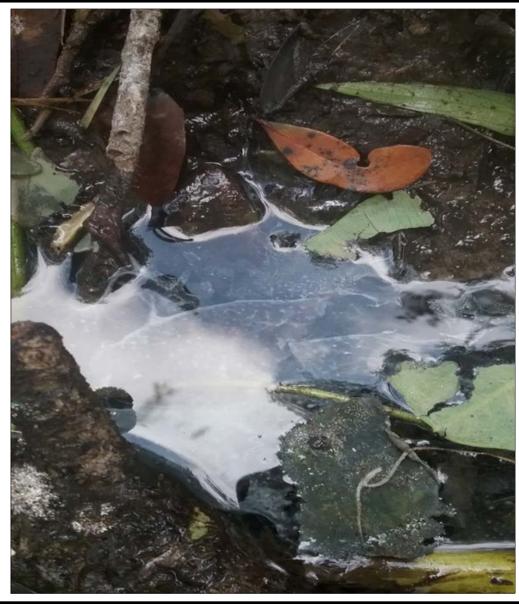
Inspector(s):	Date:	Photo Location	Photo Direction
K.O'Hara/M.Holland	12/15/2016	North of sample area	N/A

Comments: About a quarter of the way up the canal, areas of a white film on the sediment started to appear. In areas along the bank where vegetation was present, there was a film on the water. Film on the water can be a natural result of a microbial process of iron loving bacteria. Evidence of the presence of iron is shown in some following photographs.

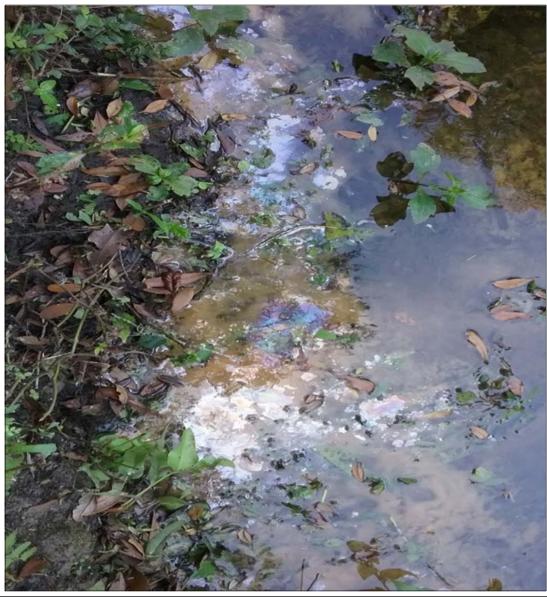
Inspector(s):	Date:	Photo Location	Photo Direction
K.O'Hara/M.Holland	12/15/2016	Upstream of P4-40 outfall	N/A

Comments: Showing a cottony precipitate at the edge of the water. PPT was orange, potentially indicitave of iron falling out of solution from water leaching through the soil. Biofilm is evident in areas where vegetation is present. This situation was only present on the east bank of the canal.
