Summary of Results

Walk the WBID Exercise for Philippi Creek (WBID1937)

FINAL DRAFT

September 27, 2017

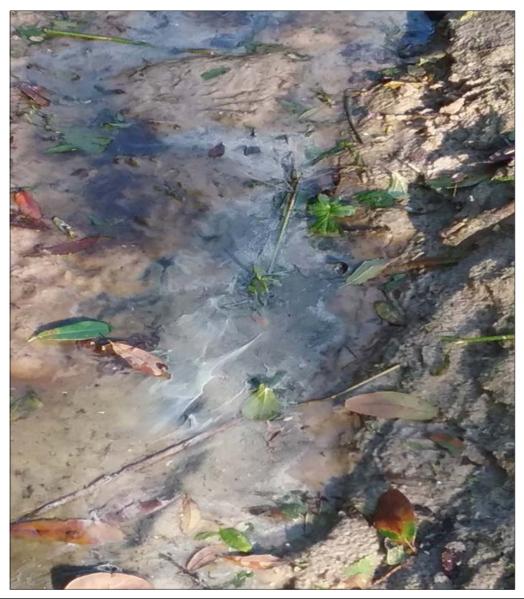
Inspector(s):	Date:	Photo Location	Photo Direction
K.O'Hara/M.Holland	12/15/2016	North of P4-40 Discharge	N/A

Comments: Once again, this white, stringy appearing substance was present. Similar situations have been seen in the presence of sulfer bacteria, however there was no odor of sulfur.

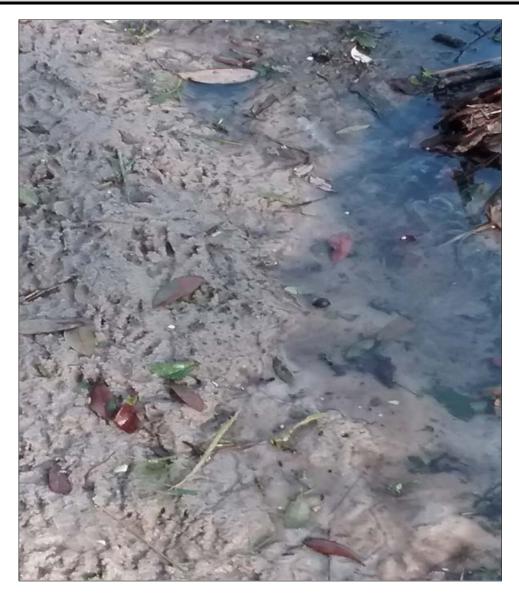
Inspector(s):	Date:	Photo Location	Photo Direction
K.O'Hara/M.Holland	12/15/2016	Same as above	N/A
Comments: Plently of animal track	s along the canal.		
	-

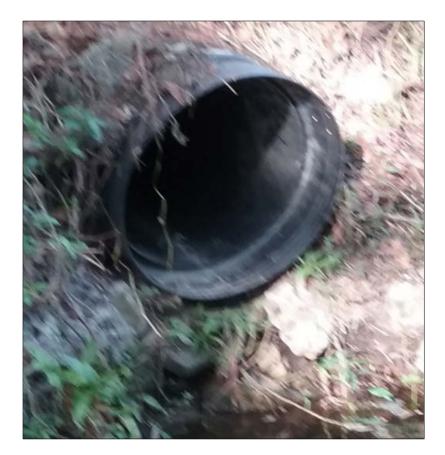
Inspector(s):	Date:	Photo Location	Photo Direction
K.O'Hara/M.Holland	12/15/2016	Outfall off Midwest PKWY	West
Comments: Attempting to show n	o discharge from t	he road.

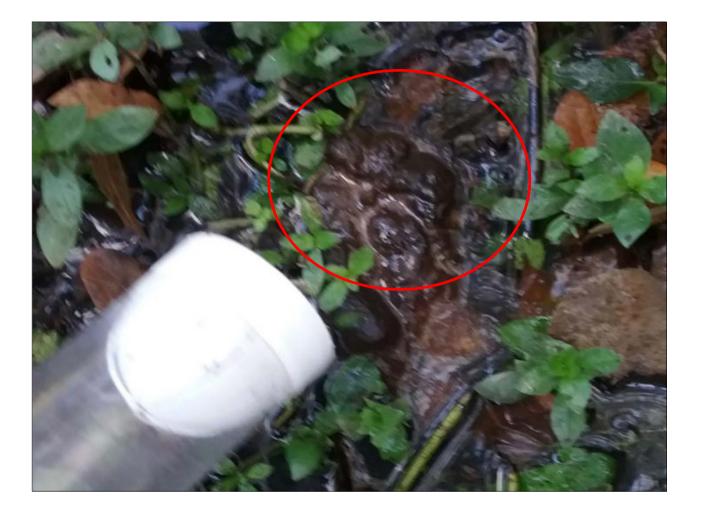
Inspector(s):	Date:	Photo Location	Photo Direction
K.O'Hara/M.Holland	12/15/2016	Downstream of above pipe	N/A
Comments: Showing animal feces	in the canal.

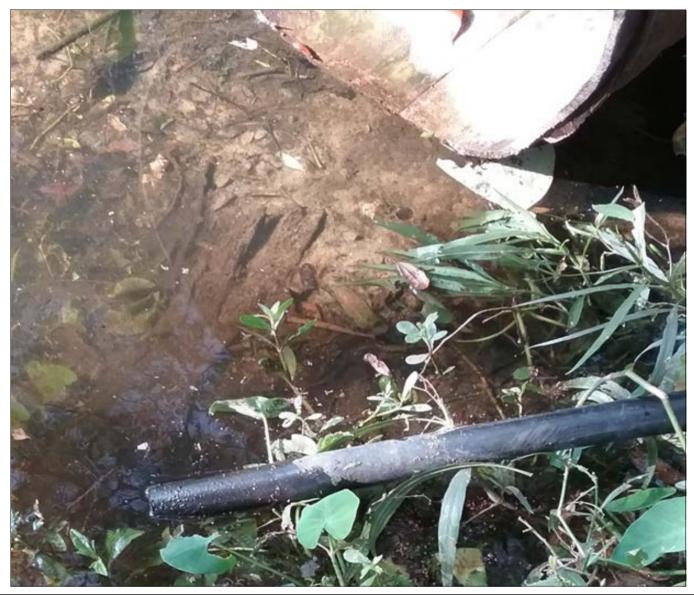
Inspector(s):	Date:	Photo Location	Photo Direction
K.O'Hara/M.Holland	12/15/2016	At the Hawkeye Cir outfall	SW

Comments: Not sure what function this pipe serves, if any. Pipes of this nature are usually attached to the washing machine and allows for greywater discharge. The pipe was reported to Air and Water Quality Staff for follow up.

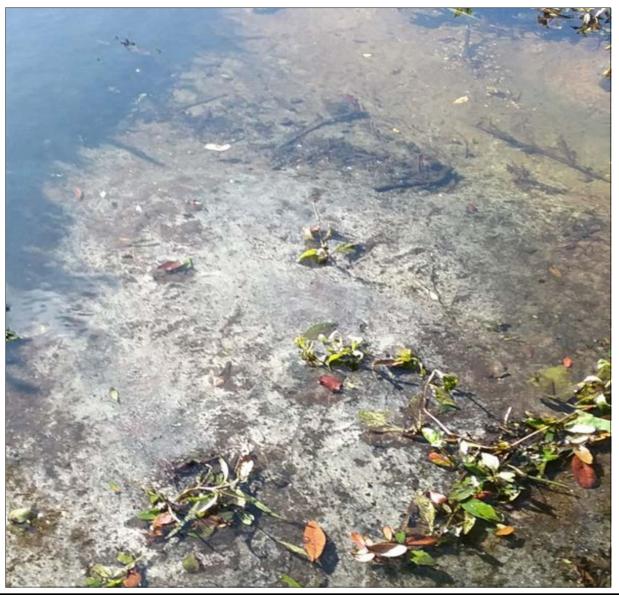
Inspector(s):	Date:	Photo Location	Photo Direction
K.O'Hara/M.Holland	12/15/2016	Same as above	SW

Comments: Showing the sediment and the white material on the sediment. This is only present after this pipe enters the canal.

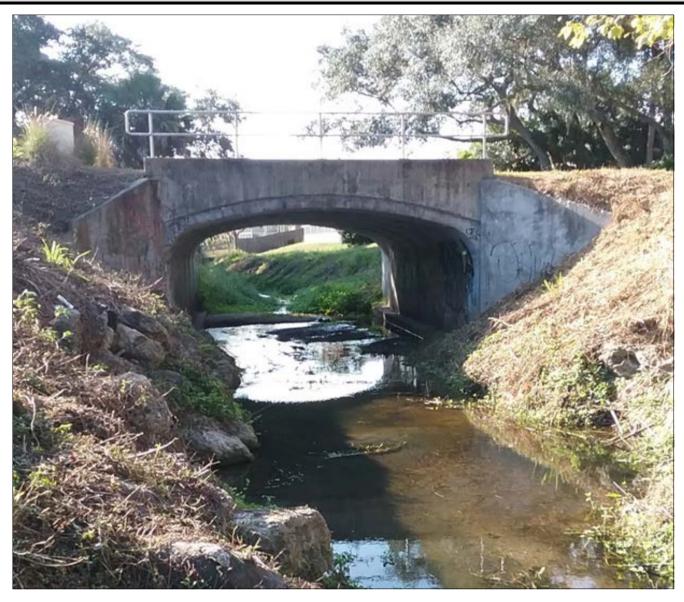
Inspector(s):	Date:	Photo Location	Photo Direction
K.O'Hara/M.Holland	12/15/2016	N of the Bridge at Woodview	South

Comments: Showing the bridge from the north. Monthly monitoring samples are taken on the south side of the bridge - in the foreground. Sand bar where the tracks and scat was visible under the bridge.

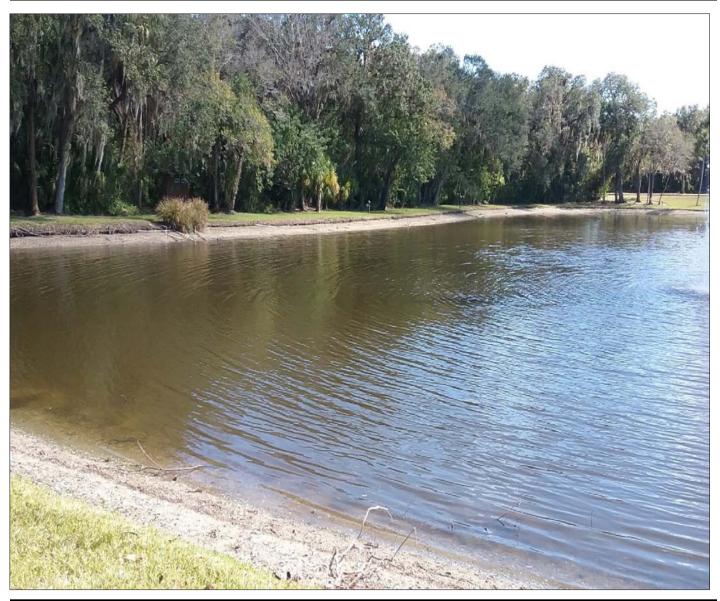
Inspector(s):	Date:	Photo Location	Photo Direction
M.Holland	1/31/2017	Pond at 17th & Longmeadow	SE

Comments: (#1)Showing a typical pond in the Meadows Subdivision. Ponds are usually well utilized by wildlife - birds and turtles. Water quality is fair, the pond is cloudy. All ponds are low from the lack of rain.

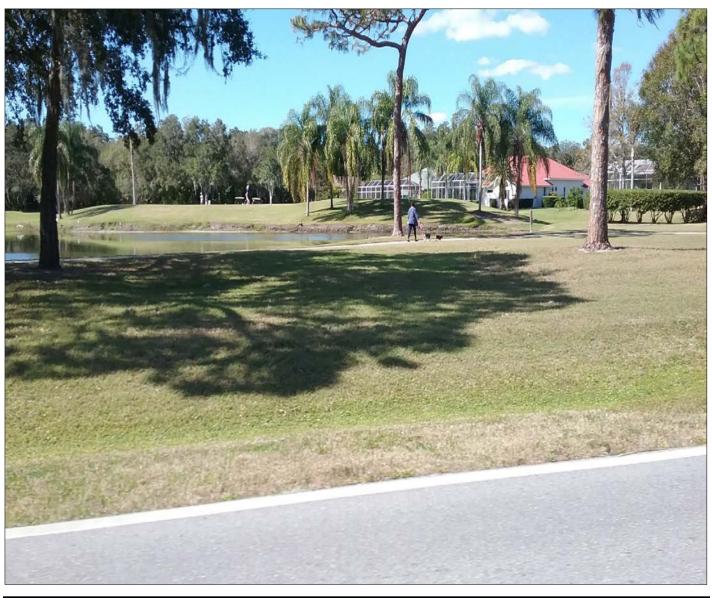
Inspector(s):	Date:	Photo Location	Photo Direction
M. Holland	1/31/2017	Londmeadow Drive	NE

Comments: (#2)The Meadows is a large residental community of mostly retirees. Shown here is common for the area, walking the dogs. It is unclear if they have outreach for picking up pet waste, and there was no obvious signage about picking up pet waste. They will be contacted in the future to assist them if they need a program.

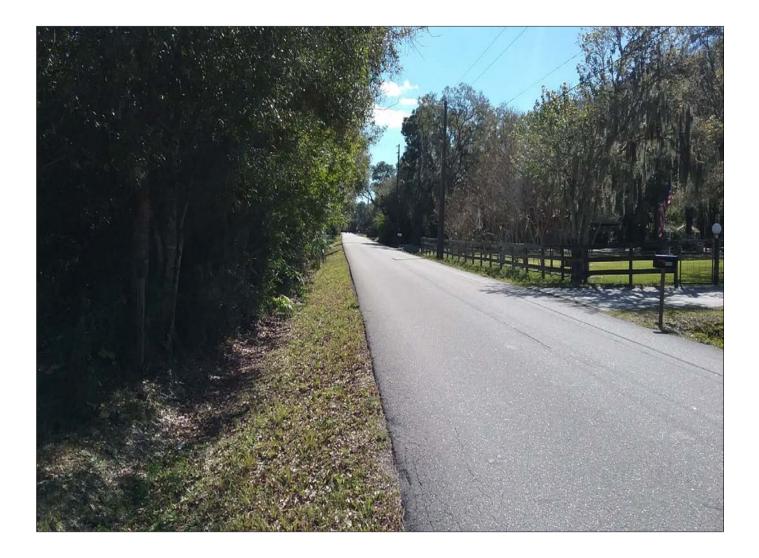
Inspector(s):	Date:	Photo Location	Photo Direction
M.Holland	1/31/2017	On Harold Ave S of Desoto	S

Comments: Showing a typical street in this neighborhood. Property sizes vary from high denisty residential to lots and larger tracts of land. With the exception of the higher density residential parcels, there is no treatment for the roadways or properties. Only 3 parcels in this area were seen to have livestock on site (horses 2-4 total; 1 pig - a very large pig).

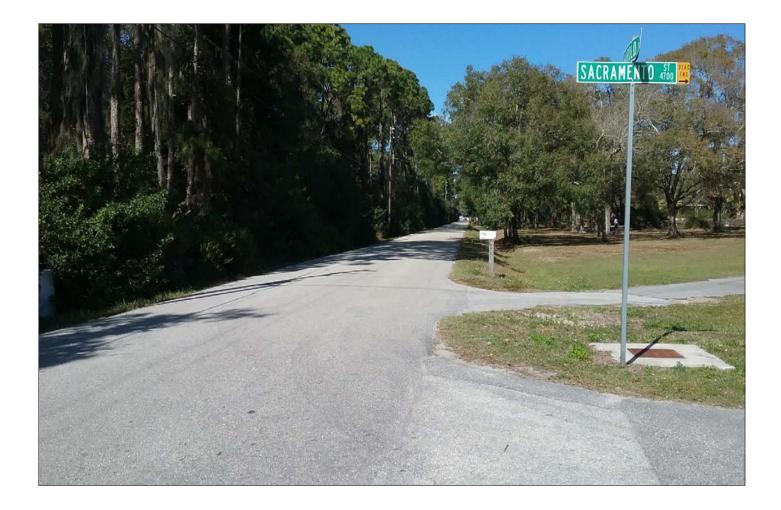
Inspector(s):	Date:	Photo Location	Photo Direction
M.Holland	1/31/2017	Intersection of above	North

Comments: (#3)Typical roadside swale in the neighborhood. All smaller swales throughout were dry. Only the large cross drains contained water. Swales and larger cross drains are well vegetated and were a mixture of sunny and shady exposure.

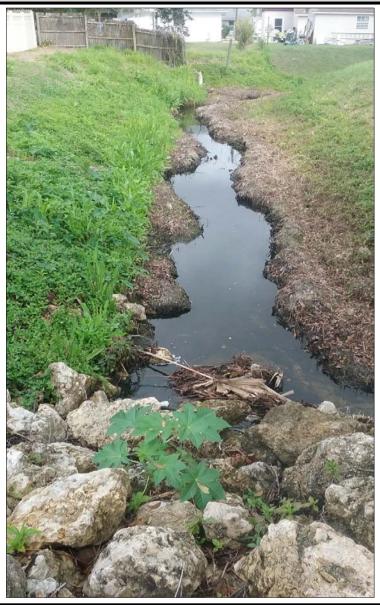
Inspector(s):	Date:	Photo Location	Photo Direction
M.Holland	2/23/2017	Seaview Street	North

Comments: (#1). Showing the ditch that flows to Phillippi Creek. Flow direction is to the south (coming towards us). Water was clear, light brown and odor free.

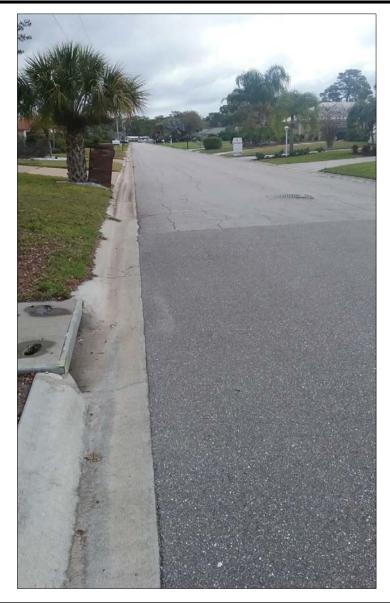
Inspector(s):	Date:	Photo Location	Photo Direction
M.Holland	2/23/2017	Seaview	West

Comments: (#1) Showing Seaview Drive. Landuse is residential, lower density. Landscapes are a varying degree of maintained. Some lawns are very lush, others not. There is evidence of the the lawn maintenance people mowing/blowing grass clippings in to the street.

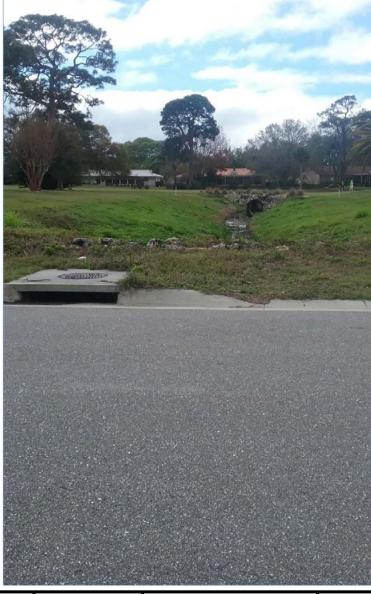
Inspector(s):	Date:	Photo Location	Photo Direction
M.Holland	2/23/2017	Seaview	South

Comments: (#1) Showing ditch south of Seaview. Area in the background is a golfcourse. The ditch makes a right hand turn after the culvert and heads to the creek.

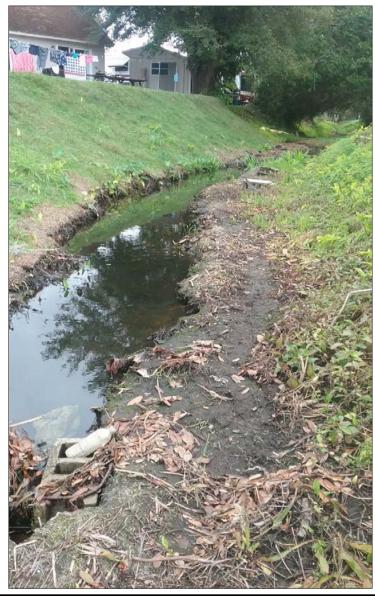
Inspector(s):	Date:	Photo Location	Photo Direction
M.Holland	2/23/2017	Seaview	North

Comments: (#2)Heading north in the ditch. Some trash in the ditch, decaying organic matter as well. There is a heavily travelled animal (probably raccoons) to the right of the flowing water. Water was still mostly clear, light brown in color. Bank to the left in the picture was recently re-sodded.

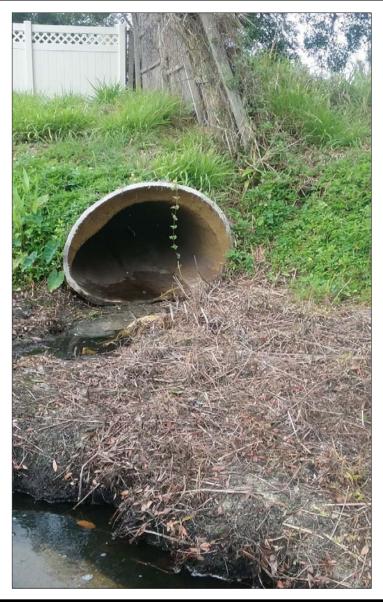
Inspector(s):	Date:	Photo Location	Photo Direction
M.Holland	2/23/2017	Bend in ditch at SV	West

Comments: (#3). Showing pipe that accepts runoff from road/property to the north (Kauffman Ave). Area in front and to the right of the pipe looks heavily travelled by animals.

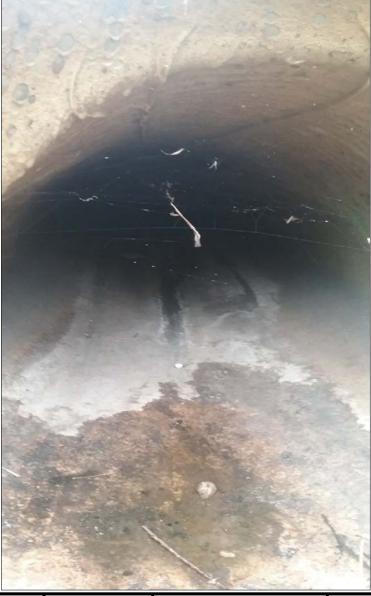
Inspector(s):	Date:	Photo Location	Photo Direction
M.Holland	2/23/2017	Same as above	inside pipe

Comments: (#3). Showing mouth of the pipe mentioned above. Stainlines indicate it conveys water at less than one quarter capacity. No odor in the pipe that would indicate animal denning. Light could been seen at the other end. Green arrow on the map - Page 1 - denotes the pipe.

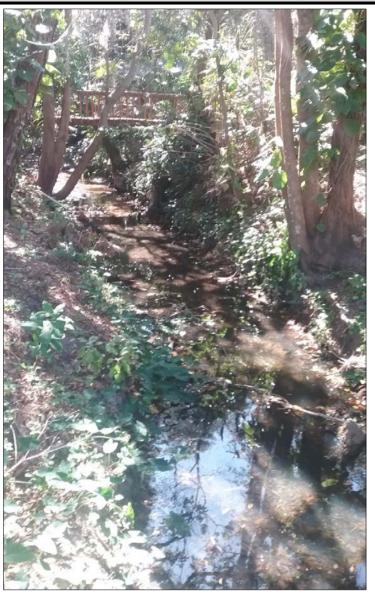
Inspector(s):	Date:	Photo Location	Photo Direction
M. Holland/J. Talbott/N.Iadavia	3/1/2017	Nassau Street	South

Comments: (#1). Looking upstream. Land use is mostly residential along Red Bug Slough. Water is clear and mostly colorless. Substrate is a mix of shelly and organic matter. Side banks are steep and vegetated with N/E species. Some minnows in the water, less than 10. No apparent wildlife activitiy in the visible area. Properties in this area have been transitioned to the County Sewer system.

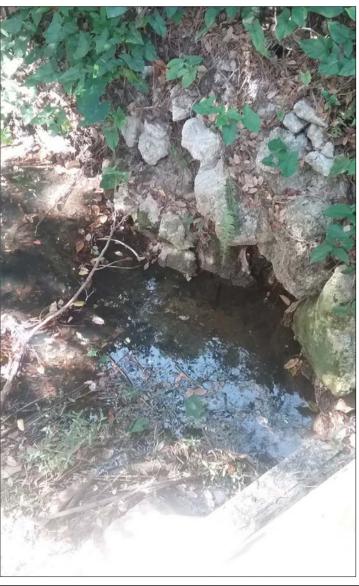
Inspector(s):	Date:	Photo Location	Photo Direction
M. Holland/J. Talbott/N.Iadavia	3/1/2017	Nassau Street	North

Comments: (#1).Showing the slough as it passes under Nassau Street. The sample was taken here. Only one of the culverts was flowing, the other was blocked. Vegetation - intact and decaying - gets bottle necked in this area.

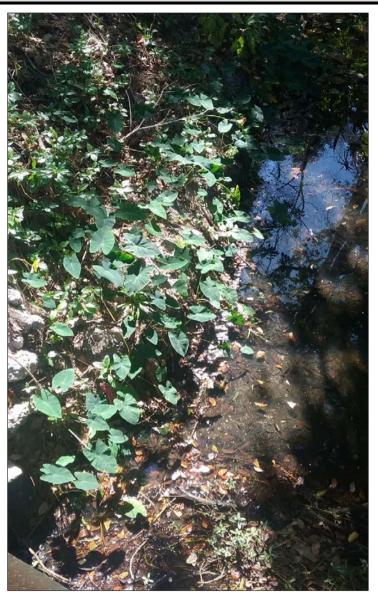
Inspector(s):	Date:	Photo Location	Photo Direction
M. Holland/J. Talbott/N.ladavia	3/1/2017	Same as above	South

Comments: (#1) Showing the eastern culvert. It is almost completely blocked, allowing for detritus to stack up here.

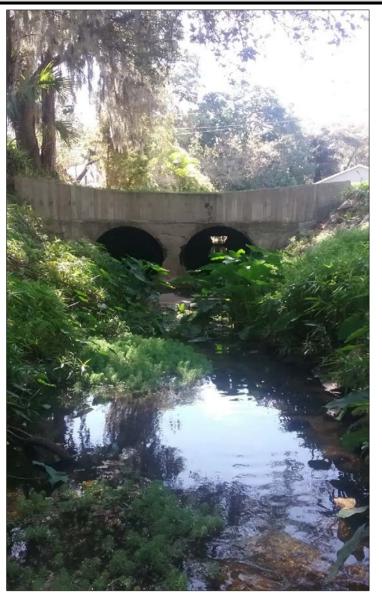
Inspector(s):	Date:	Photo Location	Photo Direction
M. Holland/J. Talbott/N.ladavia	3/1/2017	Nassau Street	South

Comments: (#2). Lookin at the downstream end of the box culverts at Nassau. Side slopes are mostly vegetated. Water is nearly completely shaded at this point of the Slough. Substrate is a mix of shell and decaying organic matter. Water is still clear, with a light brown color. Some emergent vegetation in this segment of the slough.

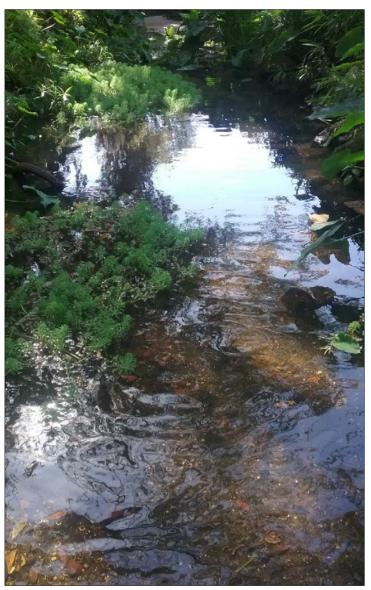
Inspector(s):	Date:	Photo Location	Photo Direction
M. Holland/J. Talbott/N.Iadavia	3/1/2017	Same as above	South

Comments: (#2) Same location as above, just closer.

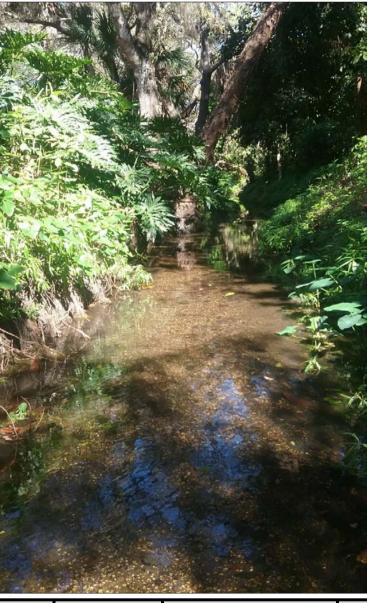
Inspector(s):	Date:	Photo Location	Photo Direction
M. Holland/J. Talbott/N.Iadavia	3/1/2017	Same as above	North

Comments: (#2) Looking further up stream. Sampling spot where E.coli is elevated is just upstream from this point, about 700 ft. The slough is mostly shaded the entire way.

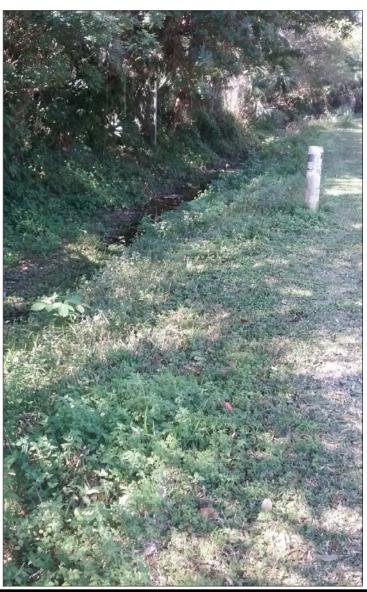
Inspector(s):	Date:	Photo Location	Photo Direction
M. Holland/J. Talbott/N.Iadavia	3/1/2017	S end of Worcester Rd	West

Comments: (#3). Showing the ditch that runs east/west at the end of Worcester. Water was low, but moving. The ditch was heavily vegetated. Substrated was a mix of sand and muck.

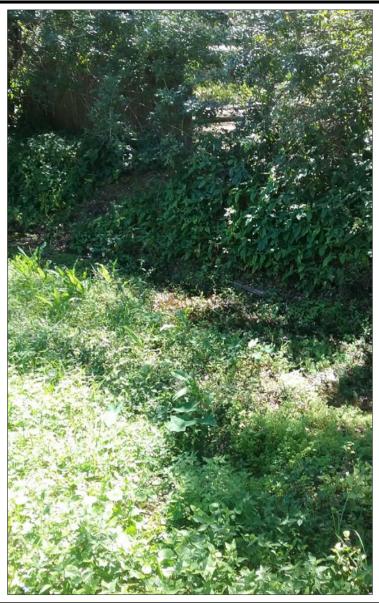
Inspector(s):	Date:	Photo Location	Photo Direction
M. Holland/J. Talbott/N.Iadavia	3/1/2017	Same as above	East

Comments: (#3). Just to the east of this location, you can see the ditch is a mix of sun and shade. The ditch is heavily vegetated on both slopes, as well as a bit in the flow way.

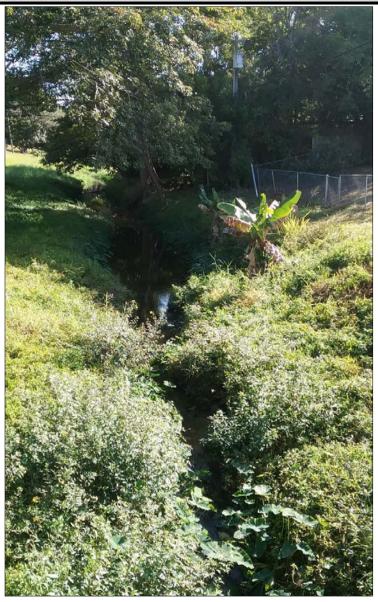
Inspector(s):	Date:	Photo Location	Photo Direction
M. Holland/A. Melton	11/29/2016	Tuttle South of Sunnyside	East

Comment: Looking east along the drainage ditch. Ditch is pretty heavily vegetated and shaded about half the time. Homes along the ditch are pretty well maintained. Heavily travelled game trails were not seen.

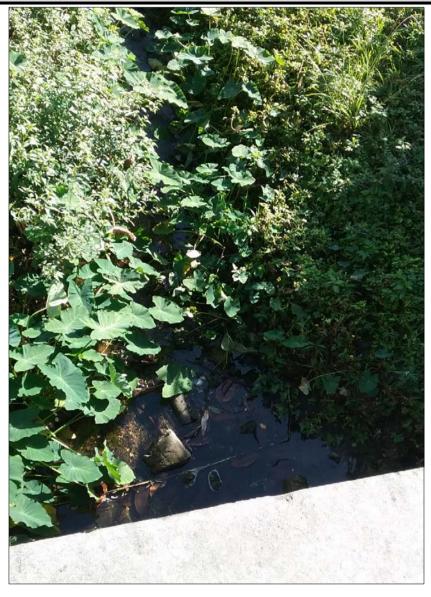
Inspector(s):	Date:	Photo Location	Photo Direction
M. Holland/A. Melton	11/29/2016	Same as above	East

Comments: Showing the general appearance of the ditch bottom. Vegetation is mostly nuisance exotic species and emergent in nature. We were unable to determine if this area is heavily travelled by wildlife due to the vegetation. A sample was taken here.

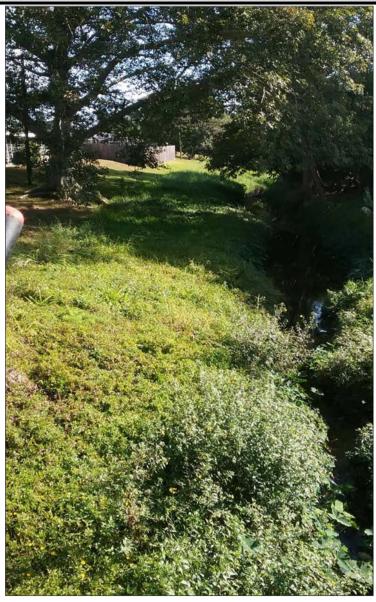
Inspector(s):	Date:	Photo Location	Photo Direction
M. Holland/A. Melton	11/29/2016	Same as above	East

Comments: Showing the overall condition of the north bank of the ditch. It appears the the back yards of homes on both the north and south banks are graded to drain to the ditch. Pet waste from the yards will end up in the ditch.

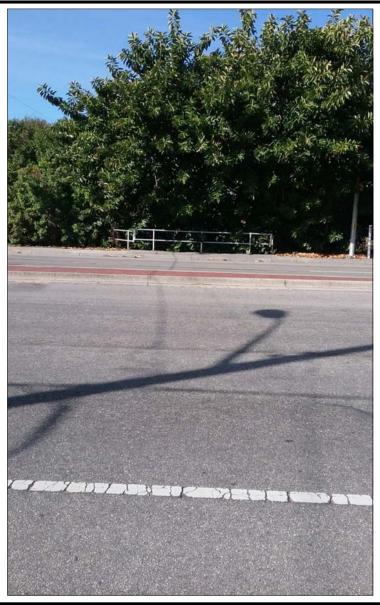
Inspector(s):	Date:	Photo Location	Photo Direction
M. Holland/A. Melton	11/29/2016	Same as above	West

Comments: Showing the west side of the road. Because of the heavy vegetation at the rail, we were not able to deterimine the status of the ditch on the west side of Tuttle.

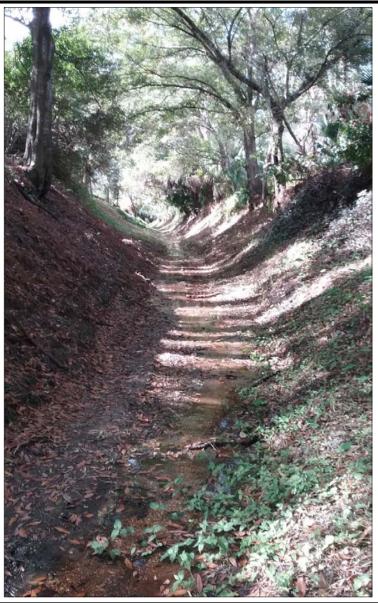
Inspector(s):	Date:	Photo Location	Photo Direction
M. Holland	11/29/2016	Ditch 4-98.2	West

Comments: Looking west along the ditch. The top of bank is mostly vegetated, shading the ditch. The water was barely flowing, just a few inches deep. The slopes were very steep the entire length.

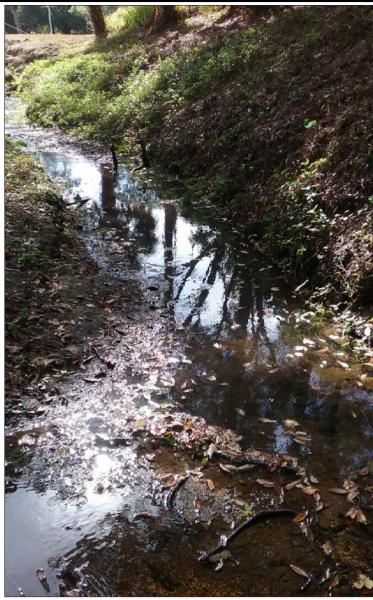
Inspector(s):	Date:	Photo Location	Photo Direction
M. Holland	11/29/2016	4-107.1	South

Comments: Looking at the conveyance ditch as it enters in to 4-98.2, 4-98.3. Residences 2 streets over - Stratford Dr - have been transitioned to sewer from on site septic. Residences from this ditch eastward still utilize on site septic systems.

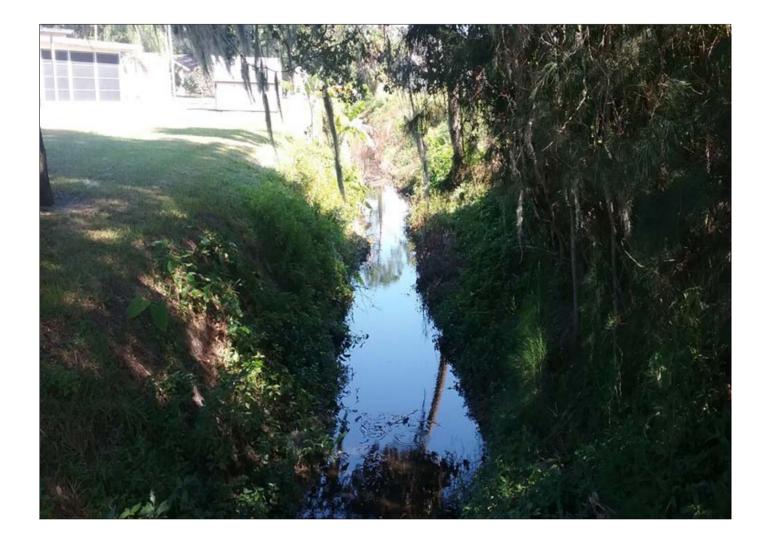
Inspector(s):	Date:	Photo Location	Photo Direction
A.Melton/M.Holland	11/16/2016	End of Schrock St.	NE

Comments: (#1*)Showing the canal it flows west through residential areas. There is a foot bridge that crosses the canal at the end of Schrock Street and Hines Ave. Homes in this area are small but well maintained. There is no treatment for stormwater in this area, direct discharge to the canal, then to Phillippi Creek.

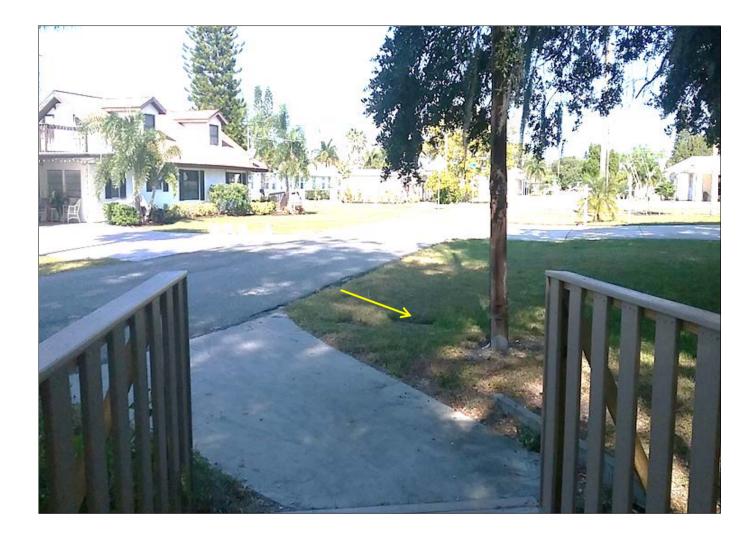
Inspector(s):	Date:	Photo Location	Photo Direction		
A.Melton/M.Holland	11/16/2016	End of Hines Ave	North		
Comments: To the left and right of	f this footbridge th	ere are pipes that accept roa	dway and yard runoff, then		
discharge stormwater from this ar	ea into the canal.	Inlet location is shown by the	yellow arrow.

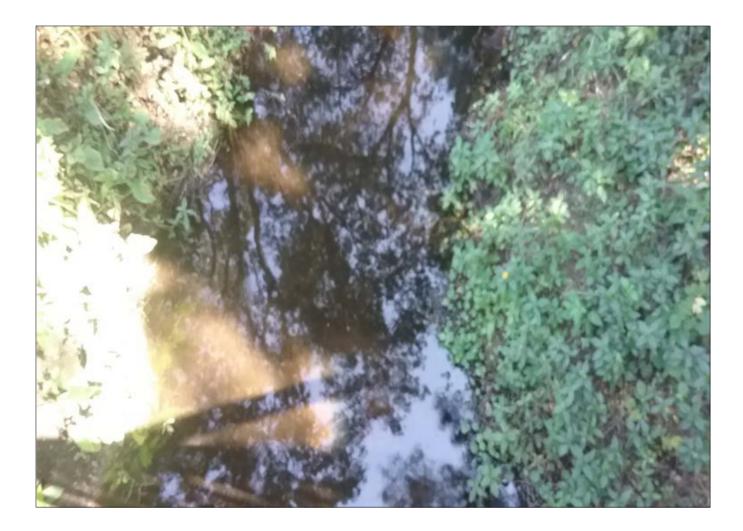
Date:	Photo Location	Photo Direction		
11/16/2016	Same as above	East		
appearance of the v	vater in the canal. Bottom wa	s sandy/shell with a slight layer of		
nad a slight musty s	mell. There was a minimal flo	w in the ditch.		
	11/16/2016 appearance of the v

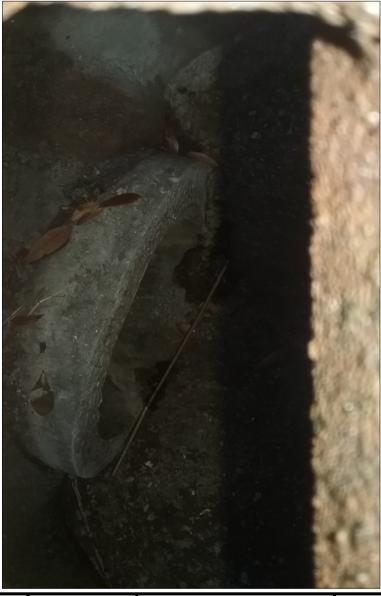
Inspector(s):	Date:	Photo Location	Photo Direction
M. Holland	12/7/2016	South Curb Inlet at Valencia	N/A

Comments: (1S) Curb inlet west of Sough Shade on Valencia. Trash cans on this inlet awaiting pick up. Inlet was dry and free from trash, leaves and sediment. No musty/odd odor was detected.

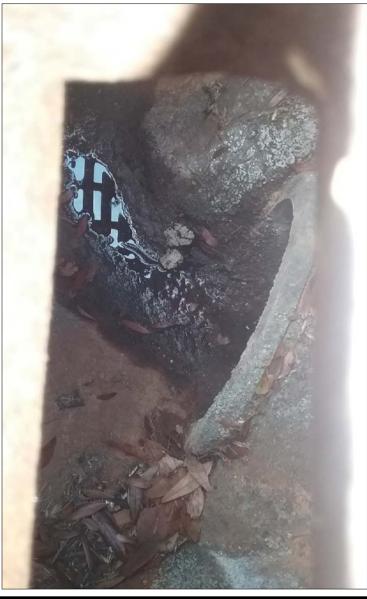
Inspector(s):	Date:	Photo Location	Photo Direction
M. Holland	12/7/2016	North Curb Inlet on Valencia	N/A

Comments: (1N) Some water (likely from lawn irrigation) and some leaves, decomposing vegetation in this inlet. No musty/odd odor was detected in this inlet.

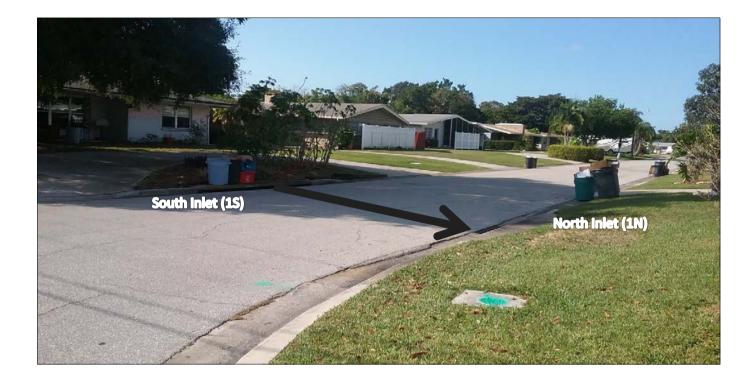
Inspector(s	s): Date:	Photo Location	Photo Direction
M. Hollan	d 12/7/2016	Valencia and S. Shade	e West

Comments: (1) Showing the North and South Inlets on Valencia at South Shade. Homes in this area are generally well maintained. Large arrow indicates pipe location and flow direction.

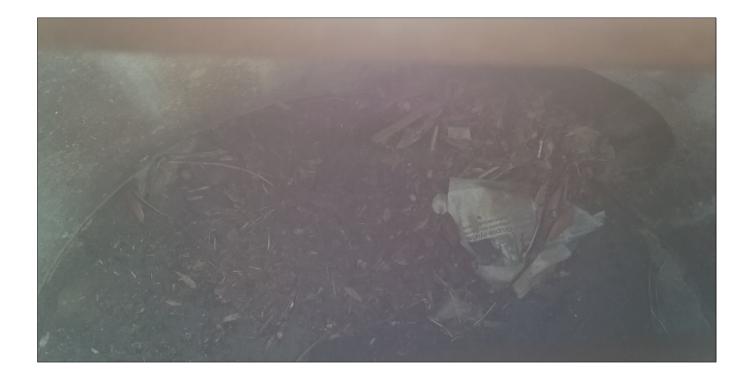
Inspector(s):	Date:	Photo Location	Photo Direction
M. Holland	12/7/2016	South Goldenrod Street	N/A

Comments: (2S). Showing the south inlet on Goldenrod street west of South Shade. The inlet has accumulated sediment, leaves and trash (about 2 inches deep in a 15 inch pipe). Garbage cans present around the inlet. No unusual musty/odd odor however.

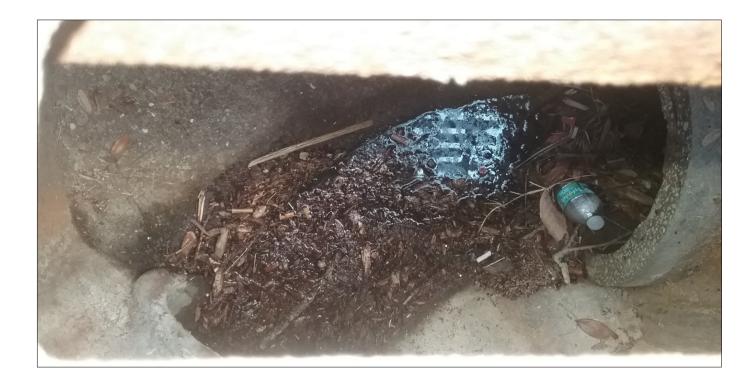
Inspector(s):	Date:	Photo Location	Photo Direction			
M. Holland	12/7/2016	North side of Goldenrod St	N/A			
Comments: (2N). Showing the nor	Comments: (2N). Showing the north curb inlet on Goldenrod west of South Shade. Again and accumulation of					
sediment, leaves and trash (about	1-2 inches deep in	n a 15 inch round pipe). No musty	/odd odors.

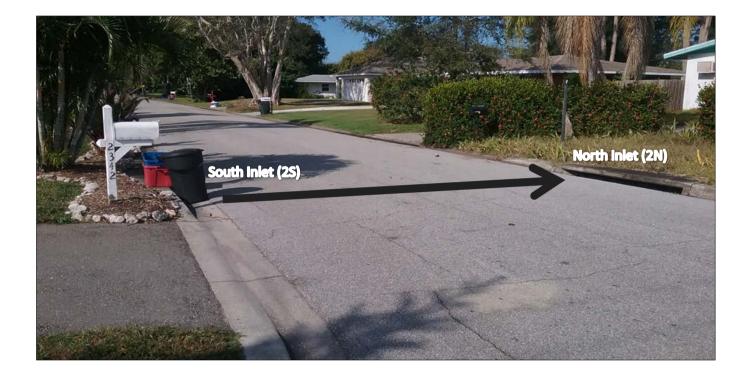
Inspector(s):	Date:	Photo Location	Photo Direction
M. Holland	12/7/2016	Goldenrod St and S. Shade	West

Comments: (2). Showing the north and south inlets on Goldenrod St. west of South Shade. Houses along this street are generally well maintained, but not overwhelmingly lush. Garbage cans present. Large arrow indicates pipe location and flow direction.

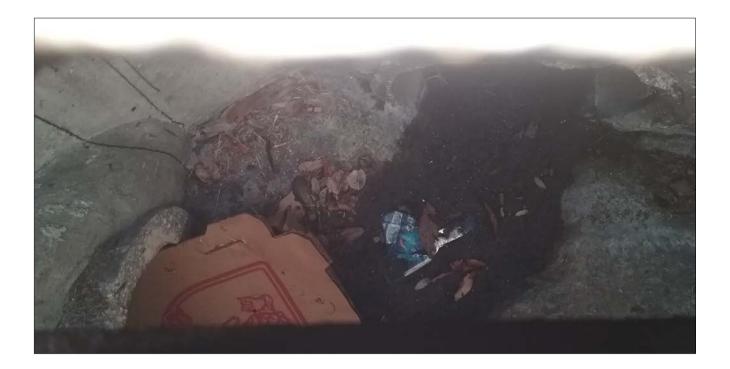
Inspector(s):	Date:	Photo Location	Photo Direction
M. Holland	12/7/2016	Rose Street West of S. Shade	N/A

Comments: (3N) Showing the north curb inlet on Rose Street West of South Shade. Inlet is relatively clear, with the exception of the pizza box. No musty/odd odors from the inlet.

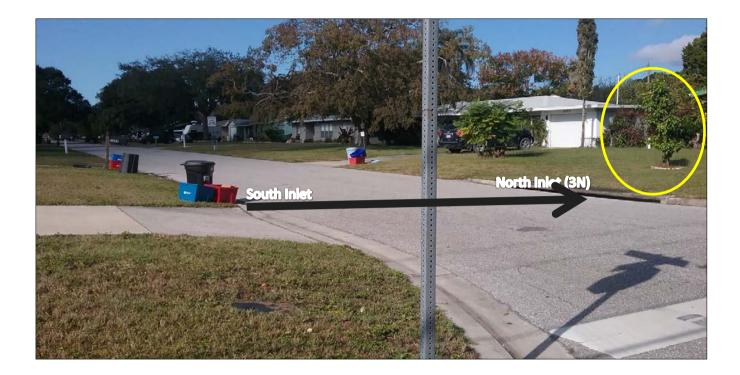
Inspector(s):	Date:	Photo Location	Photo Direction
M. Holland	12/7/2016	Rose and South Shade	West

Comments: (3) Showing the inlets on Rose Street, west of South Shade. Garbage cans present. Fruit tree directly north of the inlet to the right (highlighted in yellow), and pipe and flow directions indicated by the large arrow. Curb inlet on the south side was clean and unremarkable. No strange/musty odors from the inlets. Yards reasonably well maintained, no extremely lush yards (indicative of heavily fertilized) in the immediate area.

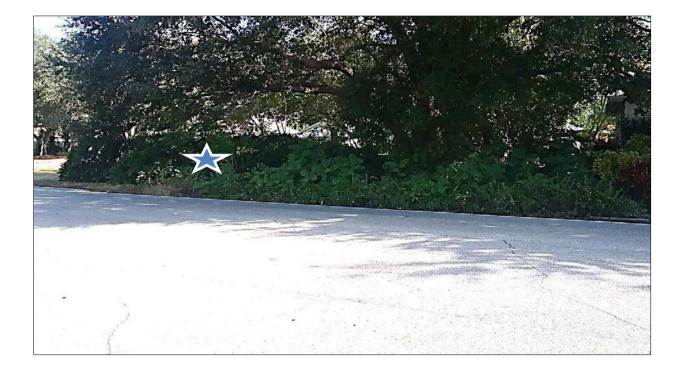
Inspector(s):	Date:	Photo Location	Photo Direction
M. Holland	12/7/2016	S. Shade and Rose St	East

Comments: (4) Location of a structure that receives flow from a curb and gutter system from the south and, a drainage ditch from the east. Approximate location of the located structure indicated by the star. It was several feet east of the road, hidden in the vegetation. There was several inches of decaying vegeation on the grate that had to be removed to look inside the structure.

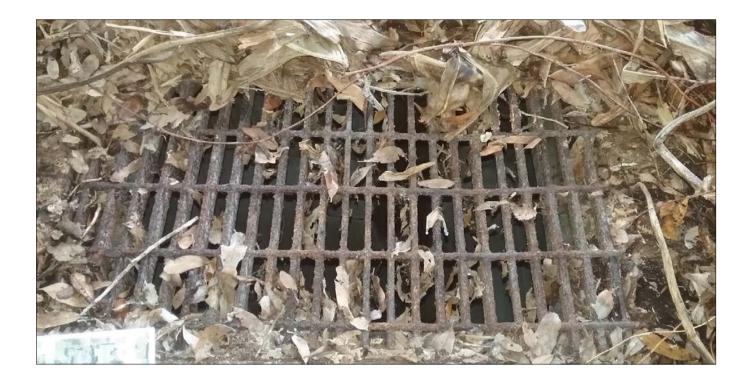
Inspector(s):	Date:	Photo Location	Photo Direction
M. Holland	12/7/2016	Rose and S. Shade	N/A

Comments: (4). Found the structure. The grate was covered by a few inches of decaying vegetation. Water was discharging into this structure, but it was not determined if it was coming from the east drainage ditch or from the curb and gutter system from the west. The only way this structure was found was one could hear water spilling in to the bottom of the structure. Warm, moist air was coming up through the grate. This warm moist air could have been a result of water (warmed from the air or sun) coming from the ditch to the east, or irrigation/stormwater warmed from contact with the pavement, and exposure to the environment.

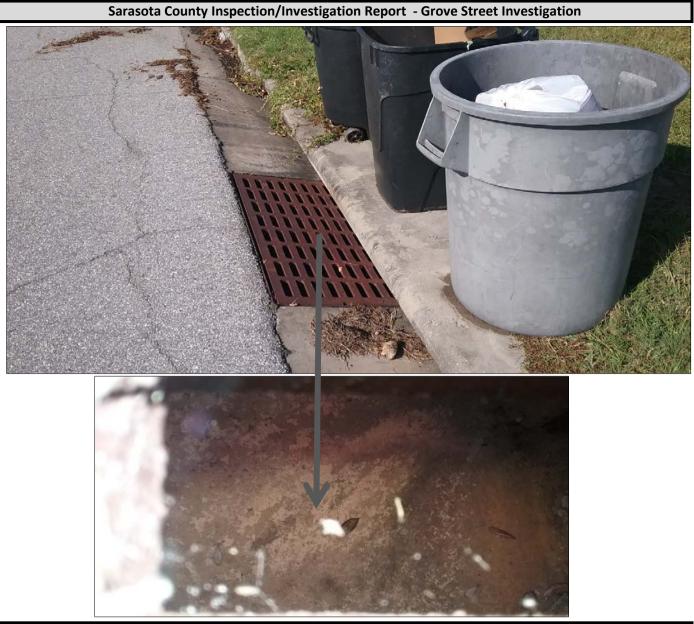
Inspector(s):	Date:	Photo Location	Photo Direction
M. Holland	12/7/2016	N. of Tangerine W of Shade	West

Comments: Showing the curb inlet on the north side of the road. Trash cans stacked for trash day right above the inlet. Homes on this street are maintained but not overly so. The inlet was clean and dry, with no strange/musty odors coming from the inlet.

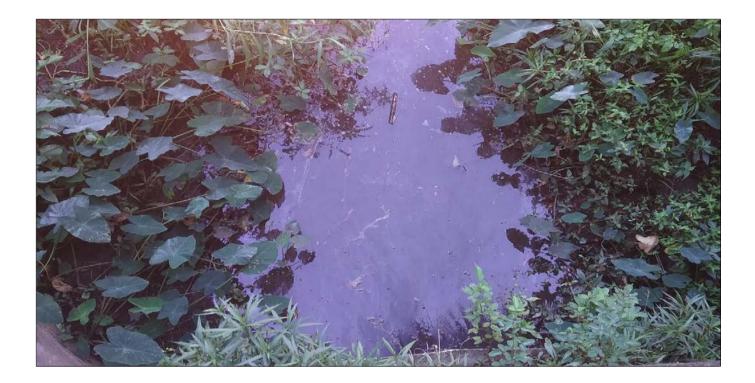
Inspector(s):	Date:	Photo Location	Photo Direction
M. Holland	12/7/2016	Discharge at Grove St	North

Comments: (1*)Water still discharging at the pipe, dispite minimal rain. Water could be from irrigation runoff from the yards, but no standing water in gutter along the roads were seen. Access to the stormwater pipes was not available. The manhole covers were in the road, so traffic would have to be maintained to view those access points.
