Summary of Results

Walk the WBID Exercise for Philippi Creek
(WBID1937)

FINAL DRAFT

September 27, 2017

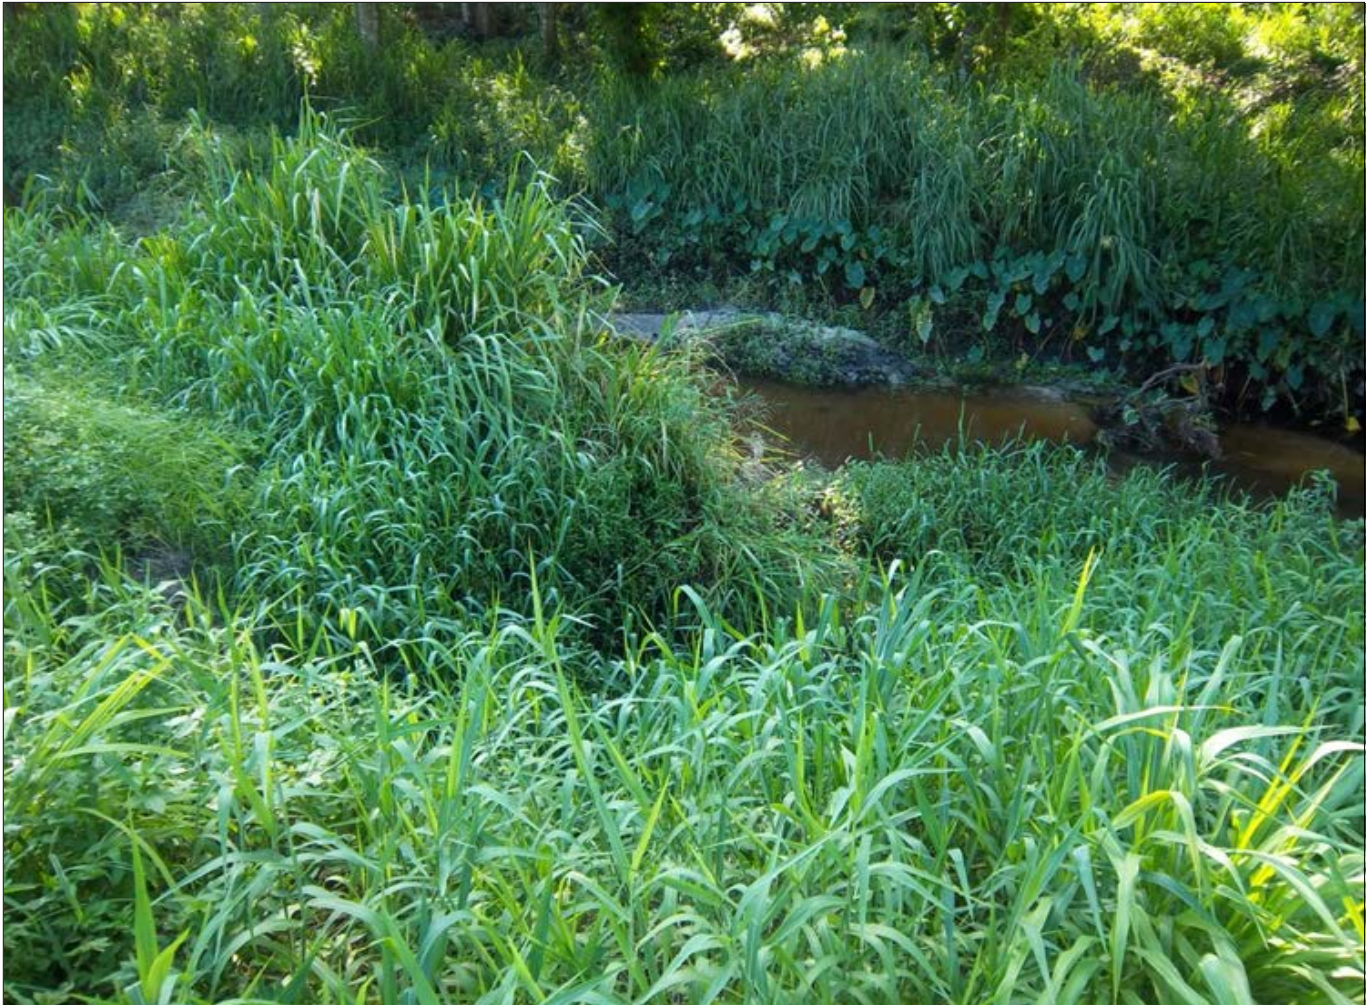
Inspector(s):	Date:	Photo Location	Photo Direction
M.Holland/R.Wells/J. Pate	8/26/2016	Phillippi Creek at Circus Blvd	NW
Comments: (b)Phillippi Creek at Circus Blvd, just east of the fire dept training area. The creek here is heavily vegetated. There is also areas of bank erosion and sloughing in of the banks. No evidence of dog walkers along this linear "park".

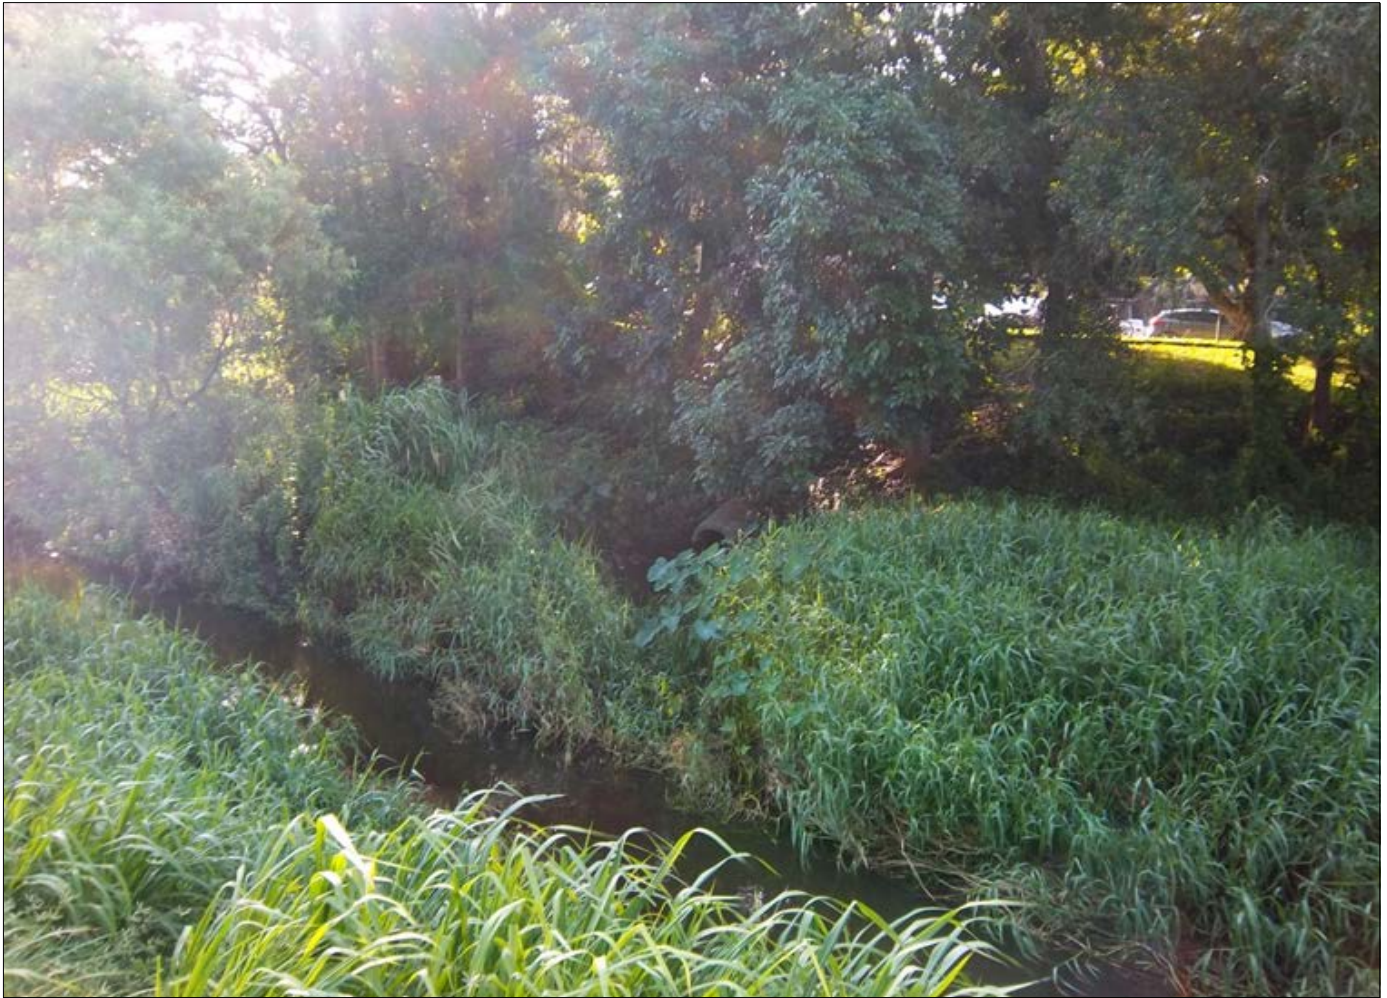
Inspector(s):	Date:	Photo Location	Photo Direction
M.Holland/R.Wells/J. Pate	8/26/2016	Phillippi Creek	NE
Comments: (c)Outfall from Amherst Street (the southern one) . Runoff comes from a apartment complex, which is on City Sewer. Lat/long is 27.3398/82.4948 of this pipe. There is no on site treatment for the stormwater for this apartment complex.

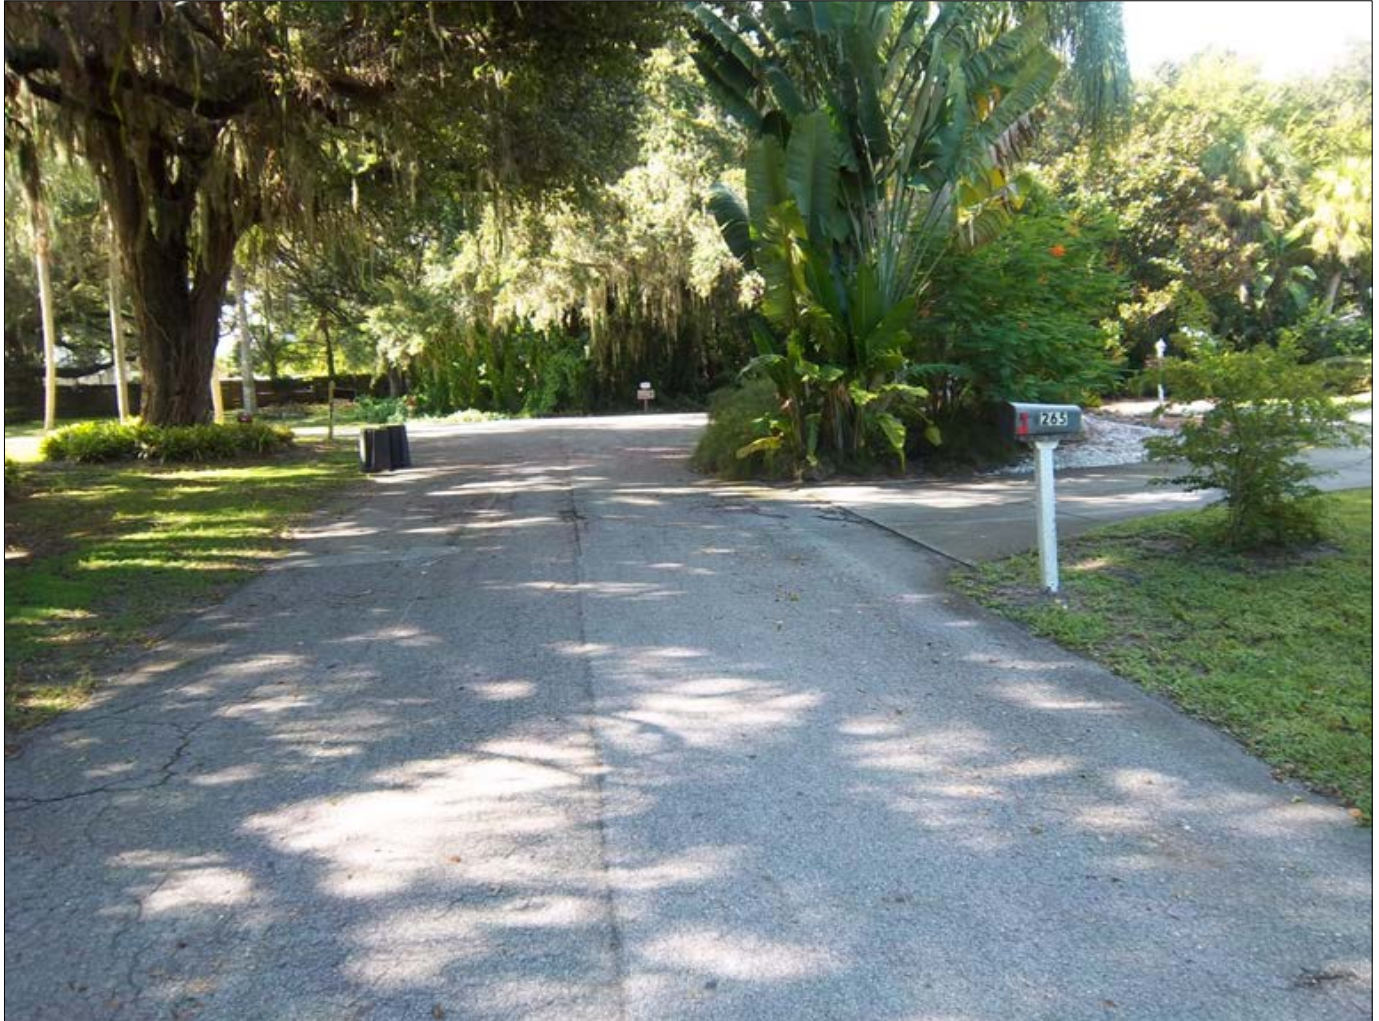
Inspector(s):	Date:	Photo Location	Photo Direction
M.Holland/R.Wells/J. Pate	8/26/2016	End of Bearded Oaks Drive	South
Comments: (f)Residential community South of Fruitville Rd and adjacent to 4-37 canal and north of BBB-WV hotspot for Fecal Coliform. This subdivision is not on City sewer.

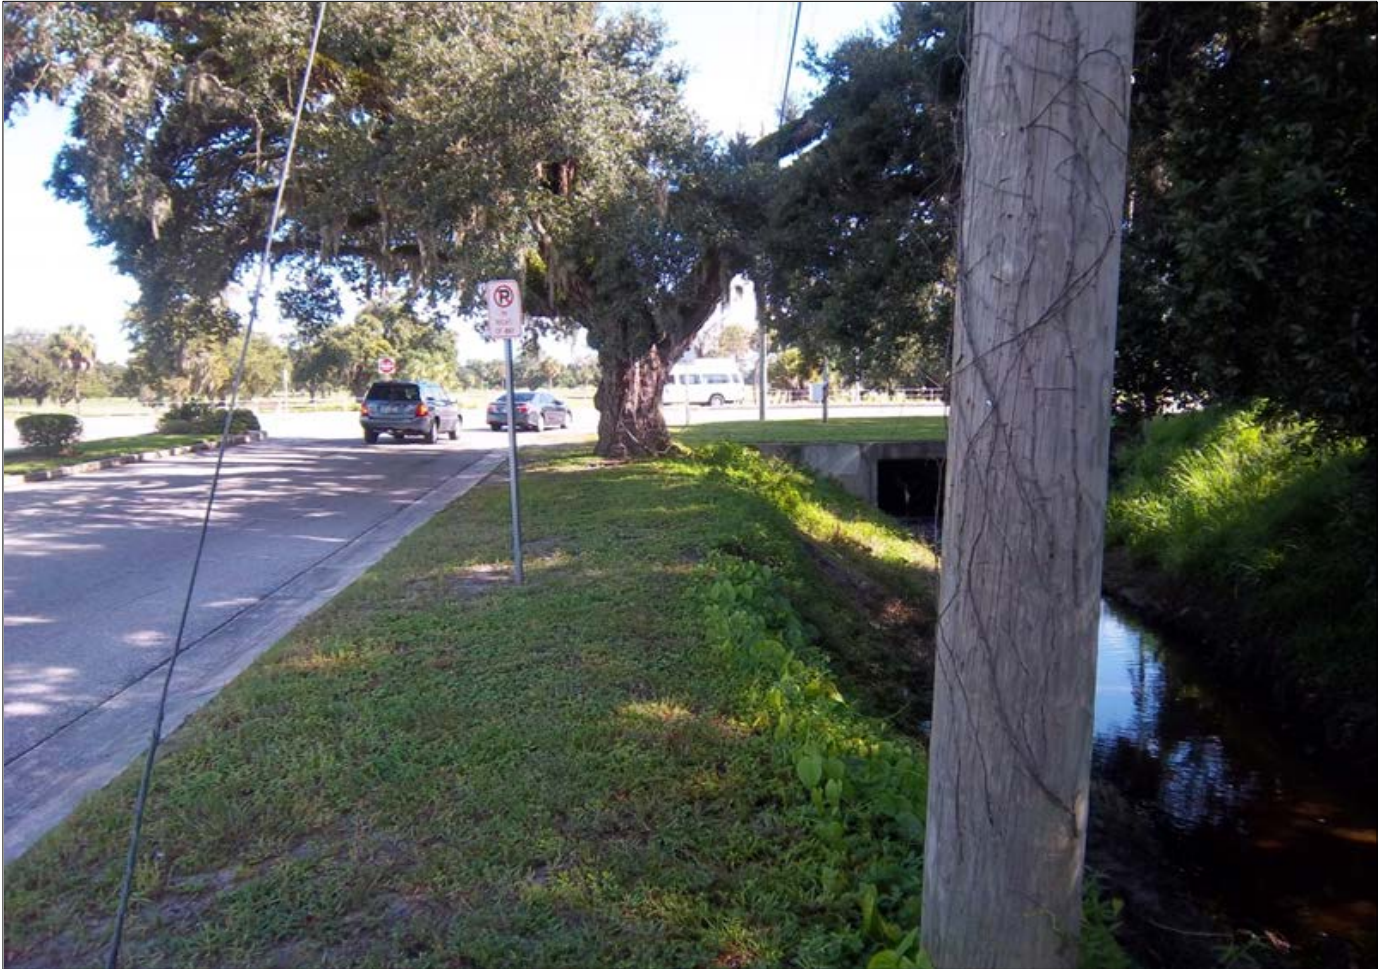
Inspector(s):	Date:	Photo Location	Photo Direction
M. Holland	8/26/2016	Same as Above	North

Comments:(g) Looking towards Fruitville Rd. 4-37.3 is to the right.

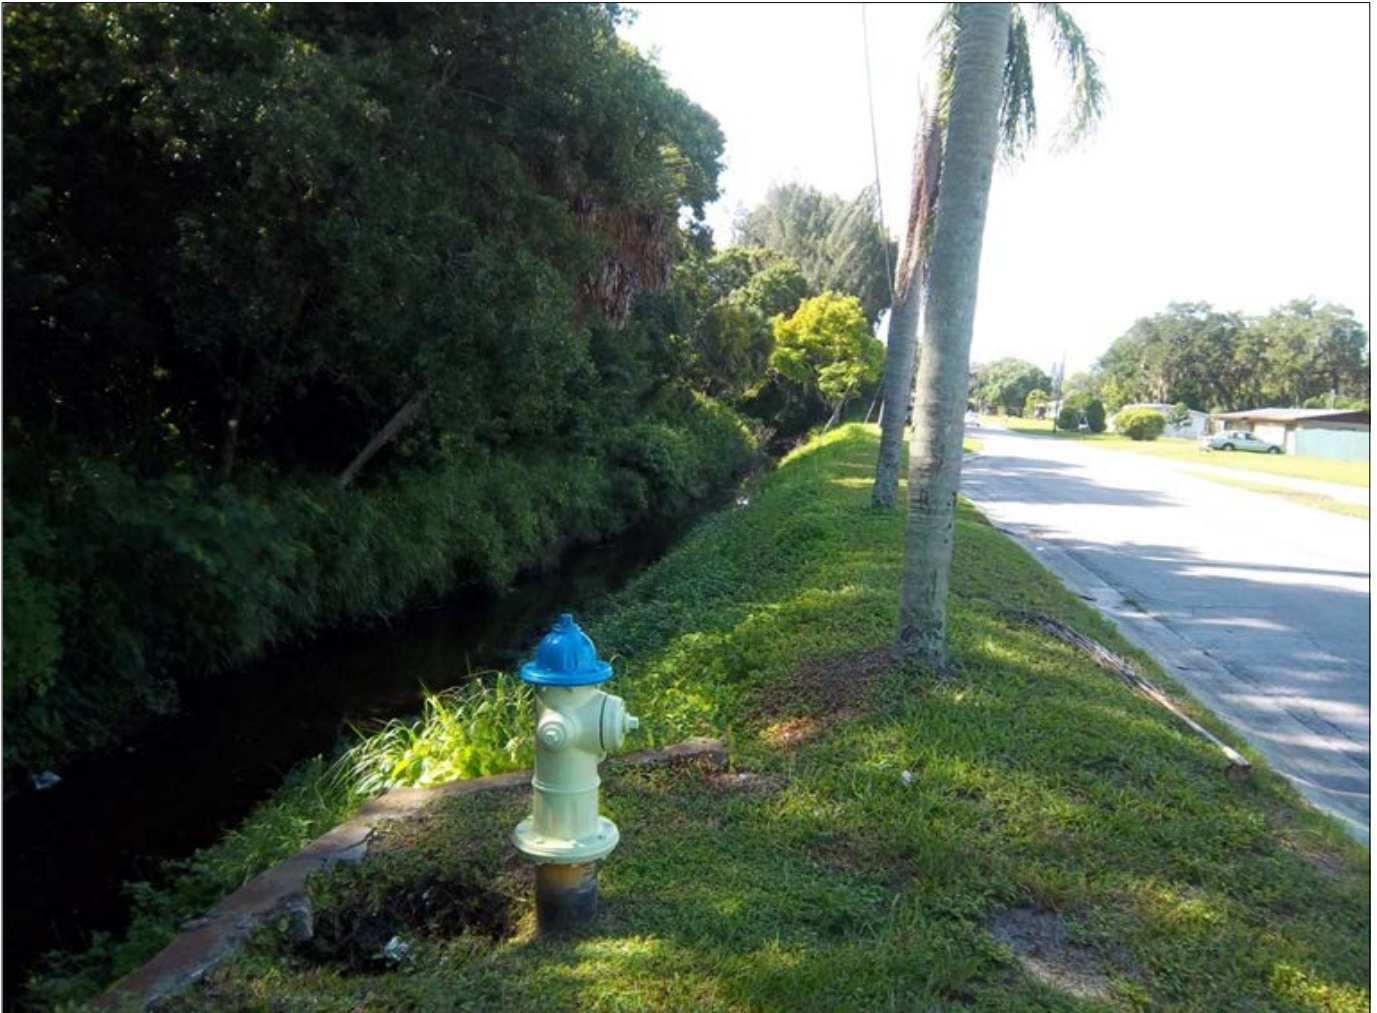
Inspector(s):	Date:	Photo Location	Photo Direction
M. Holland	8/26/2016	Same as Above	South
Comments: (g)Looking south along 4-37.3. The side banks on the west side of the canal (same side as the fire hydrant) are very steep and are eroding in some areas. The east side is heavily vegetated.

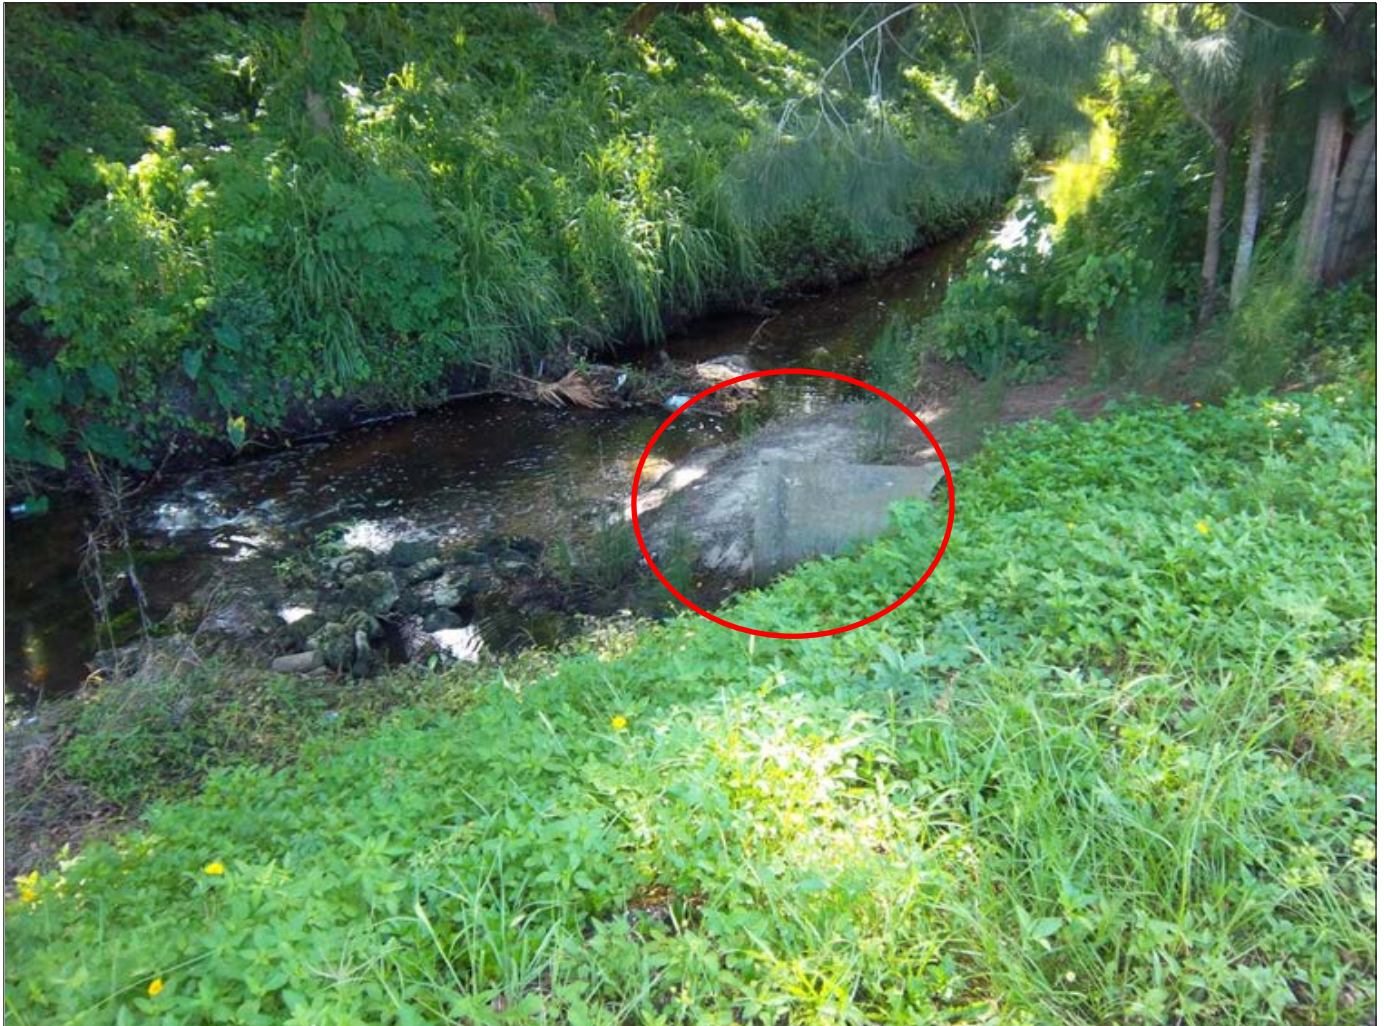
Inspector(s):	Date:	Photo Location	Photo Direction
M. Holland	8/26/2016	Canal 4-37	SE
Comments: (h)Stormwater pipe that collects from Wolverine and Midwest Pkwy. Pipe was discharging minimally at the time of the site visit in to Canal 4-37.3.

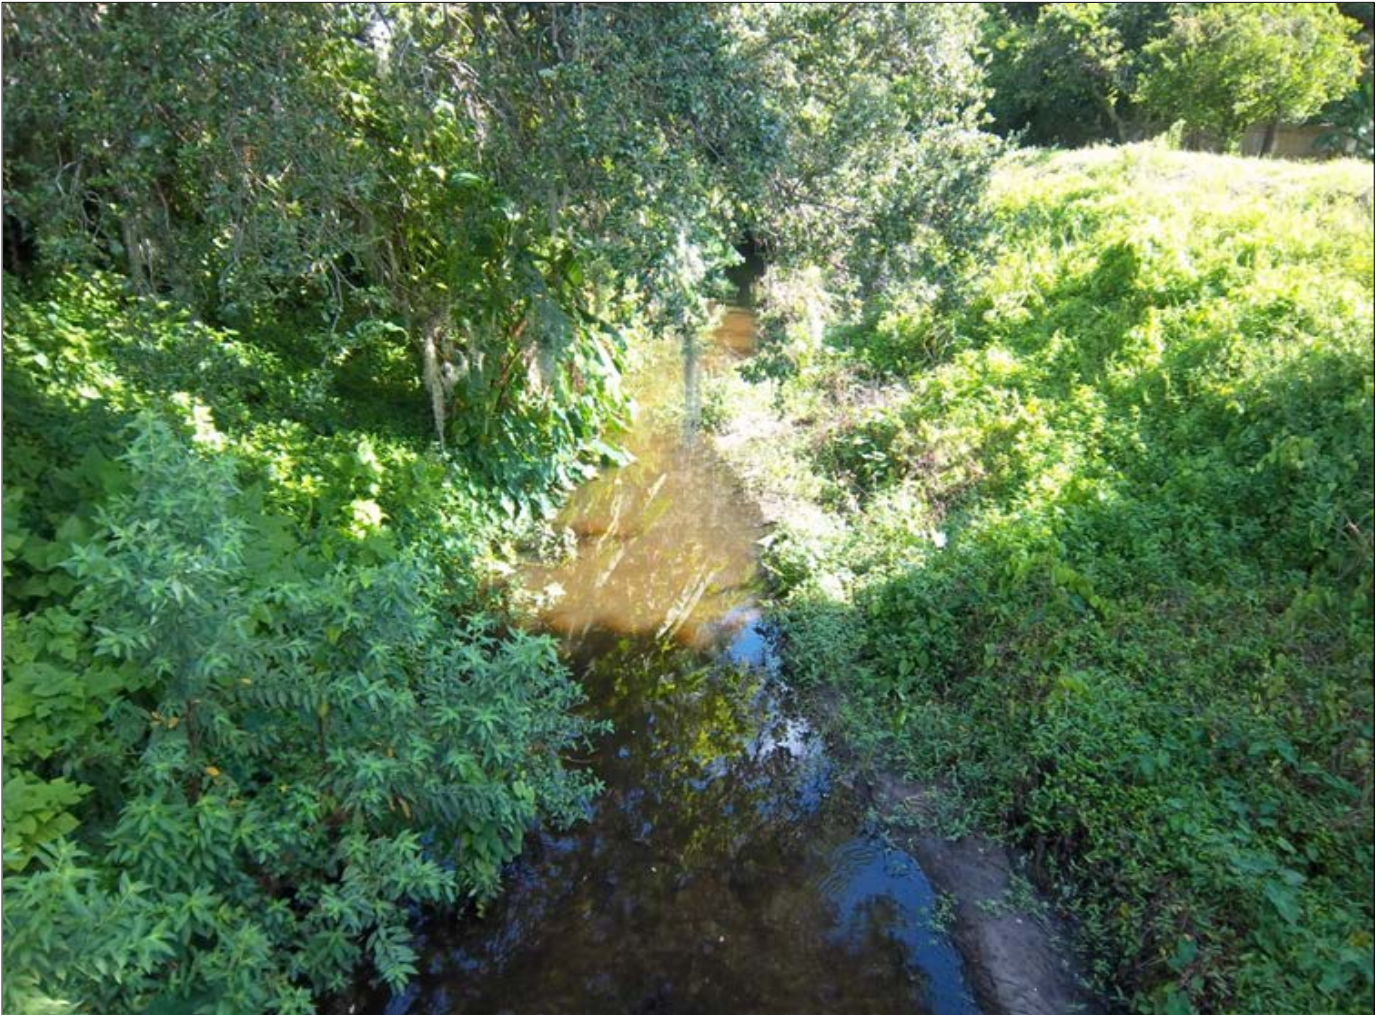
Inspector(s):	Date:	Photo Location	Photo Direction
M. Holland	8/26/2016	Bridge over Canal 4-37 @ Davis	North
Comments: (j)Showing canal 4-37.3 at the bridge. Bottom is mostly sandy with some shell. Banks are heavily vegetation, water is still clear, but cloudier than upstream. Since this is residential, there are dogs throughout (could hear barking), but there was no obvious signs of pet waste in the neighborhood.

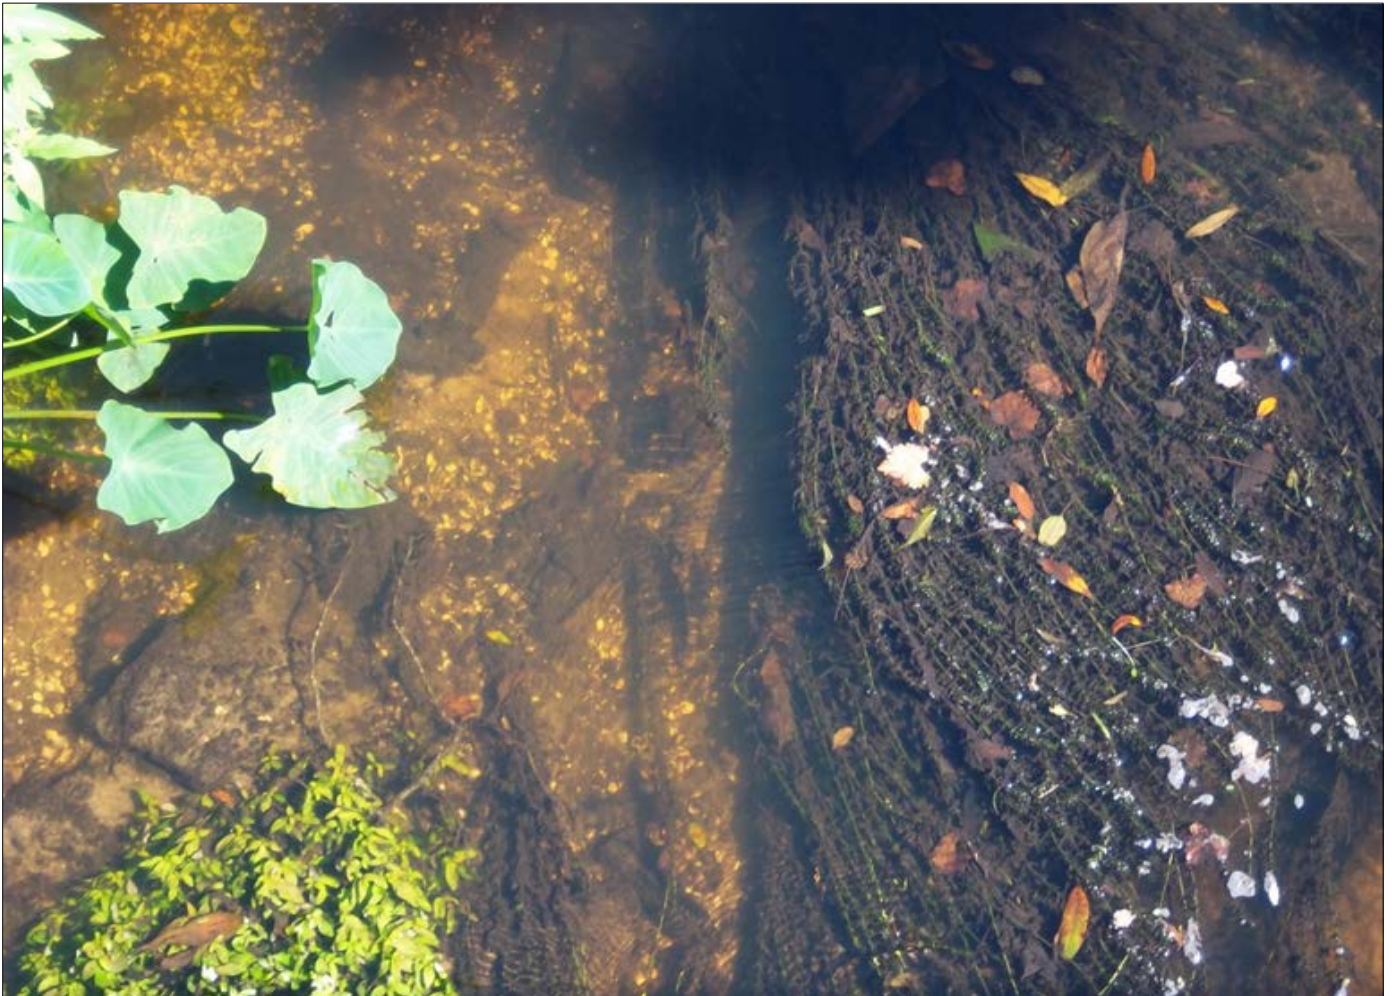
Inspector(s):	Date:	Photo Location	Photo Direction
M. Holland	8/26/2016	Same as Above	North
Comments: (j)Showing the water before it passes under the bridge. Water is a bit cloudier than upstream. Aquatic vegetation is present. Banks are heavily vegetated as well.

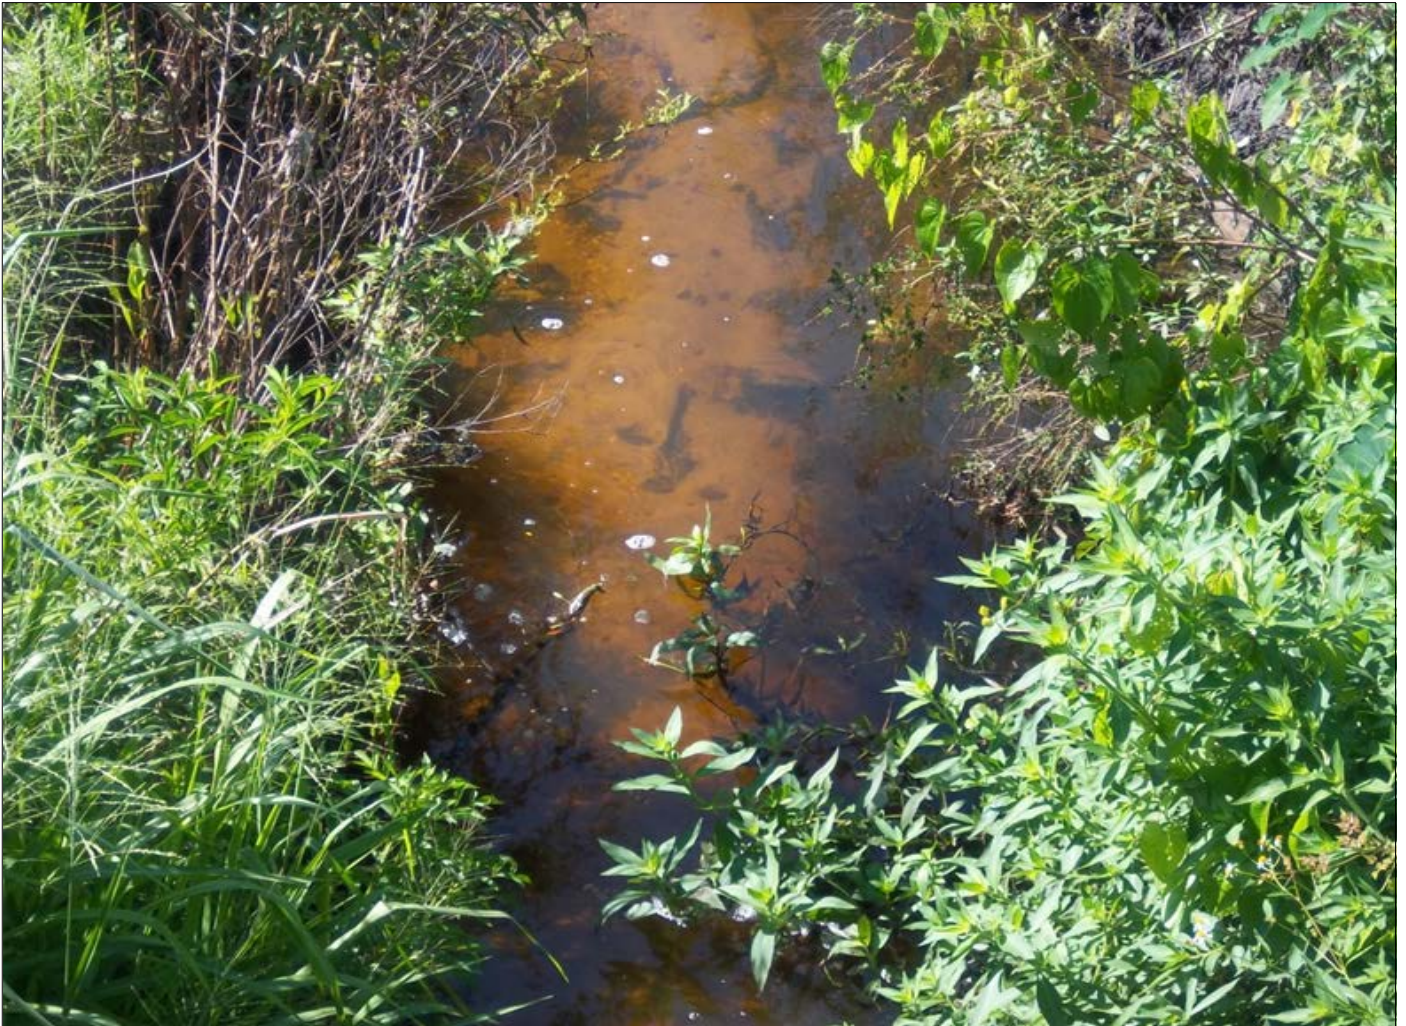
Inspector(s):	Date:	Photo Location	Photo Direction
M. Holland	8/26/2016	Same as Above	South
Comments: (j) Looking at 4-37 on the south side of the bridge. Banks are heavily vegetated, aquatic vegetation present as well. Bottom is sandy.

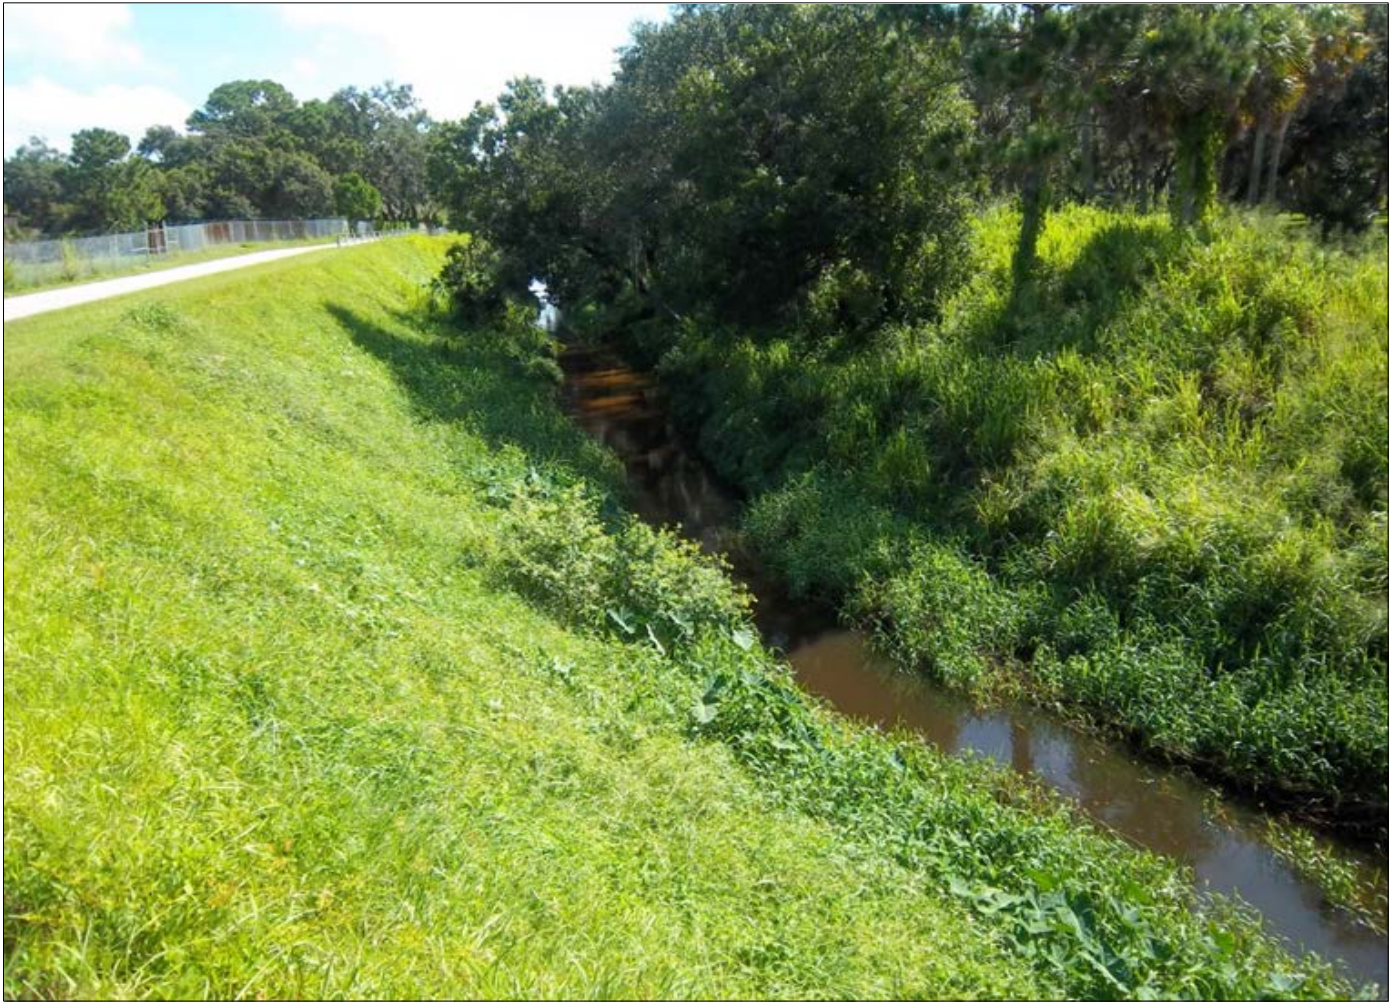
Inspector(s):	Date:	Photo Location	Photo Direction
M. Holland	8/26/2016	Linear Park north of Fruitville	North
Comments: (k)Following the linear park north of Fruitville and to the west of Fruitville Park. Canal is known as 4-14 in this area. Shoreline is very steep, with some areas of major erosion (older and now vegetated). Entire length is heavily vegetated.

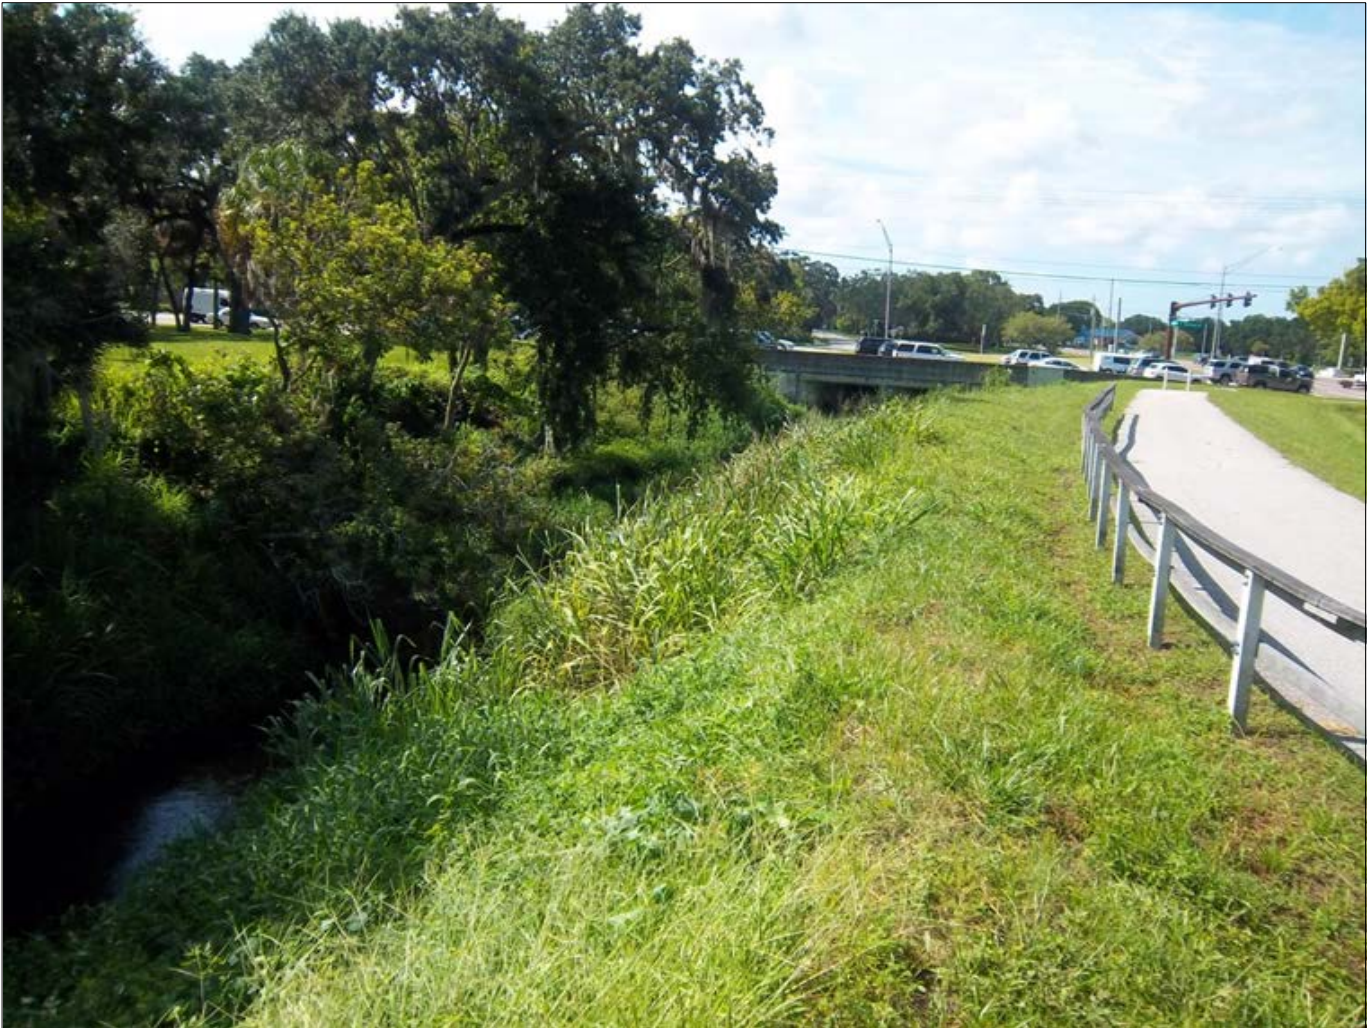
Inspector(s):	Date:	Photo Location	Photo Direction
M. Holland	8/26/2016	Same as Above	South
Comments: (k)Showing the canal looking south towards Fruitville Rd. No evidence of dog walking along this linear park. There are no heavily traveled critter trails along the creek.

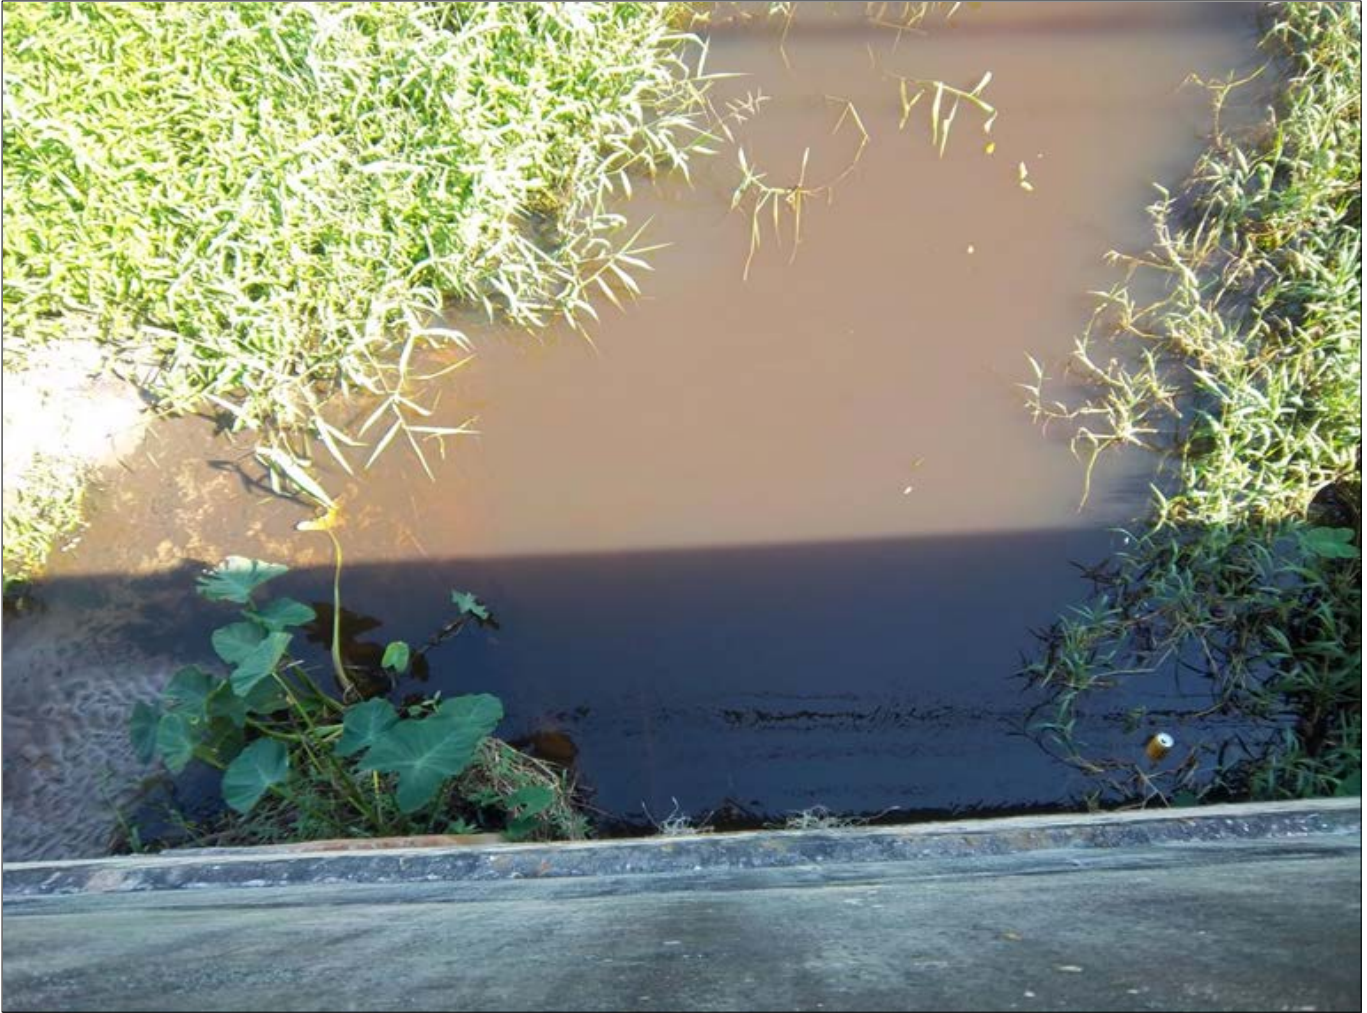
Inspector(s):	Date:	Photo Location	Photo Direction
M. Holland	8/26/2016	At Fruitville and 4-14	North
Comments: (I) Showing water as it flows south. Water is somewhat cloudy, flowing. It appears the bottom is sandy throughout.

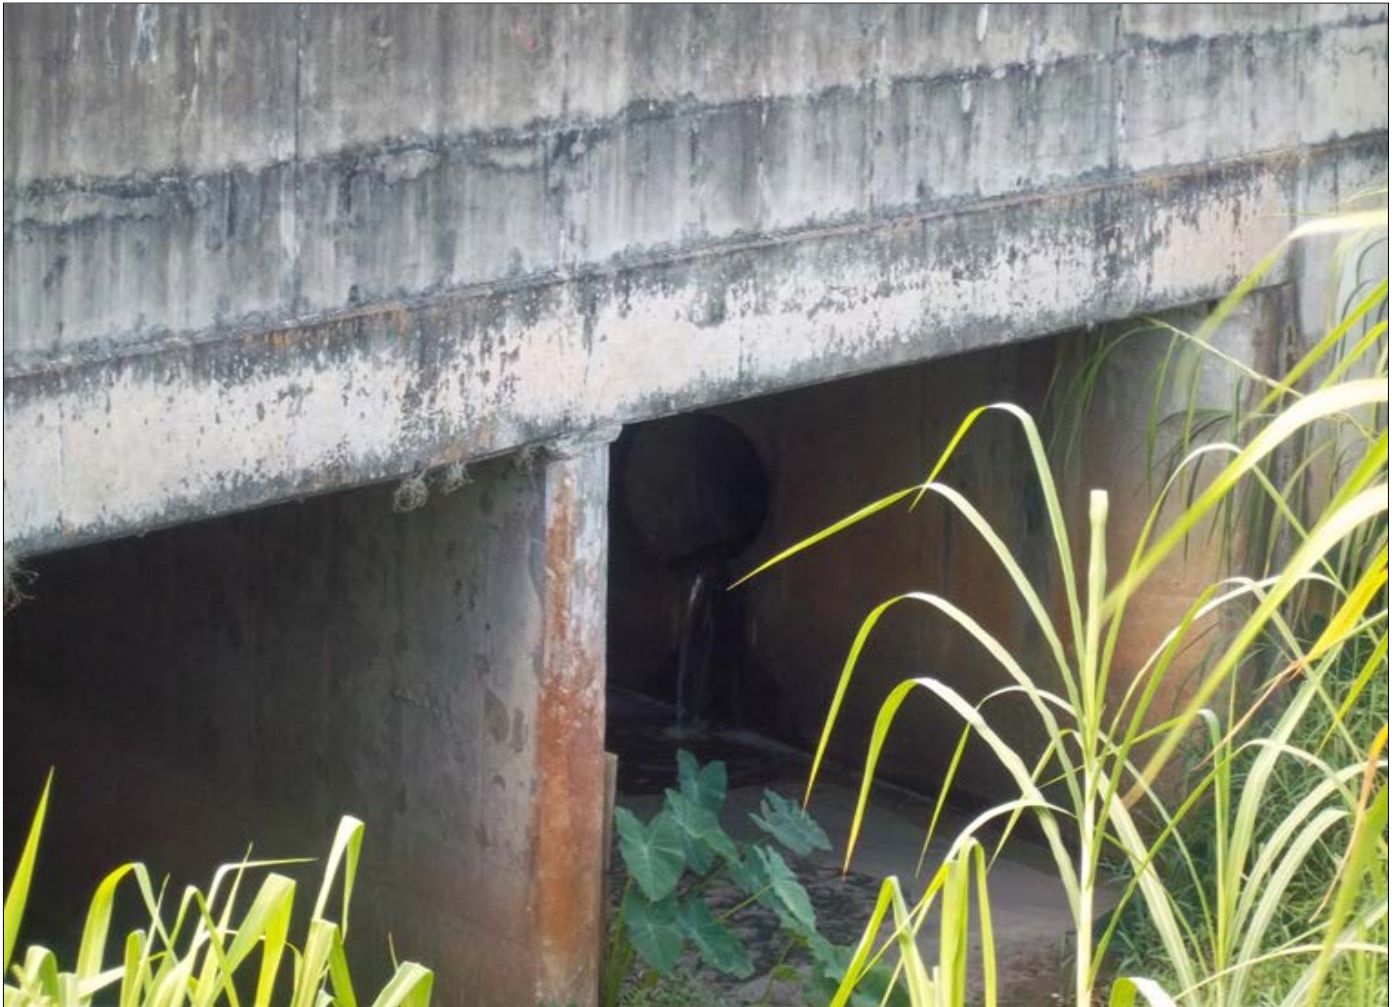
Inspector(s):	Date:	Photo Location	Photo Direction
M. Holland	8/26/2016	Same as above	SW
Comments: (I) Showing the discharge point of a stormwater pipe that collects water along Beneva Road north of Fruitville. The regularly sampled point is upstream of this.

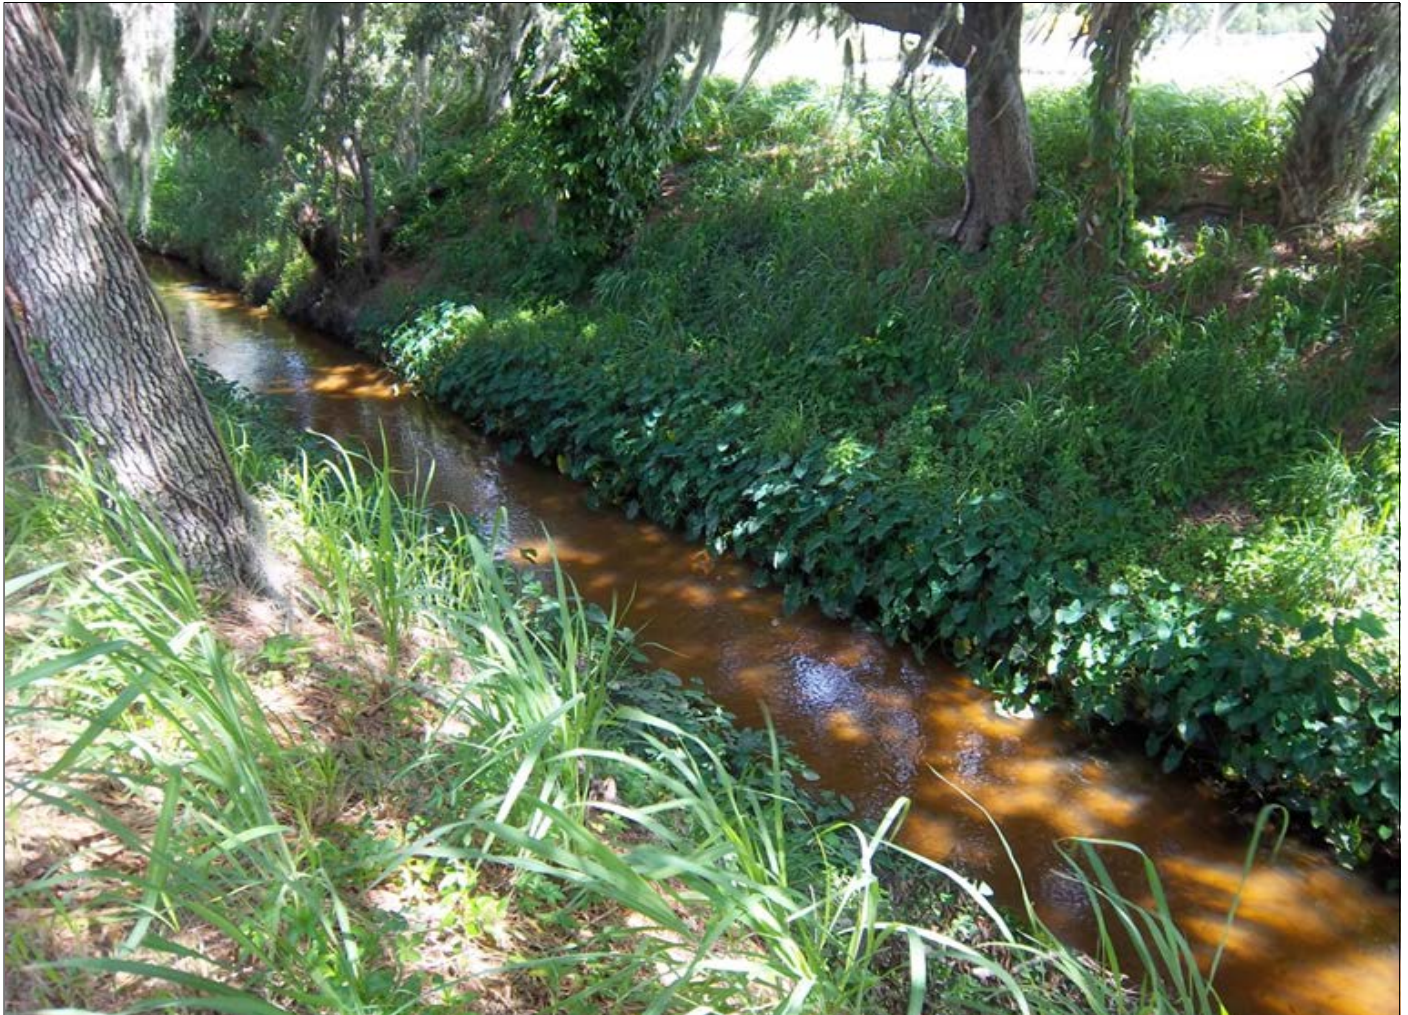
Inspector(s):	Date:	Photo Location	Photo Direction
M. Holland	8/26/2016	4-14 South of 17th Street	NE
Comments: (m)Showing the canal just south of 17th Street. Sandy bottom, no aquatic vegetation, shoreline is heavily vegetated and mostly shaded.

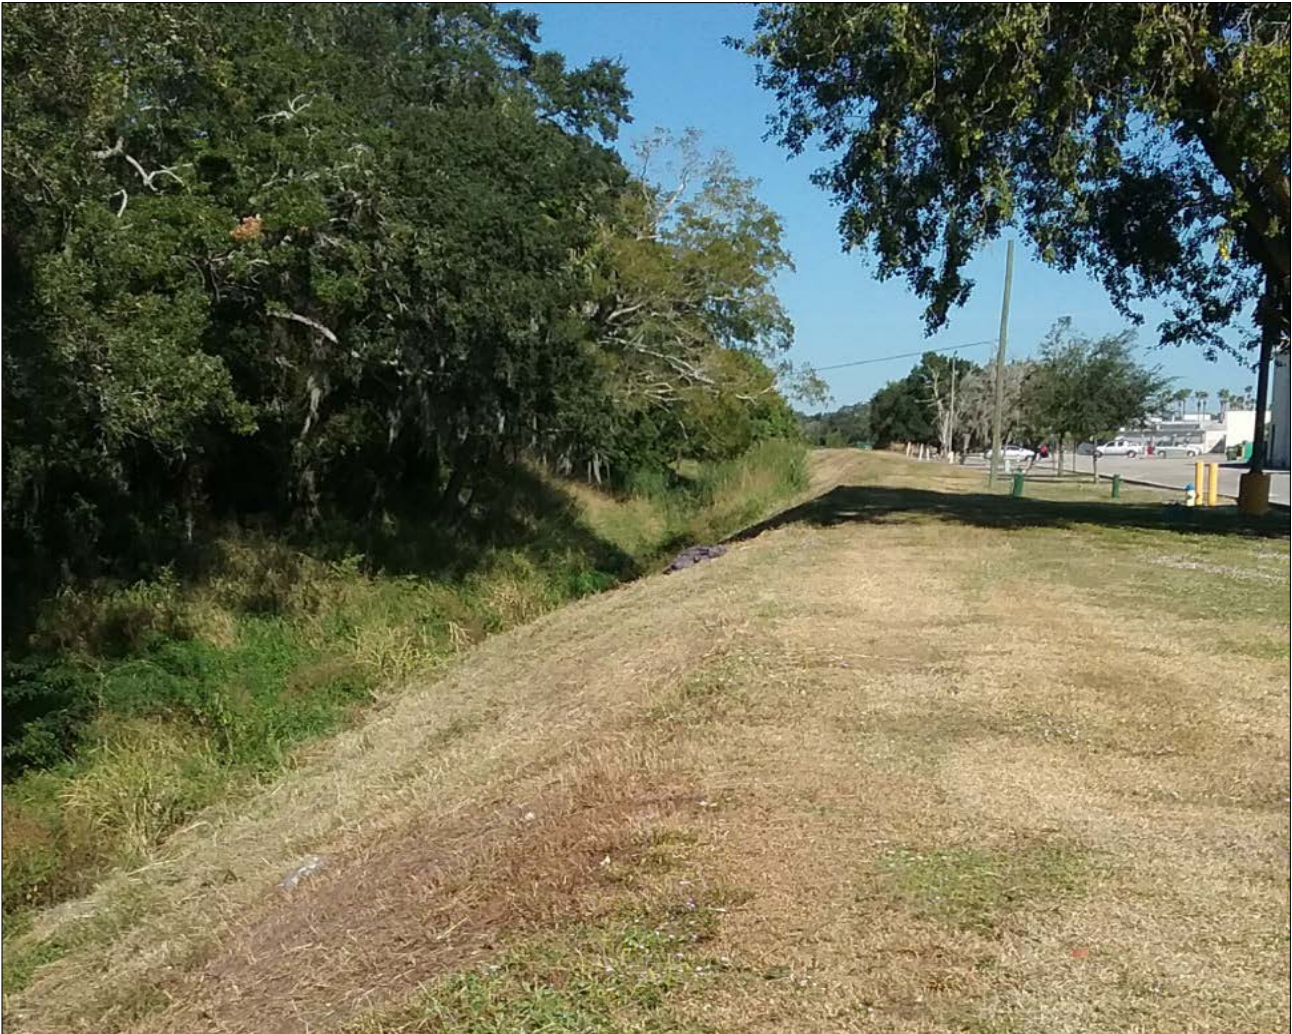
Inspector(s):	Date:	Photo Location	Photo Direction
A. Melton, J. Talbott, M. Holland	11/10/2016	Same as above	North
Comments: (#1) Showing the upstream side of the sample location. Commercial use is to the right, residential to the left. No signs of homeless encampments in this particular area.
