Summary of Results

Walk the WBID Exercise for Philippi Creek
(WBID1937)

FINAL DRAFT

September 27, 2017

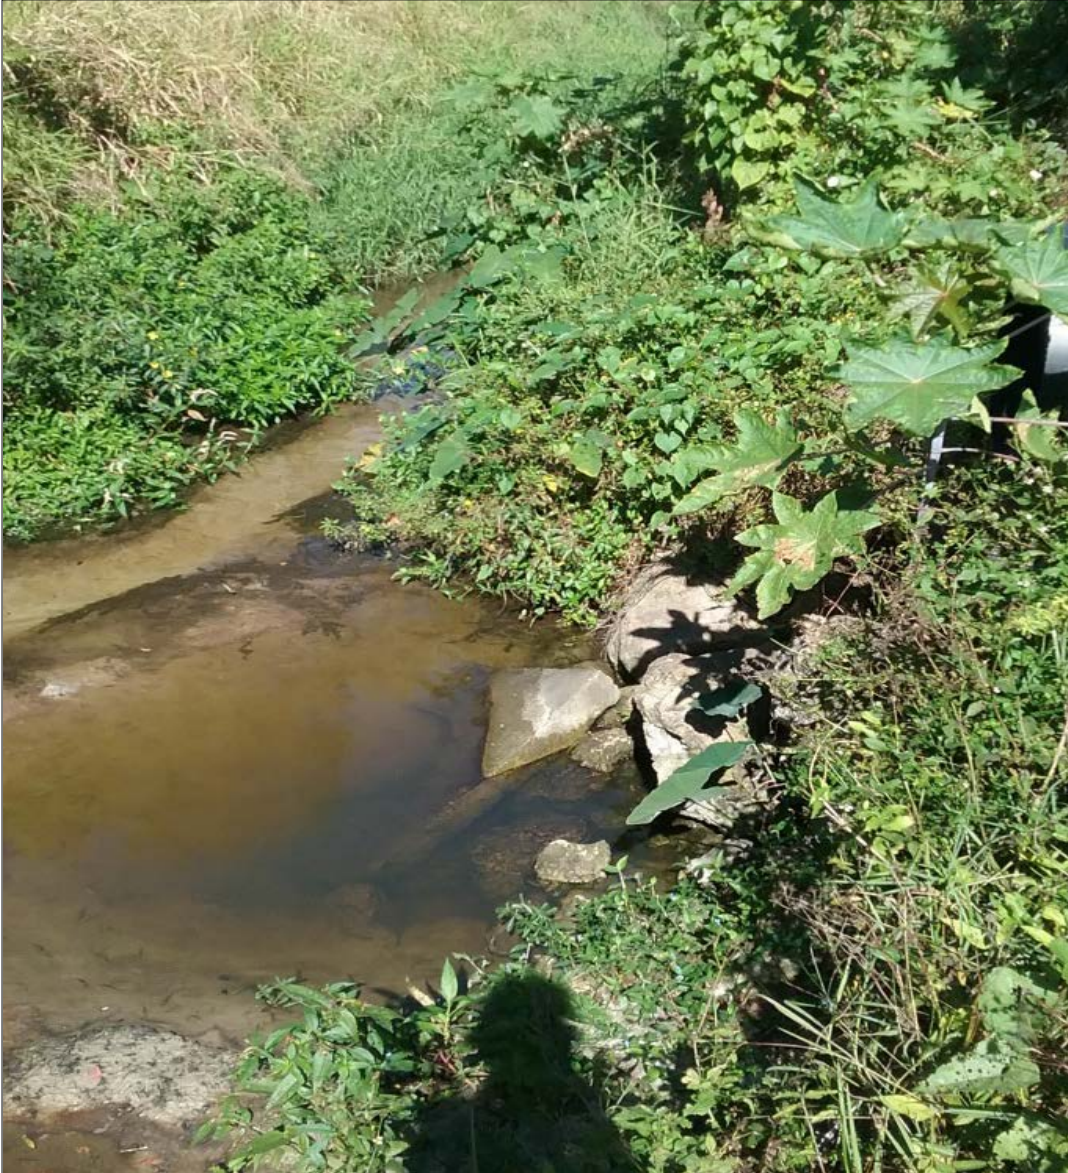
Inspector(s):	Date:	Photo Location	Photo Direction
A. Melton, J. Talbott, M. Holland	11/10/2016	Upstream of Sample site	NW
Comments: (#2)At the outfall of one of the retention ponds for the shopping center. The pond is heavily wooded and appears to be used intermittently as a homeless encampment. The bottom sediment was sand, there was wildlife tracks as well.

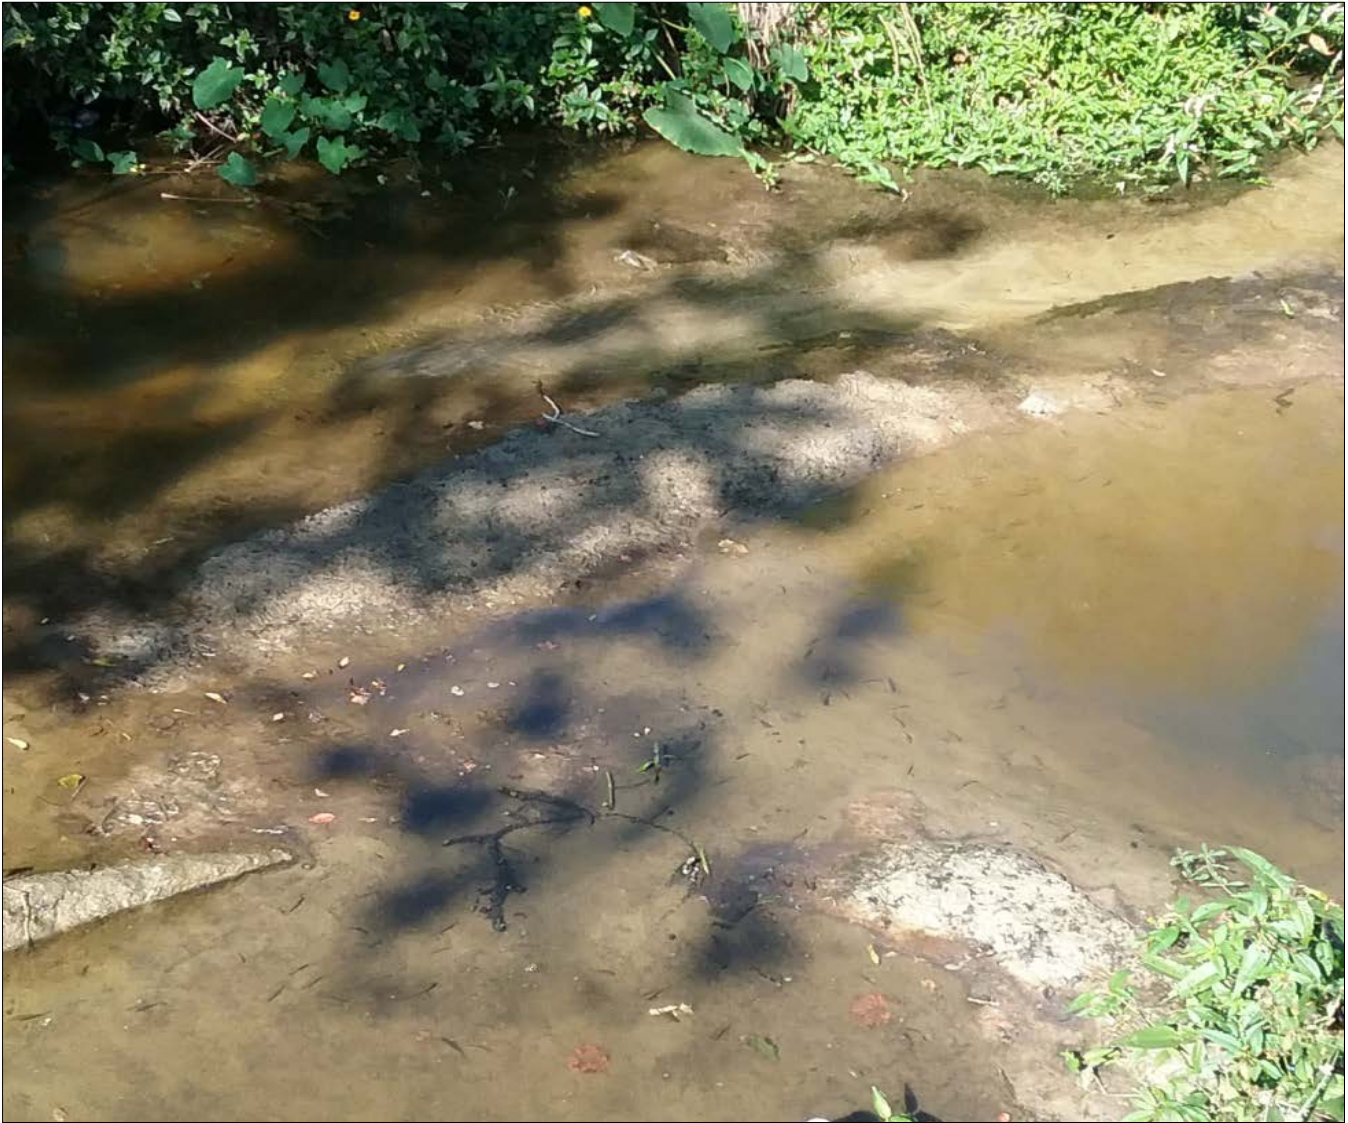
Inspector(s):	Date:	Photo Location	Photo Direction
A. Melton, J. Talbott, M. Holland	11/10/2016	Same as Above	NW
Comments:(#2) Showing the bottom sediment and the wildlife tracks. Flow was present, but not from the outfall pipe.

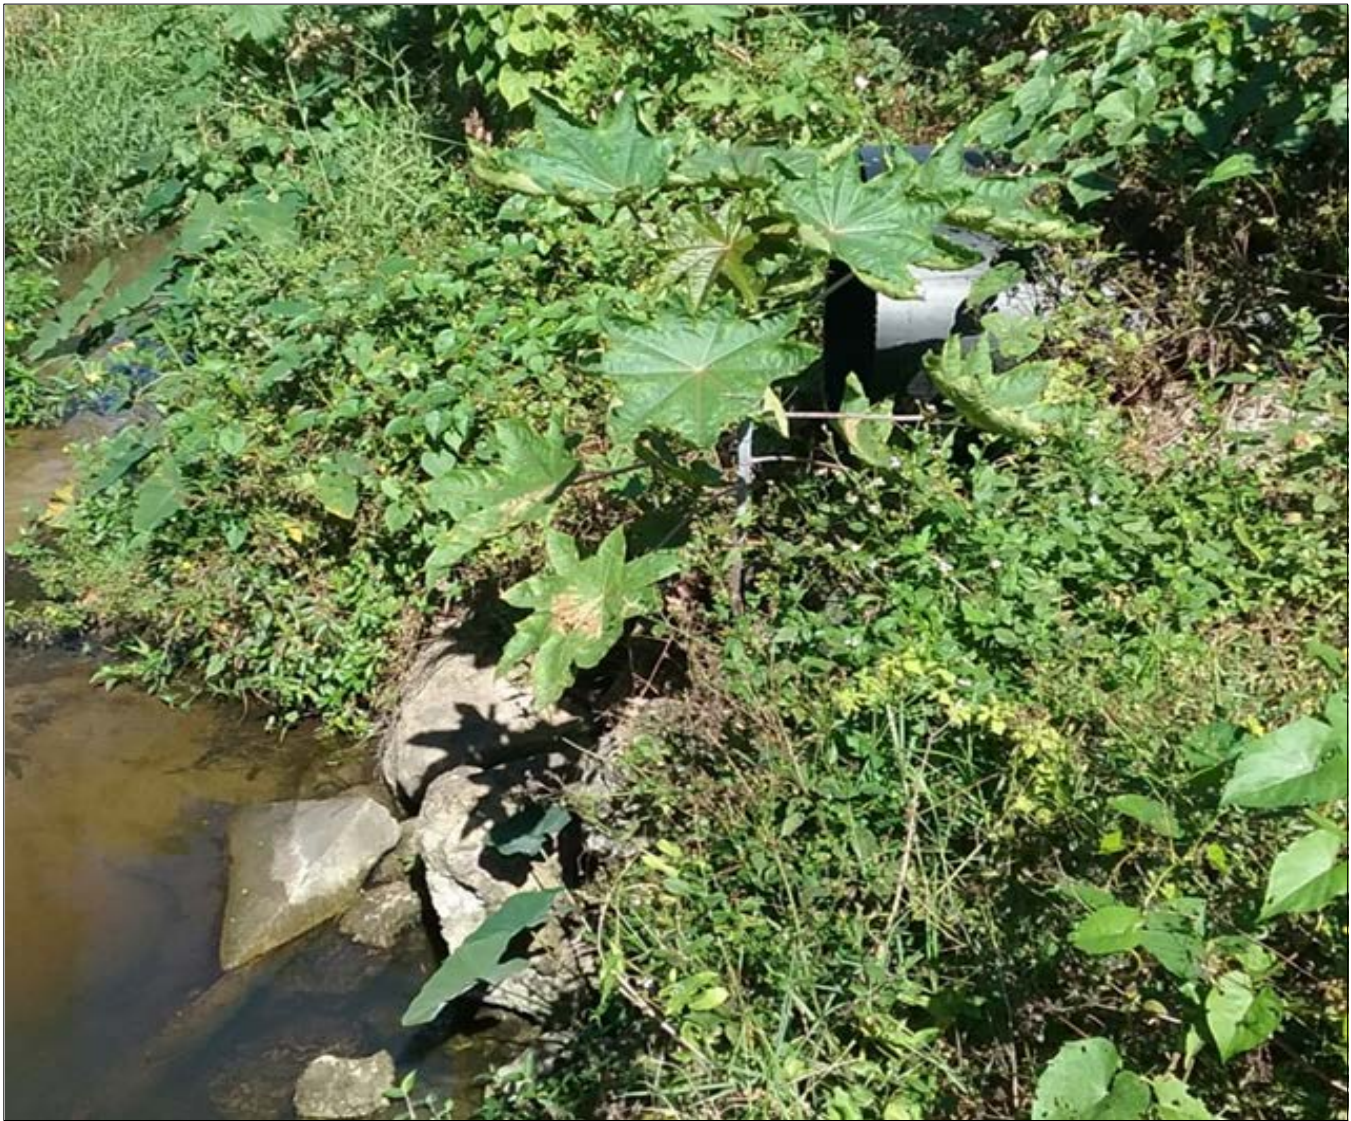
Inspector(s):	Date:	Photo Location	Photo Direction
A. Melton, J. Talbott, M. Holland	11/10/2016	Same as above	North

Comments: (#2) Showing the outfall pipe from the detention area.

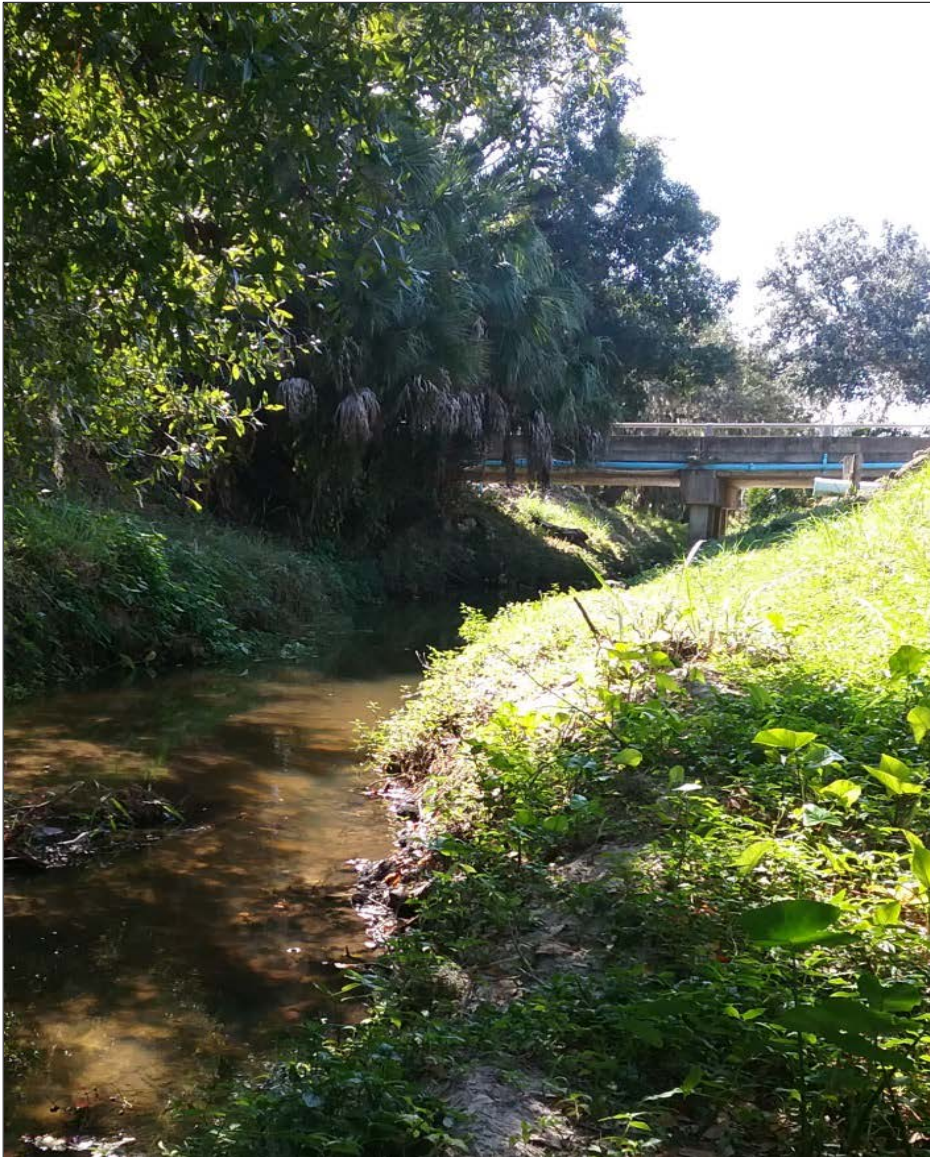
Inspector(s):	Date:	Photo Location	Photo Direction
A. Melton, J. Talbott, M. Holland	11/10/2016	N of Main B - Fruitville	South

Comments: (#4) Showing the entrance to Bobby Jones Golf Course, which is about 50 yds downstream.

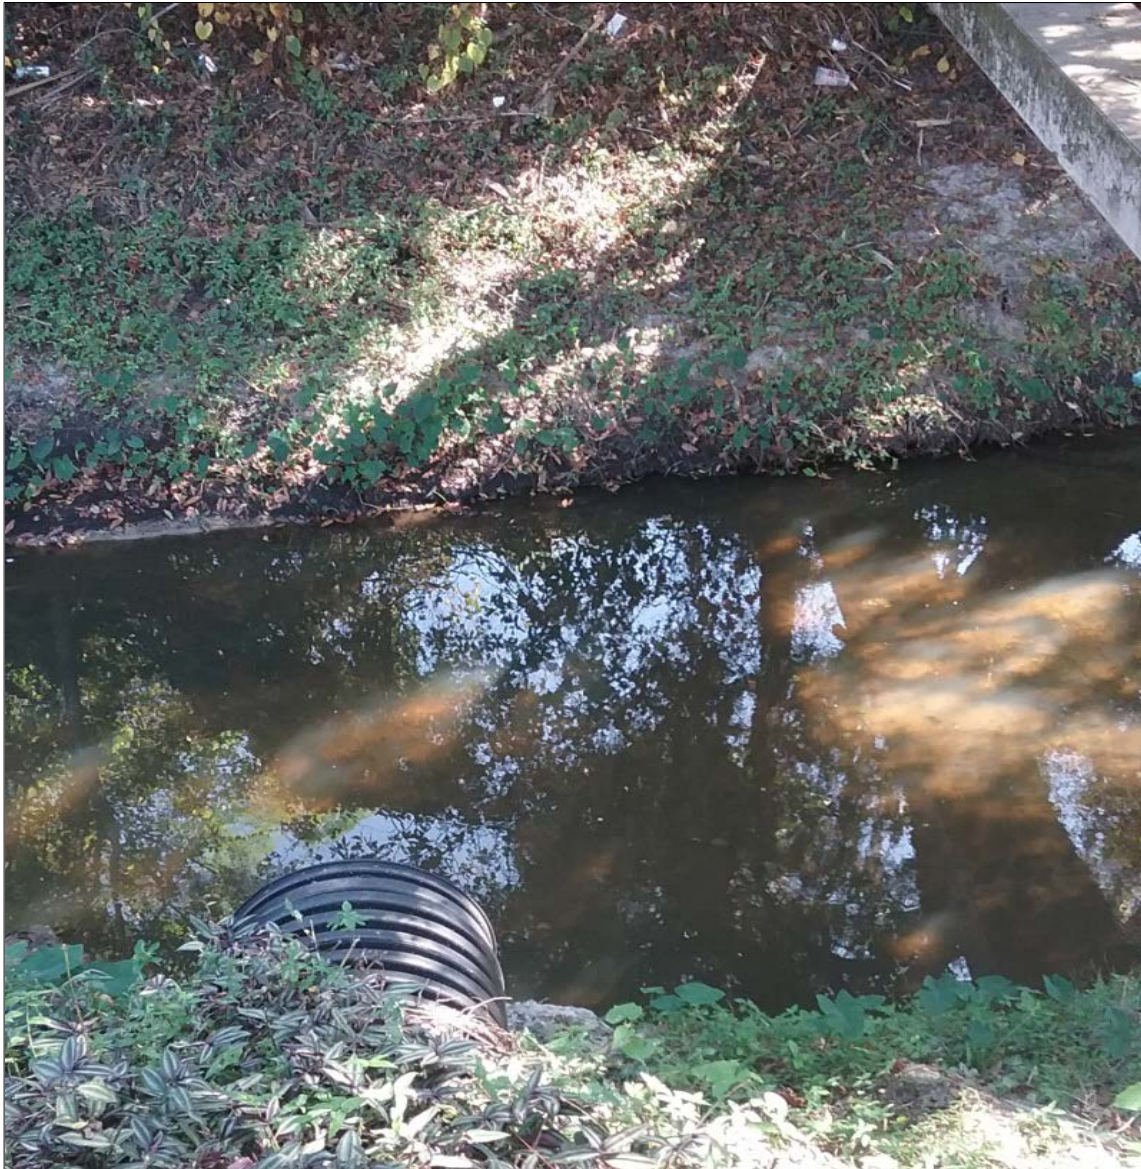
Inspector(s):	Date:	Photo Location	Photo Direction
A. Melton, J. Talbott, M. Holland	11/10/2016	Same as above	SE

Comments: (#4). Showing the sample area. A sample was taken just to the right of the outfall pipe. The bottom sediment was sand, the canal was flowing south (left to right). No flow from the outfall pipe, which accepts stormwater from the adjacent Circus Blvd. Some erosion in the canal bottom from discharge from the pipe, but rip-rap has been added for energy dissipation.

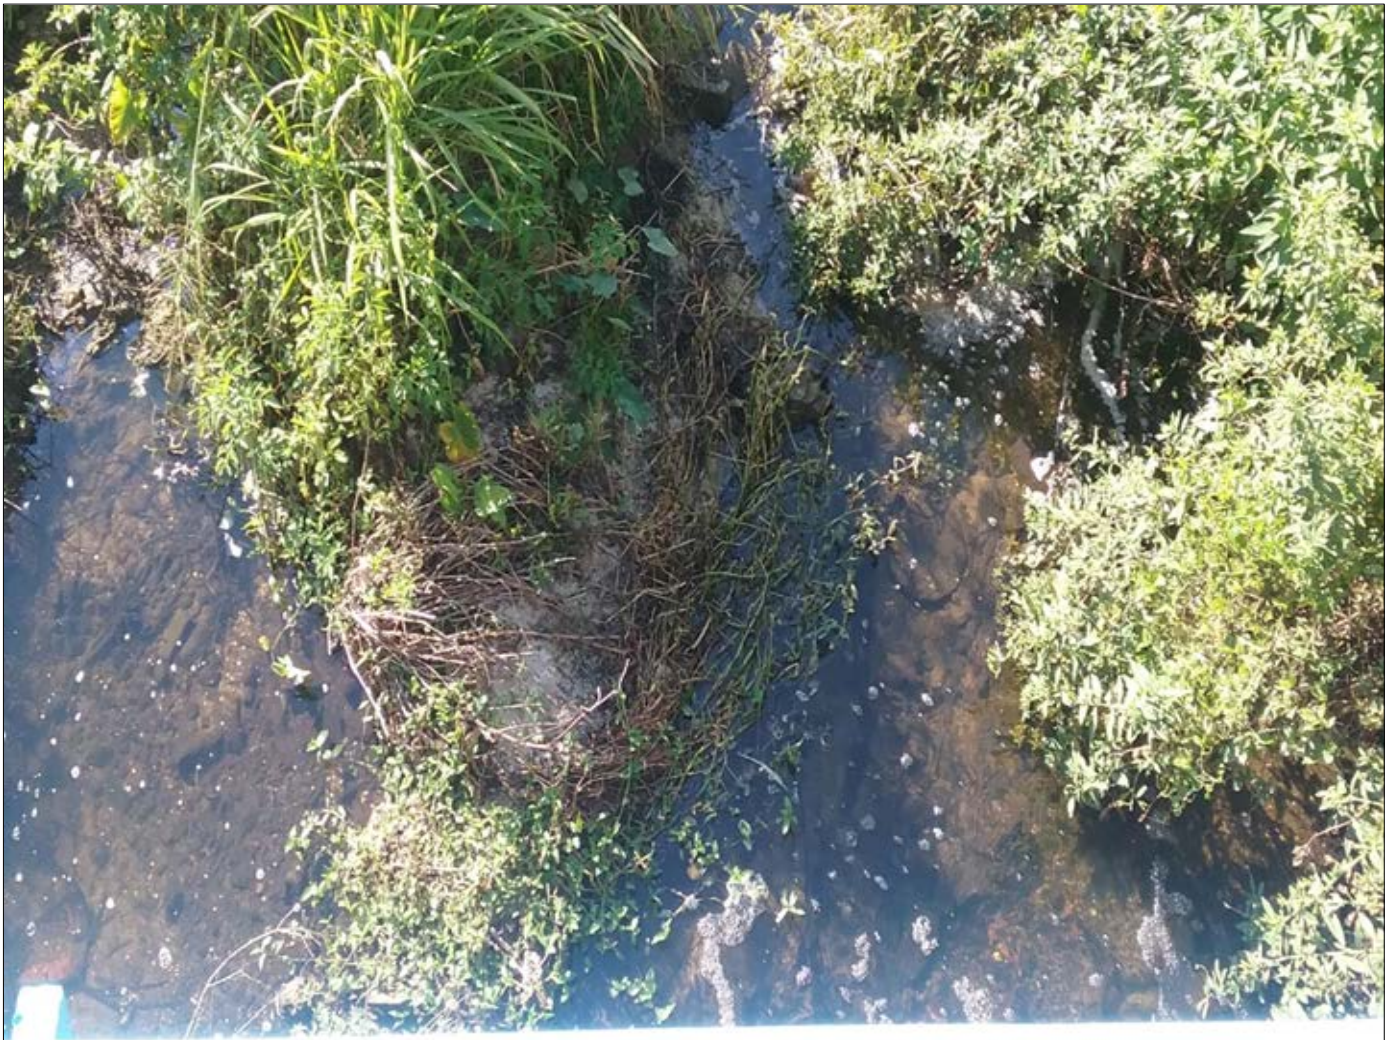
Inspector(s):	Date:	Photo Location	Photo Direction
A.Melton/M.Holland	11/16/2016	Davis Blvd.	South
Comments: (*1)Showing canal bottom about 20ft down from the bottom of the bridge at Davis Blvd. Water was flowing, bottom was rocky. Sample was taken here, at the downstream (south) side of the bridge. We are about 1,400 ft upstream from Woodview Dr, a documented hot spot for bacteria.

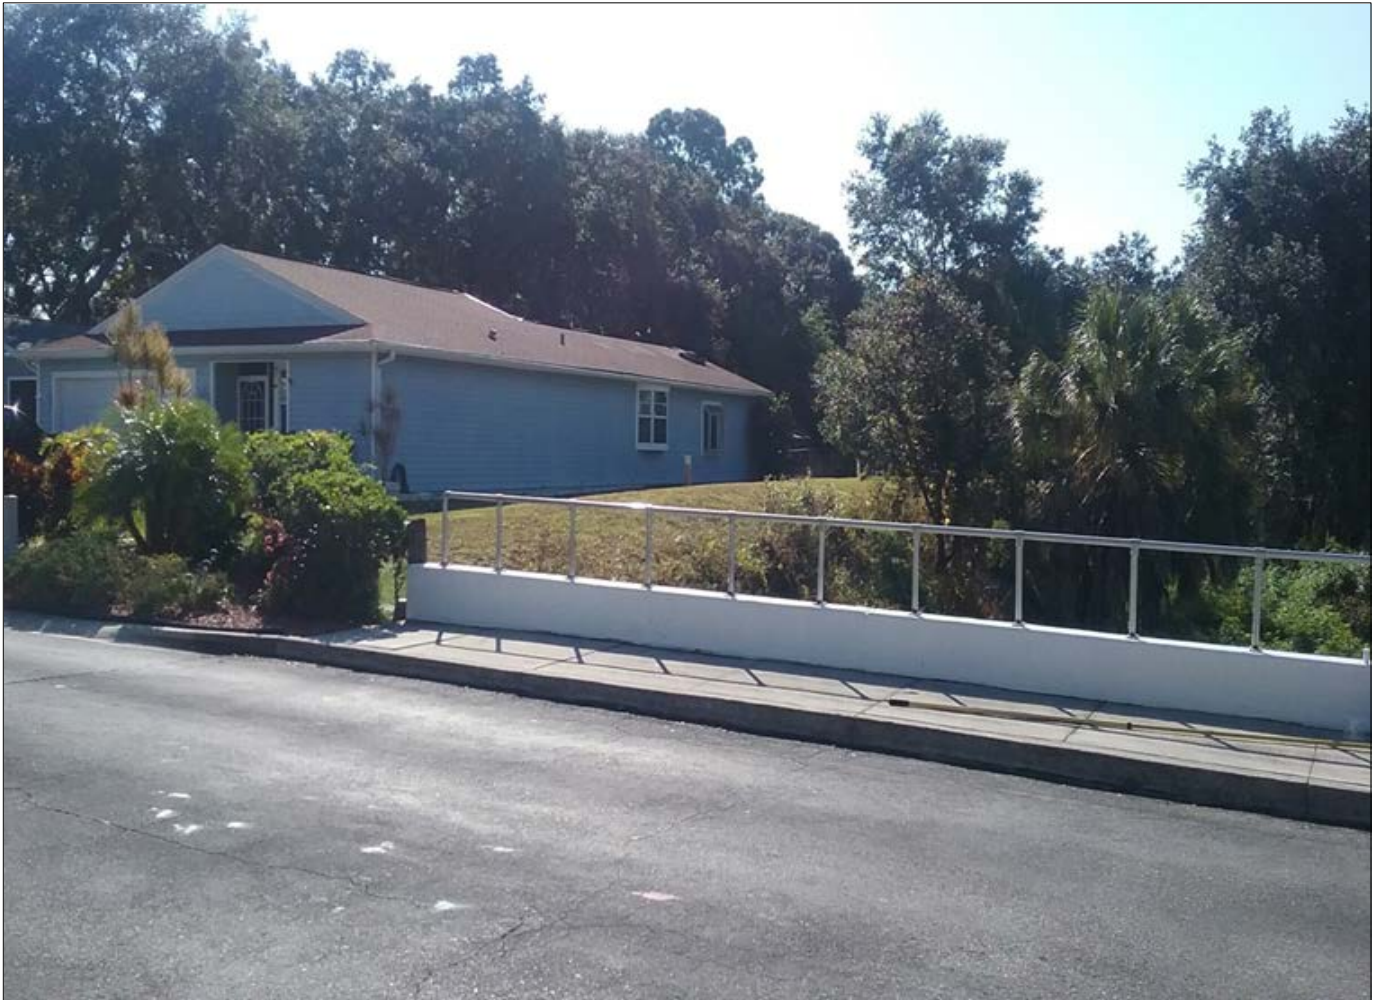
Inspector(s):	Date:	Photo Location	Photo Direction
A.Melton/M.Holland	11/16/2016	East side of Davis Blvd.	East
Comment: (#1*)Showing residence on the East side of the canal, south side of the bridge. Once again, there does not appear to be direct discharge to the canal, at least from the visible portion of the lot.

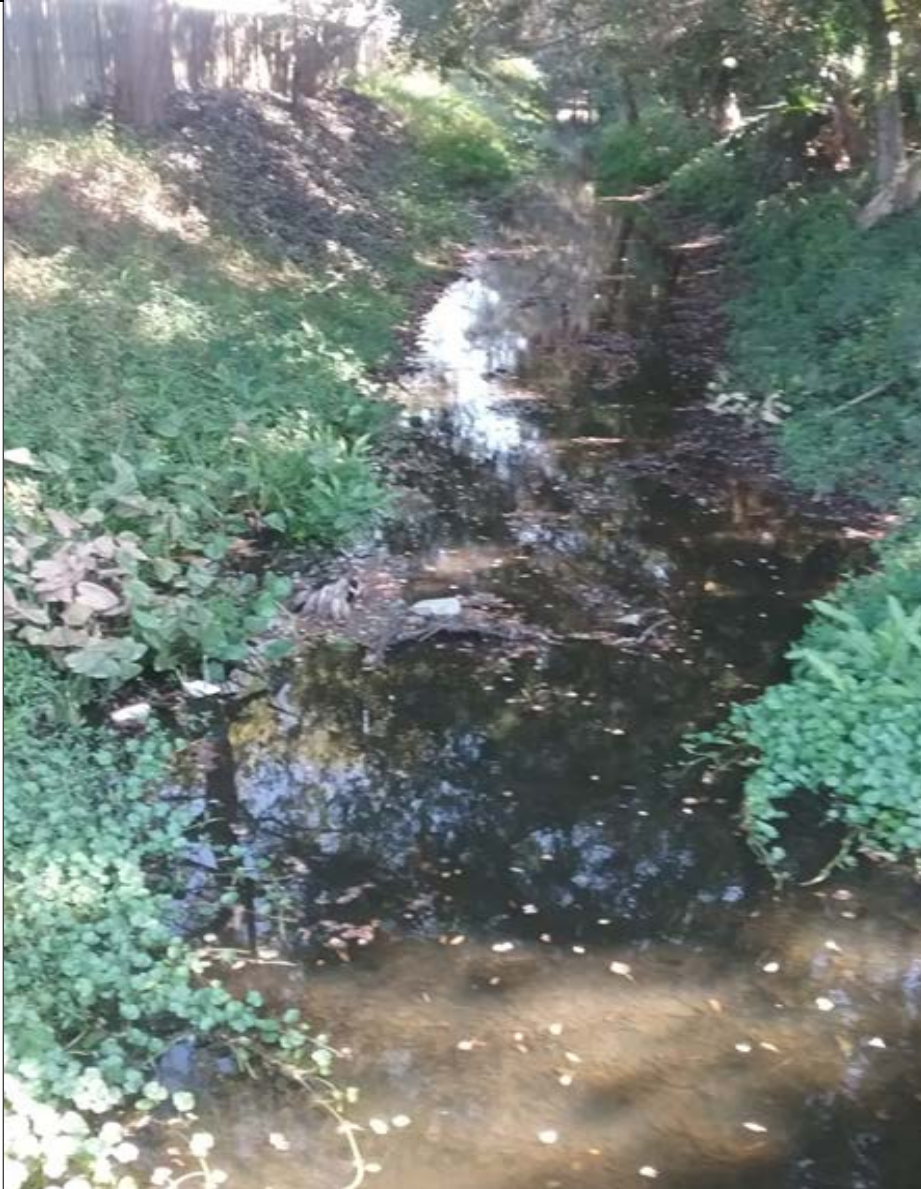
Inspector(s):	Date:	Photo Location	Photo Direction
A.Melton/M.Holland	11/16/2016	Beneva south of Bahia Vista	East
Comments: (#1*) South of Beneva Square Shopping Center. Looking east at the canal that passes under Beneva and flows west towards Phillippi Creek. Canal appears heavily shaded along this section. Heavy detritus in the bottom of the canal, bottom appears mucky. Turtles were seen upstream. This area is about 1,500 ft upstream of a known hot spot for bacteria at Seaview Drive.

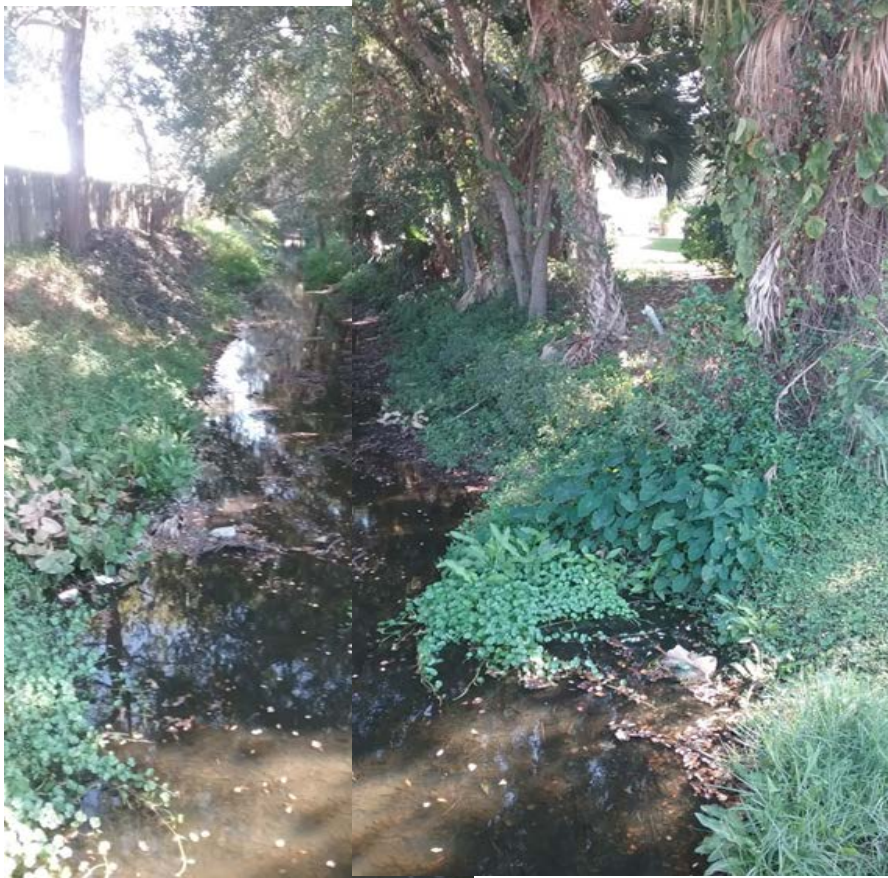
Inspector(s):	Date:	Photo Location	Photo Direction
A.Melton/M.Holland	11/16/2016	Same as above	NE
Comments: Showing a composite of the north and south banks of the canal. Slopes are relatively shallow and heavily vegetated. Beneva Shopping Center is on the left (north) of the canal, residential is on the right (south) of the canal. Stormwater from the shopping center discharges via stormwater pond to the canal. Dumpsters for this center were in good shape.

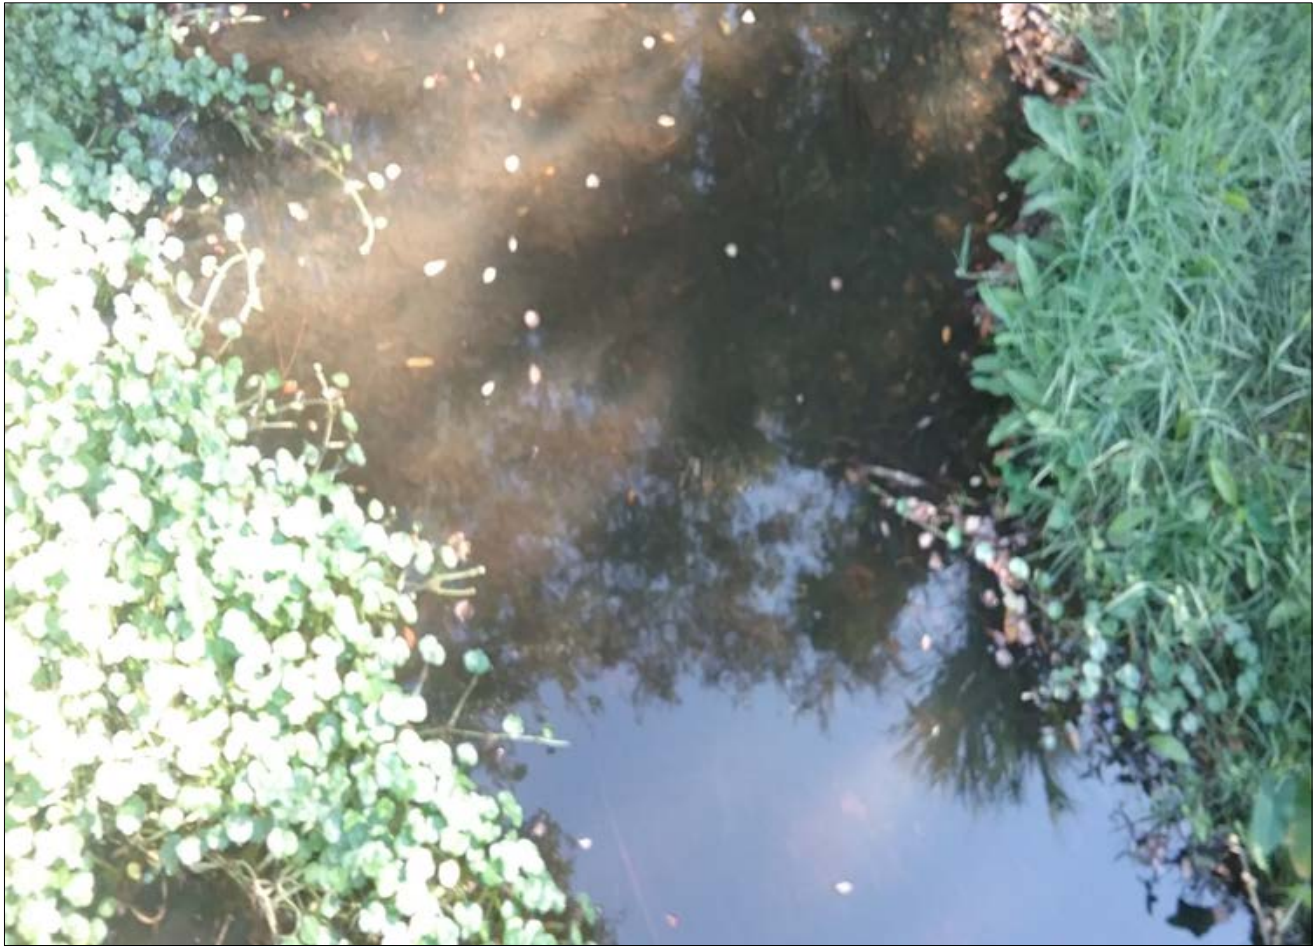
Inspector(s):	Date:	Photo Location	Photo Direction
A.Melton/M.Holland	11/16/2016	Same as above	NE
Comments: Showing water clarity in the canal.

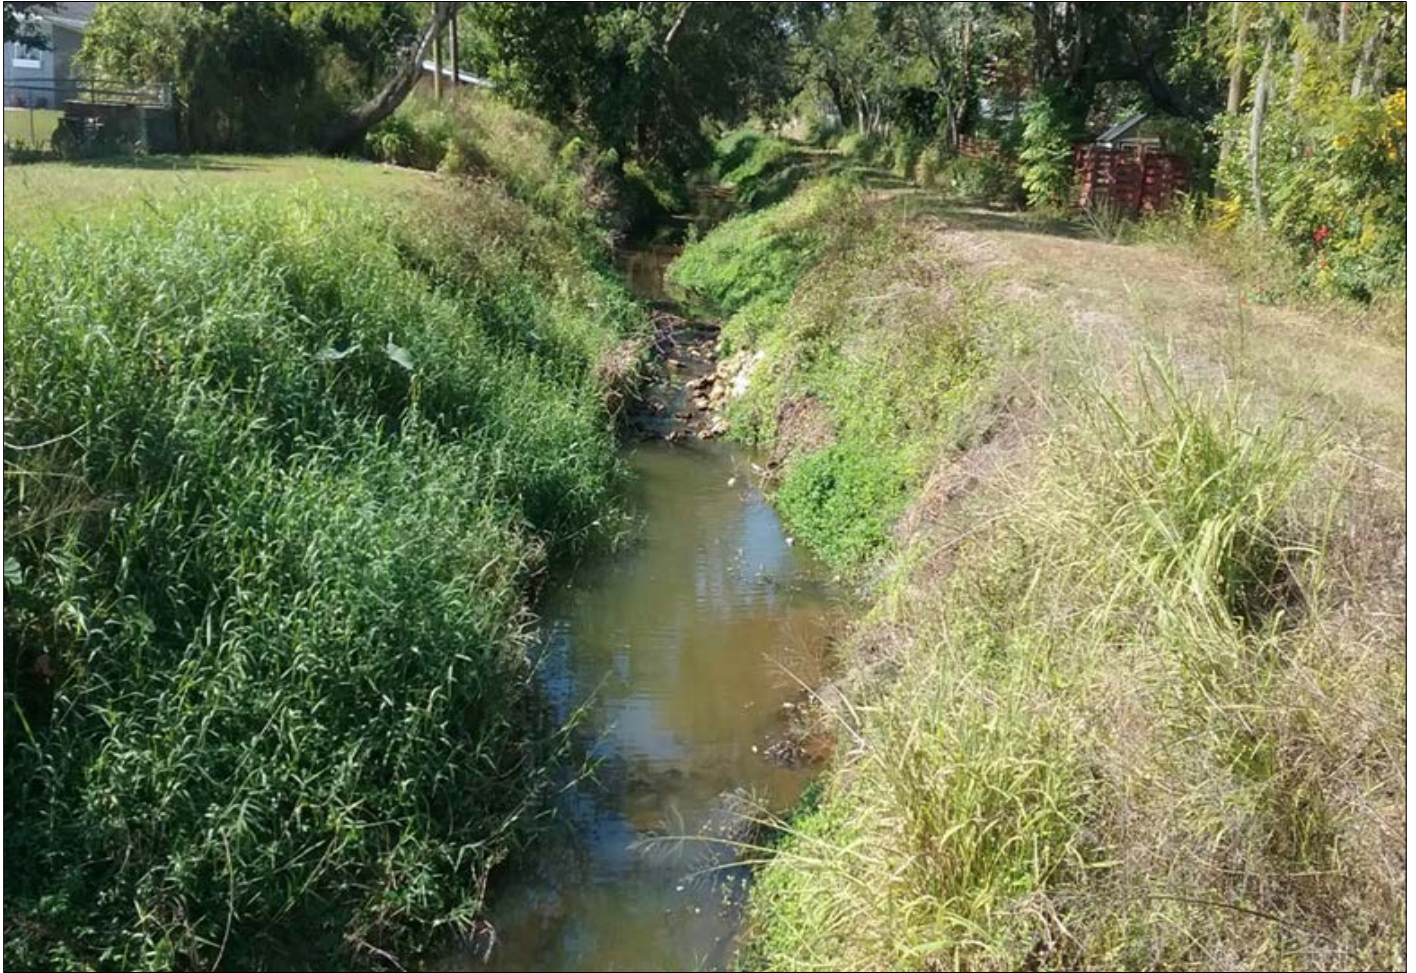
Inspector(s):	Date:	Photo Location	Photo Direction
A.Melton/M.Holland	11/16/2016	Brookmead and Lokai	West
Comments: (#1*)Showing canal as it flows under Lokai Pl. Water is running east (coming towards the bridge). Slopes are steep and vegetated, but showing evidence of erosion/sloughing.

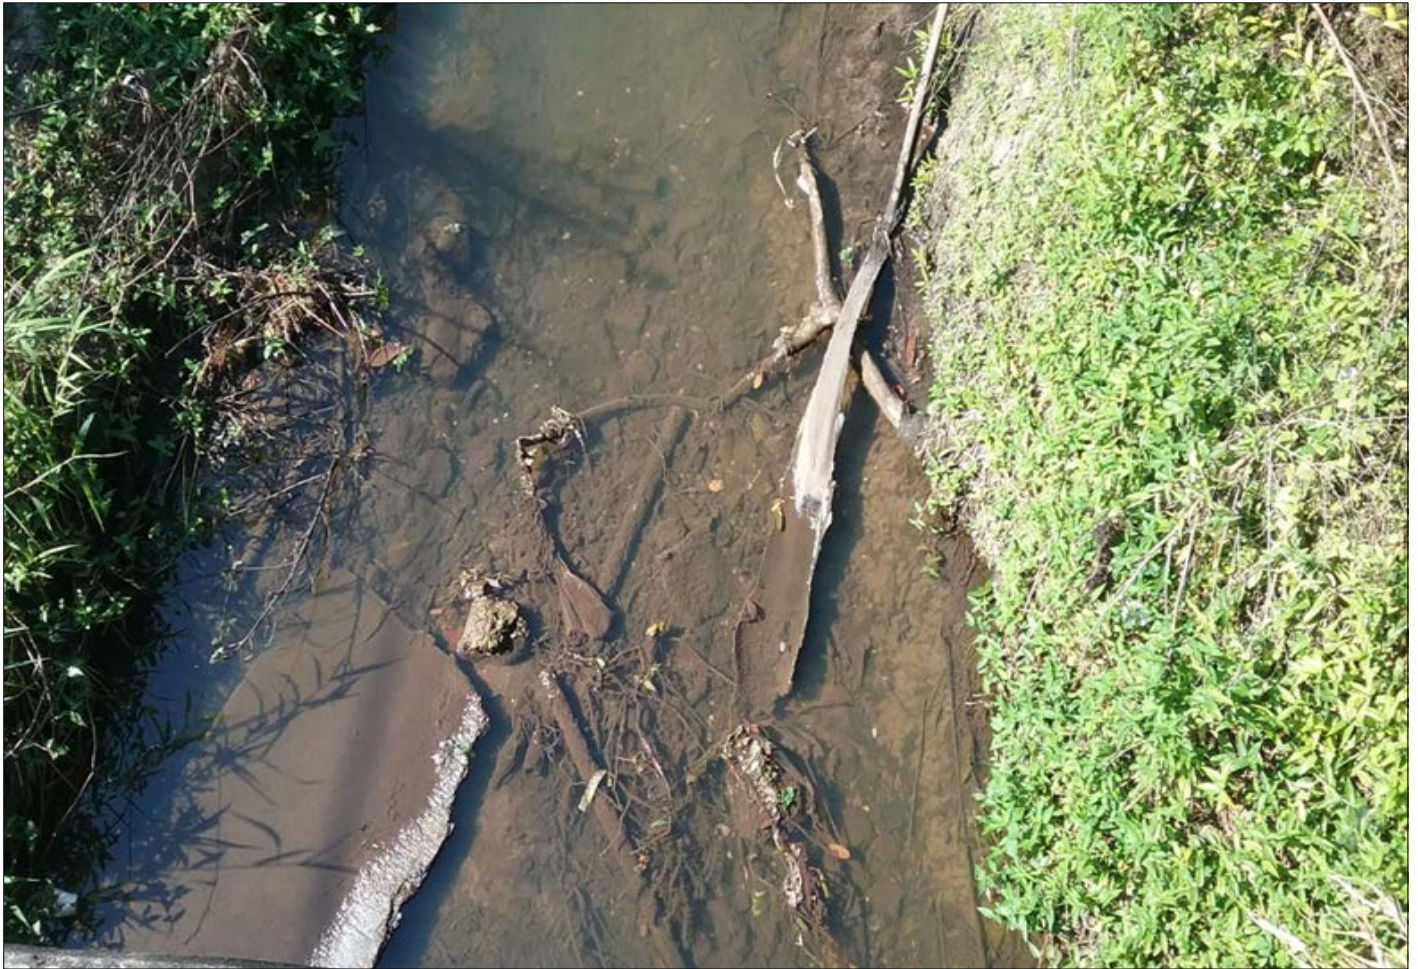
Inspector(s):	Date:	Photo Location	Photo Direction
A.Melton/M.Holland	11/16/2016	Same as above	West
Comments:(#1*) Showing the canal as it flows under Lokai. Water was light brown (a bit tannic) and somewhat cloudy. Bottom was mucky. Evidence of wildlife in the area (tracks in the mud). A sample was taken here for further testing. Shallow muddy areas such as these can promote the growth of bacteria.

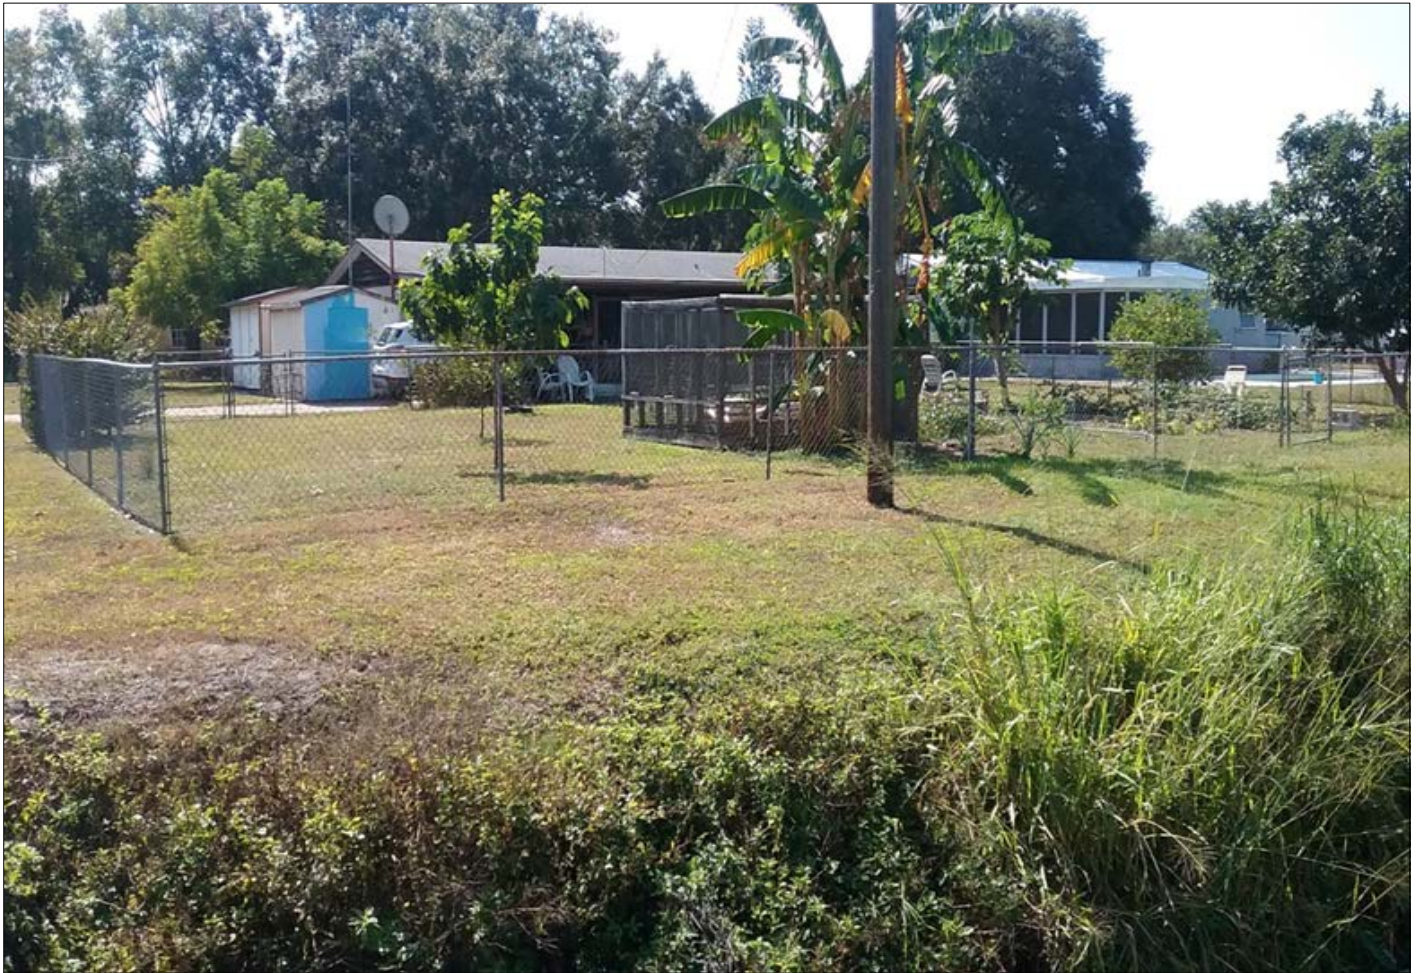
Inspector(s):	Date:	Photo Location	Photo Direction
A.Melton/M.Holland	11/16/2016	Same as above	SW
Comments: (#1*)Showing typical residential land use upstream of the sample sight. Potential for sheet flow from the homes to the canal. This home is at the NW corner of Bell Meade Drive and Lokai Place.

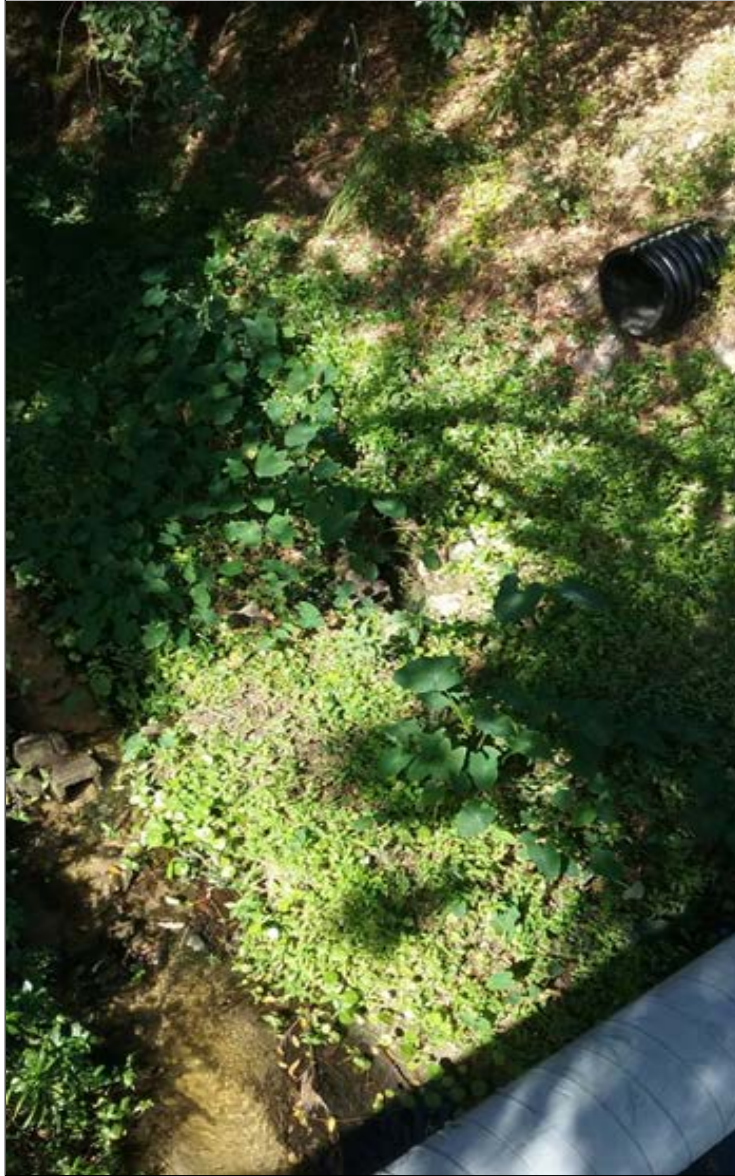
Inspector(s):	Date:	Photo Location	Photo Direction
A. Melton, M. Holland	11/29/2016	West side of South Shade	NE
Comments: (#1)Showing the canal on the west side of South Shade. This area is several blocks upstream of the hotspot located on Brink.

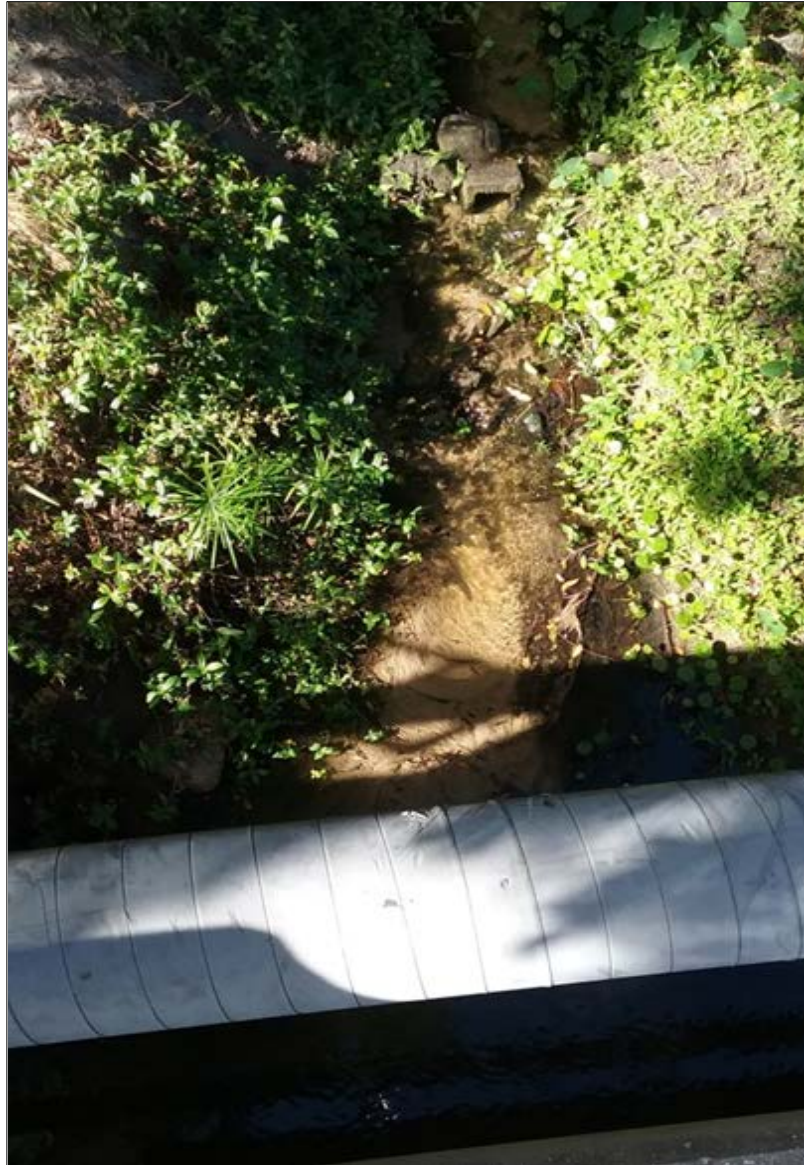
Inspector(s):	Date:	Photo Location	Photo Direction
A. Melton, M. Holland	11/29/2016	S. Shade	West
Comments: (#1)Showing the canal bottom. Sandy, mostly shade. This area is heavily travelled by animals. Game trails are evident, as well as tracks.

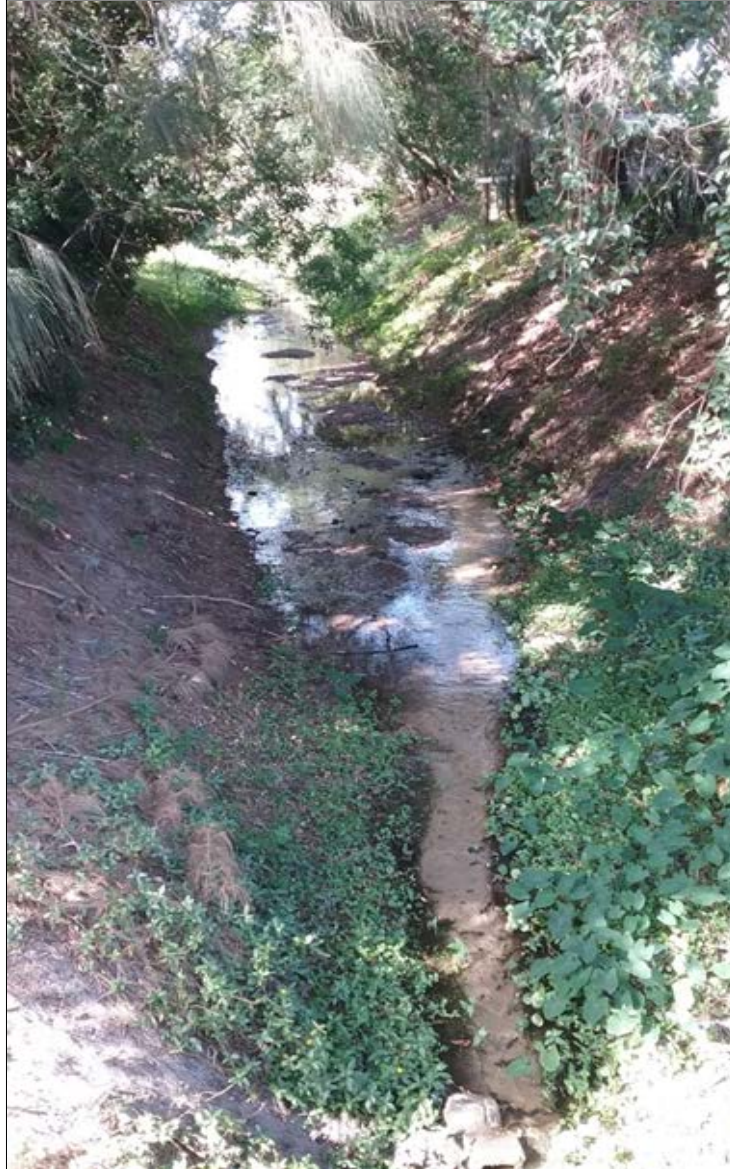
Inspector(s):	Date:	Photo Location	Photo Direction
A. Melton, M. Holland	11/29/2016	Same as Above	West
Comments: (#1*) Showing upstream from the sampling location. Banks are mostly vegetated. Residential on both sides.

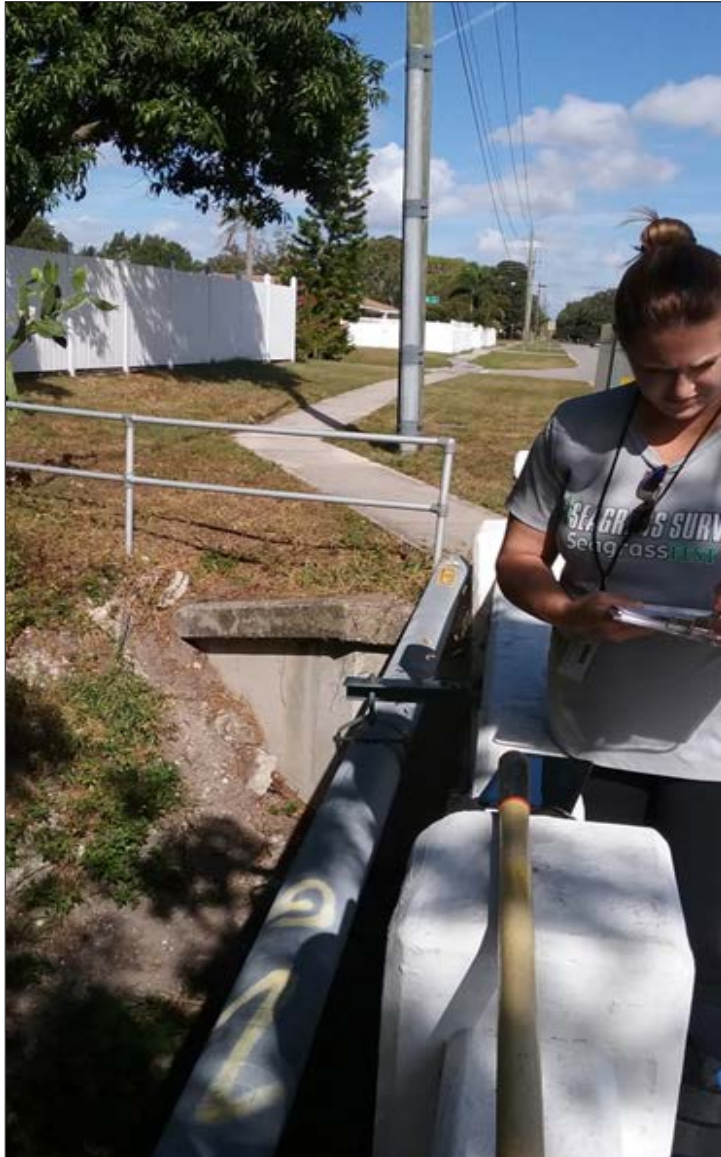
Inspector(s):	Date:	Photo Location	Photo Direction
A. Melton, M. Holland	11/29/2016	West side of South Shade	North
Comments: (#1) Showing Ashley entering in information in the sampling tablet. Just to her left is a game trail that leads from the roadside down to the ditch.

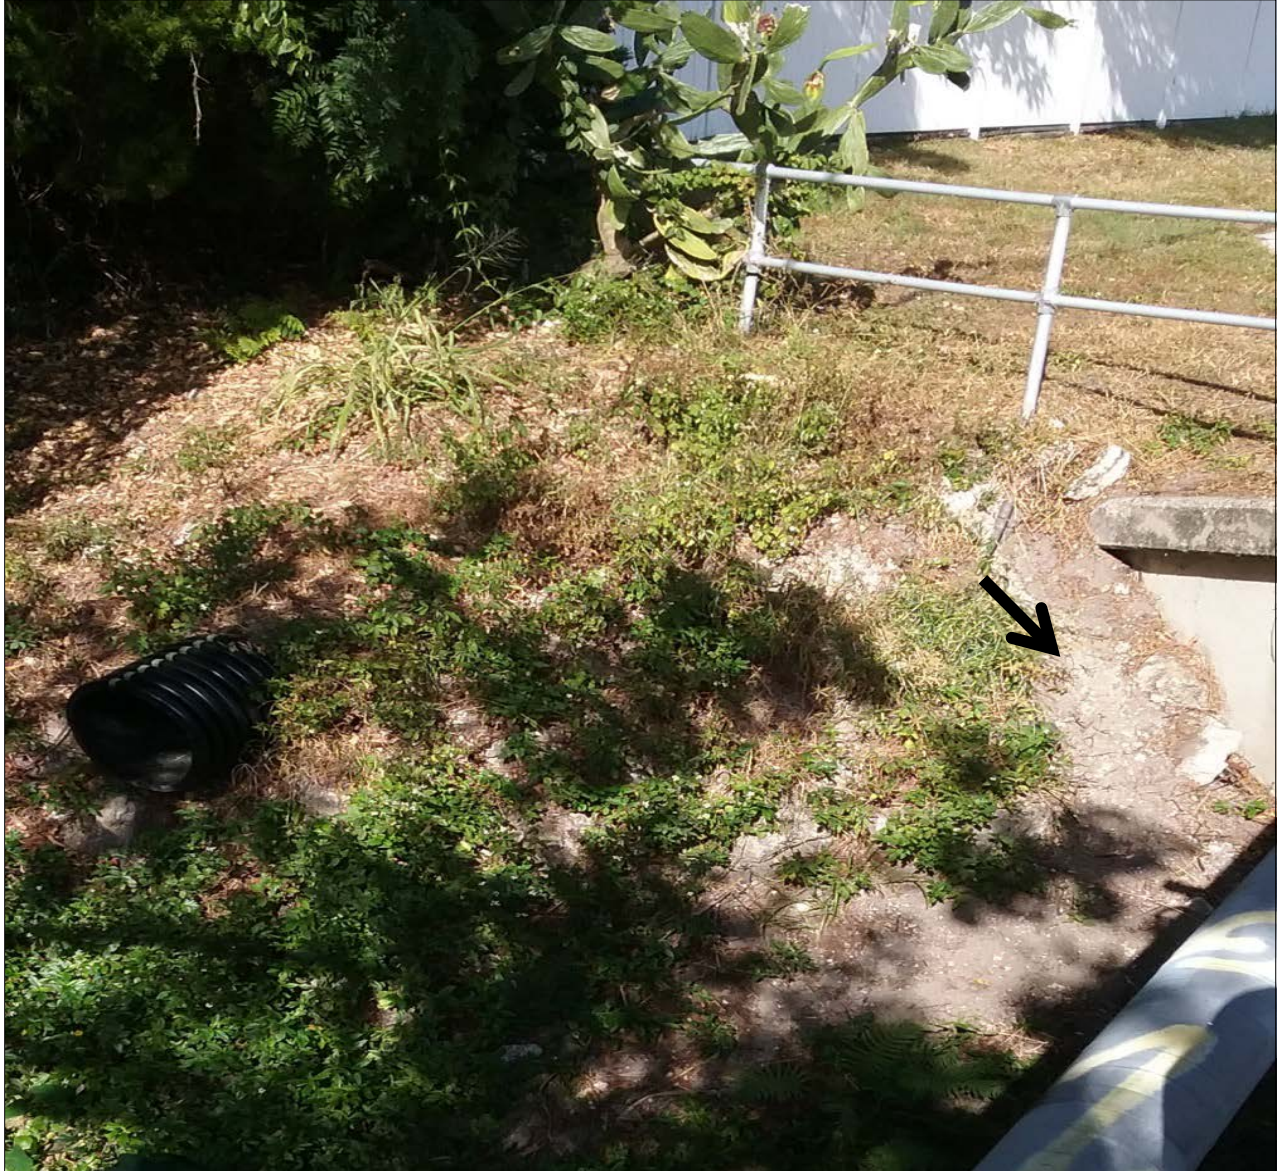
Comments: Showing the north bank with the heavily traveled trail on the right side of the photo.
