Summary of Results

Walk the WBID Exercise for Philippi Creek
(WBID1937)

FINAL DRAFT

September 27, 2017

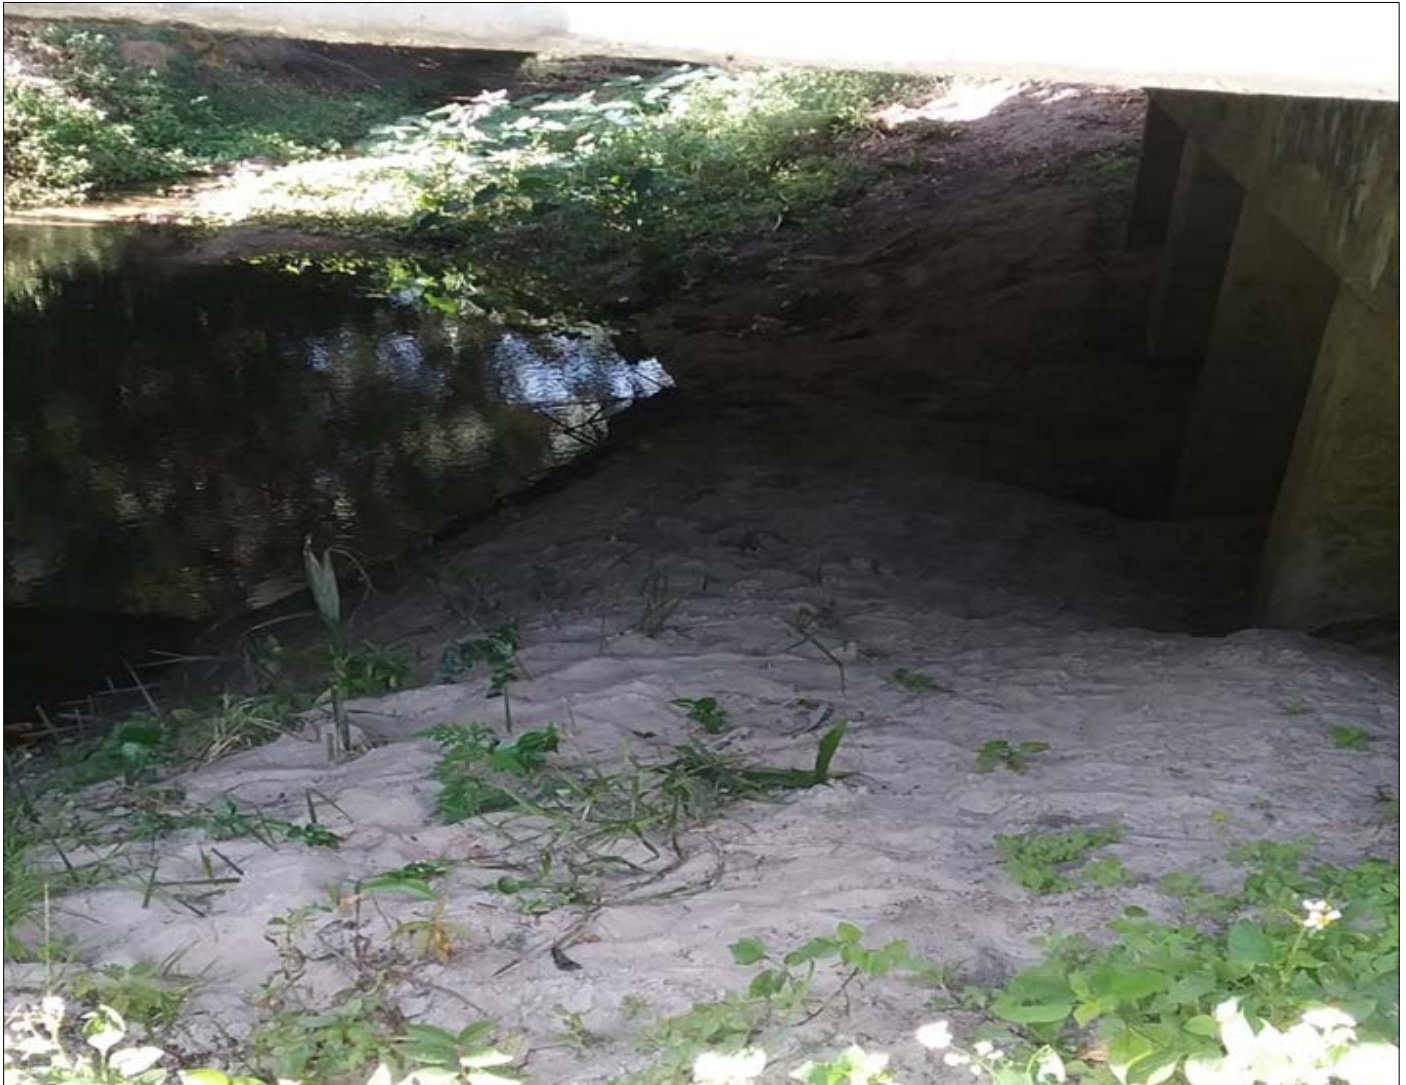
Inspector(s):	Date:	Photo Location	Photo Direction
A. Melton, M. Holland	11/29/2016	East side of S. Shade	West
Comments: Showing the area under the bridge. Lots of animal tracks here, and some human.

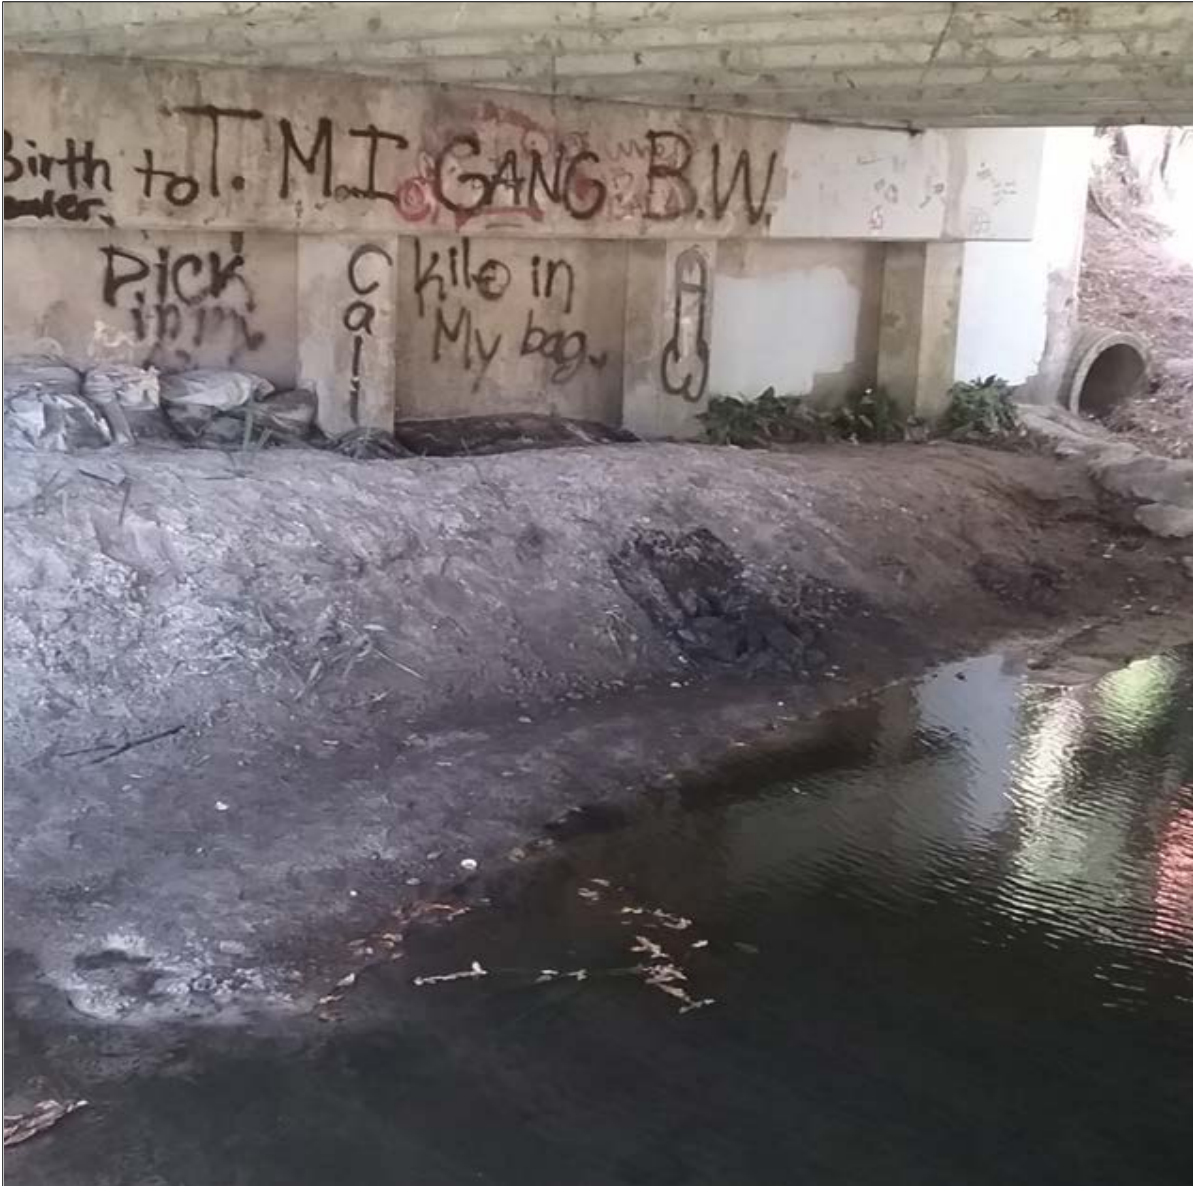
Comments: Showing the south shore of the canal under the bridge. Lots of animal tracks, some human.

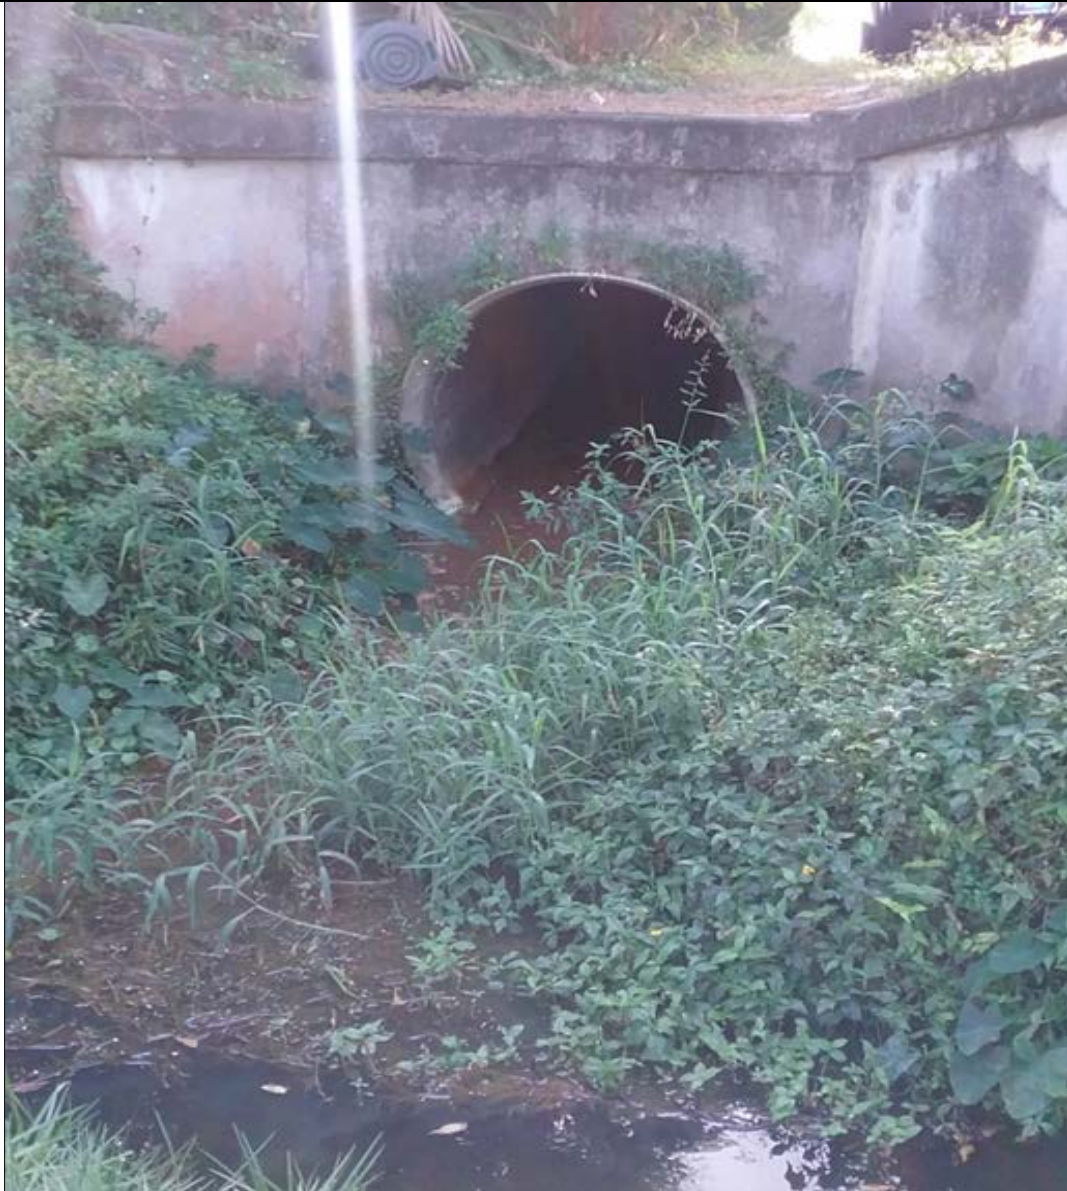
Inspector(s):	Date:	Photo Location	Photo Direction
A. Melton, M. Holland	11/29/2016	West side of S. Shade	South
Comments: Showing a pipe currently discharging discolored water into the canal. Unsure the beginning of the pipe - where it is.

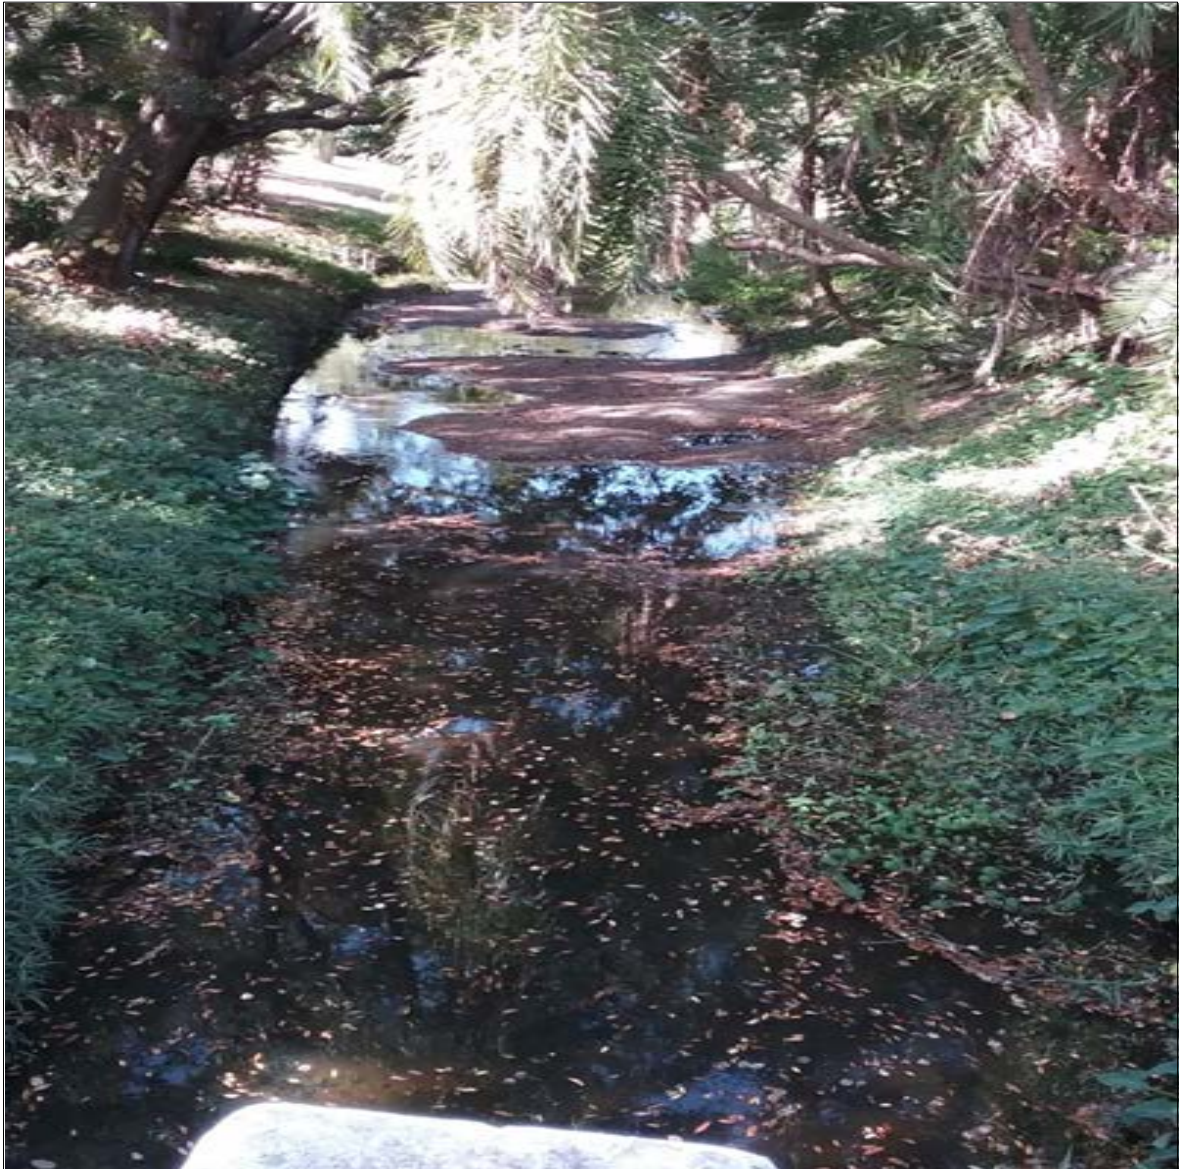
Comments: (#1) Looking west of the bridge on Brink . The canal is a mix of sun and shade, heavily vegetated on both sides. Sand bar in the background is typically the area where the neighbor to the south (on the left) that feeds birds with fish/meat scraps (reportedly). Wildlife tracks are everywhere.

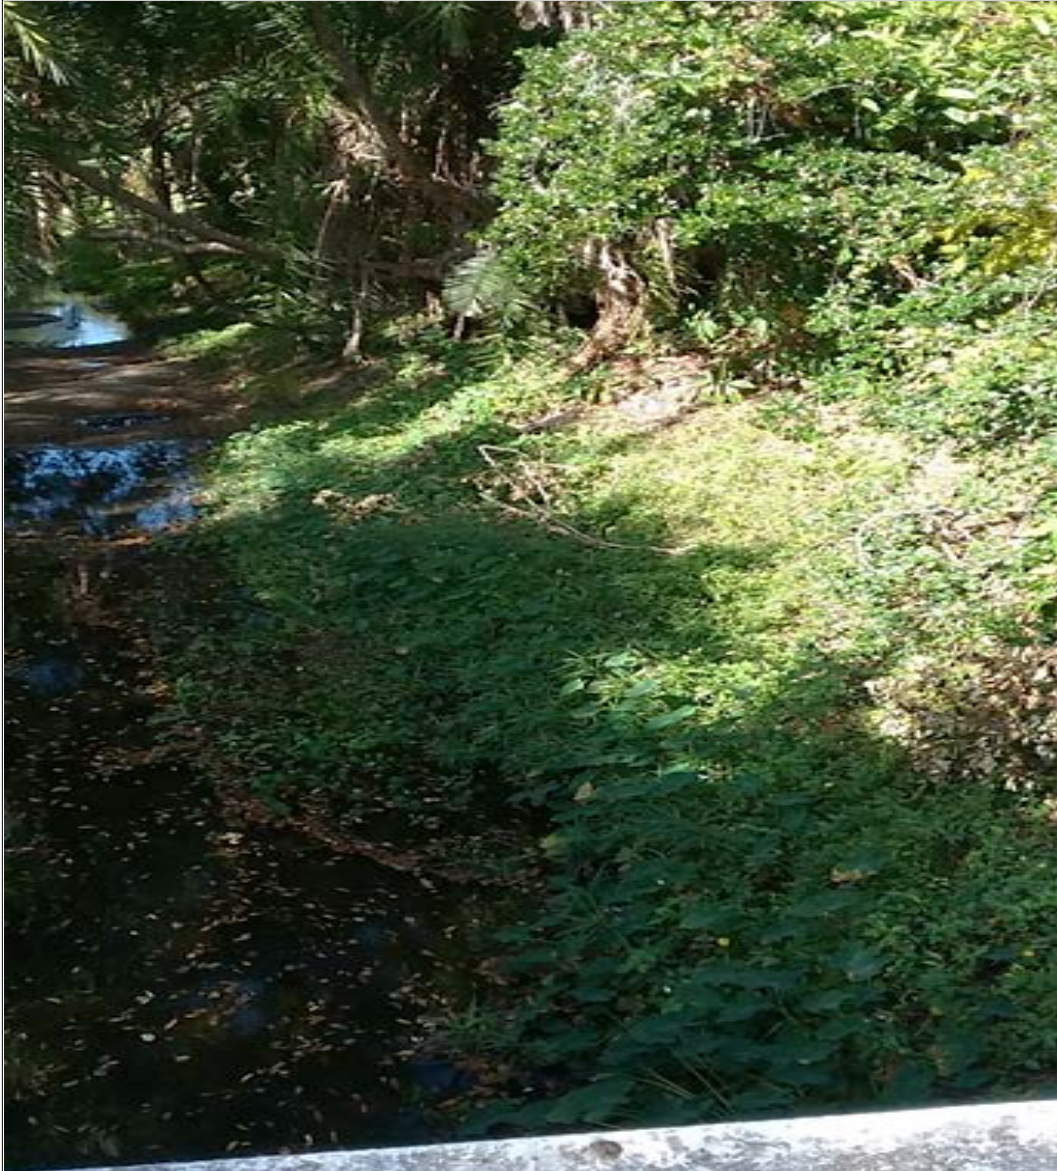
Inspector(s):	Date:	Photo Location	Photo Direction
A. Melton and M. Holland	11/29/2016	Same as above	West
Comments: Showing the northern ditch. Residential land use on both sides, along the entire length. There was a strong smell of urine/musty animal smell in this area. The sand bar in the background was covered in animal tracks. The property on the right of the photo has fruit trees (bananas) adjacent to the creek.

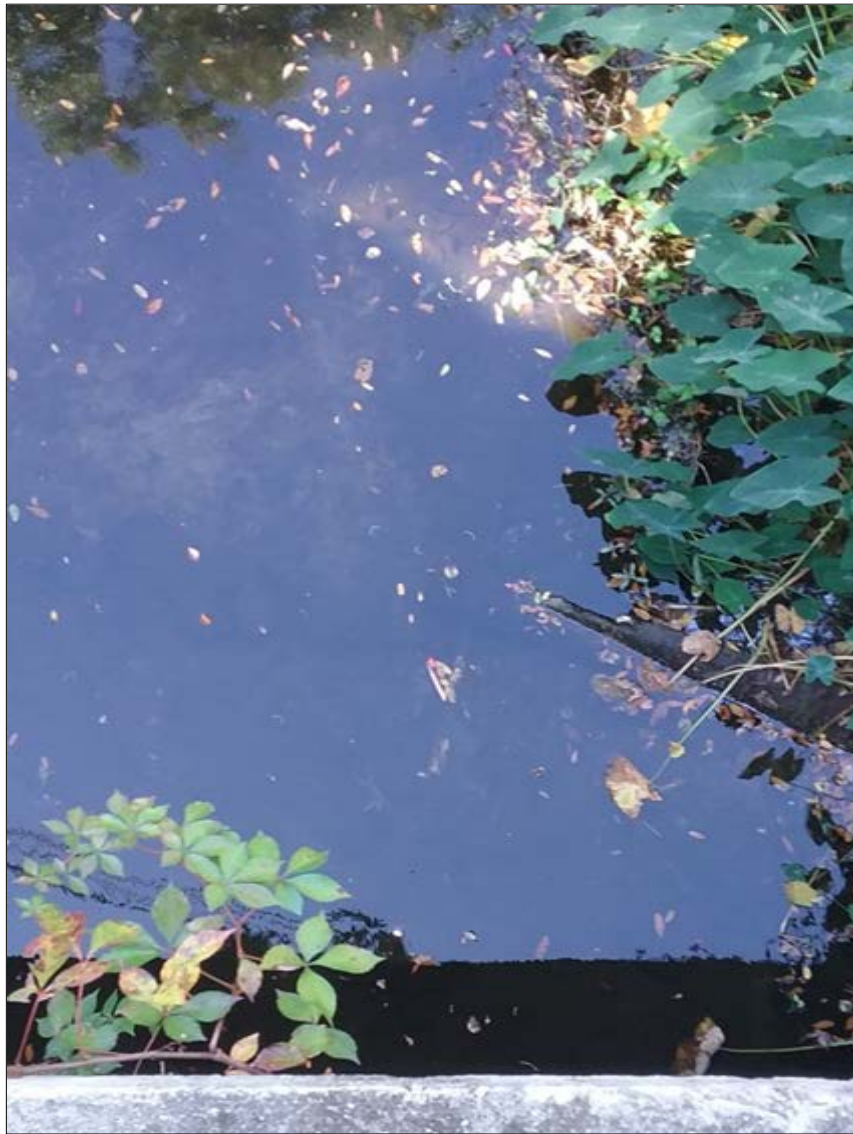
Inspector(s):	Date:	Photo Location	Photo Direction
A. Melton/M.Holland	11/29/2016	Same as above	West side of Bridge
Comments: Looking down from the bridge on the west side. The water was clear and flowing. Water depth was less than 7-8 inches deep. No odor to the water. The sample was taken here, about halfwater between the banks in the flow line.

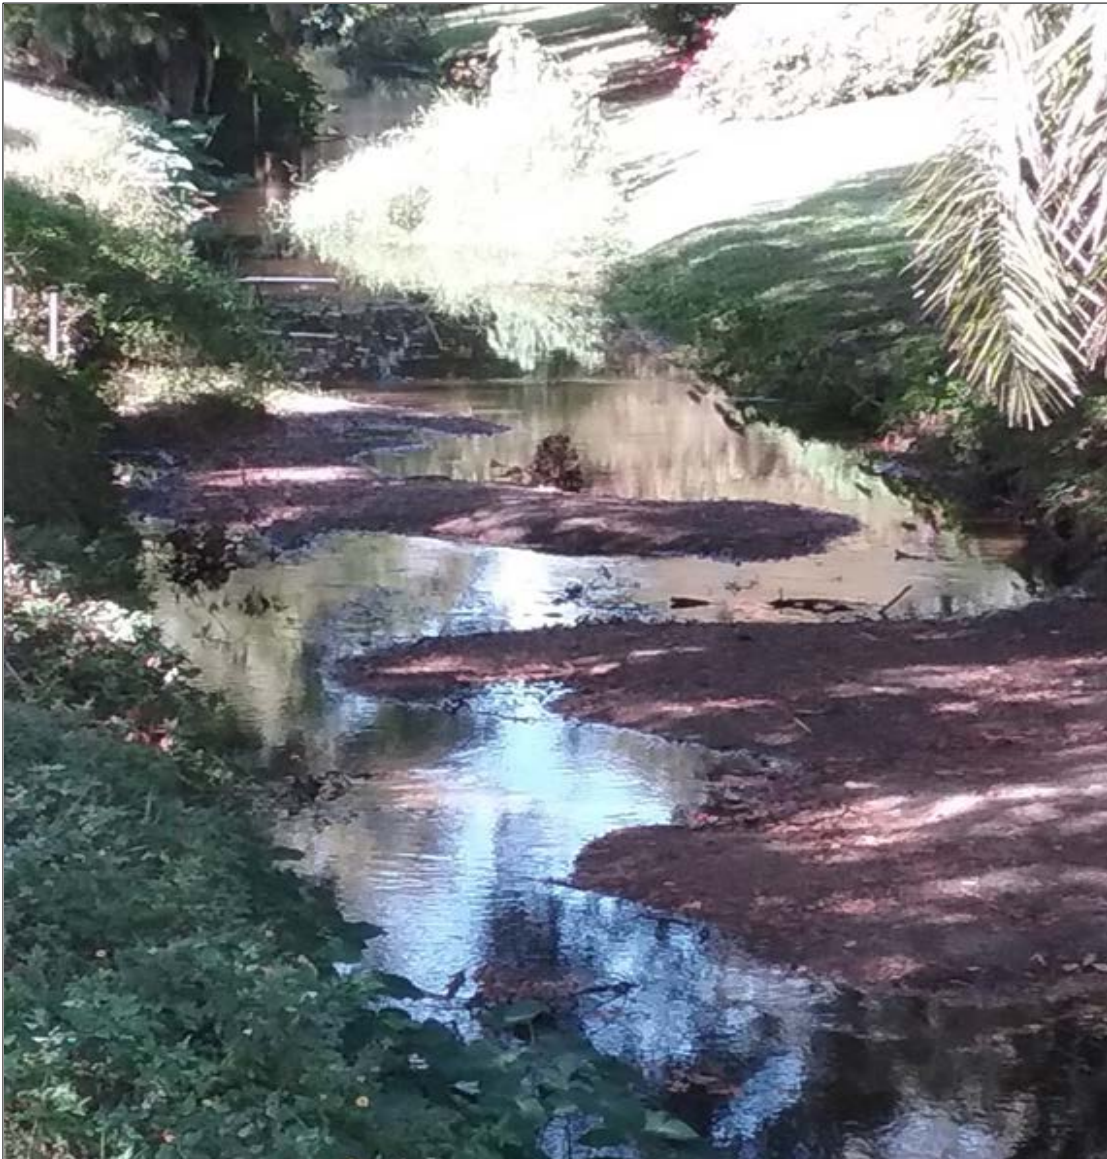
Comments: Showing the other side of the sand bar (above). You can see the canal is still flowing. The slope are gentle, and covered with vegetation. As previously mentioned, the sandy areas are covered with wildlife tracts.

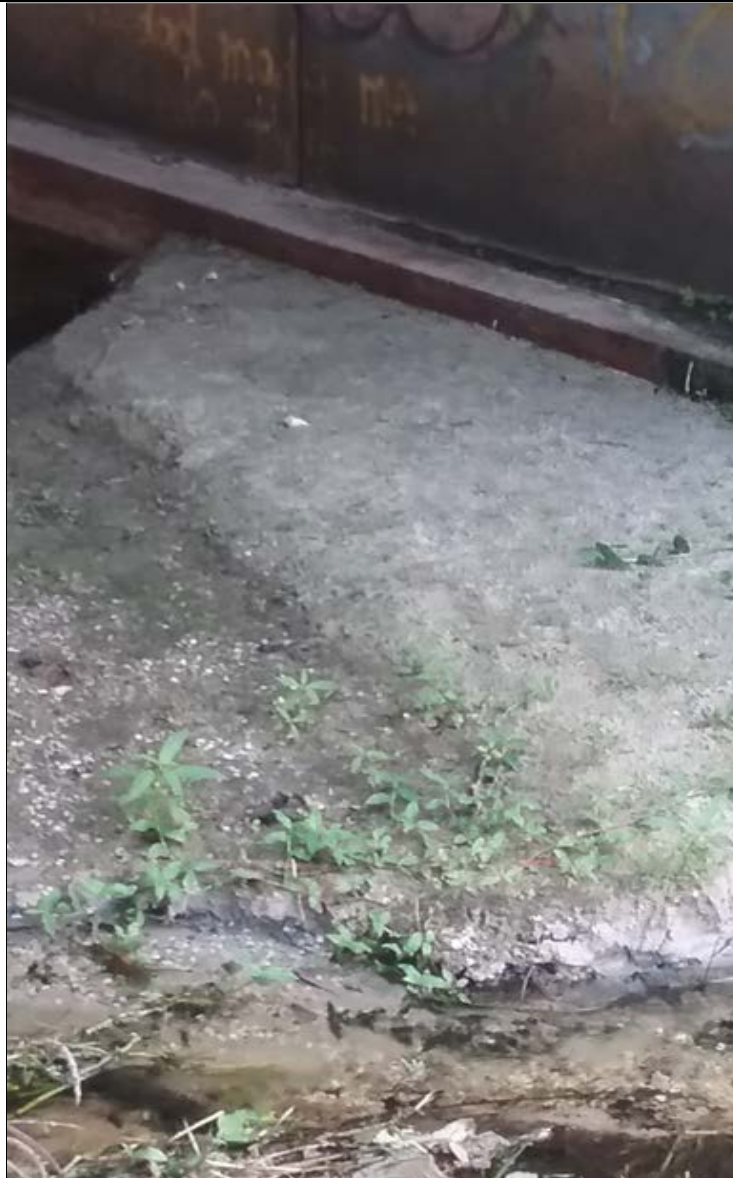
Inspector(s):	Date:	Photo Location	Photo Direction
K.O'Hara/M.Holland	12/15/2016	Under bridge at Woodview	SW
Comments: Looking at area under bridge downstream of the sample site. Sandy area is covered with animal tracks (raccoon). This is canal 4-27.

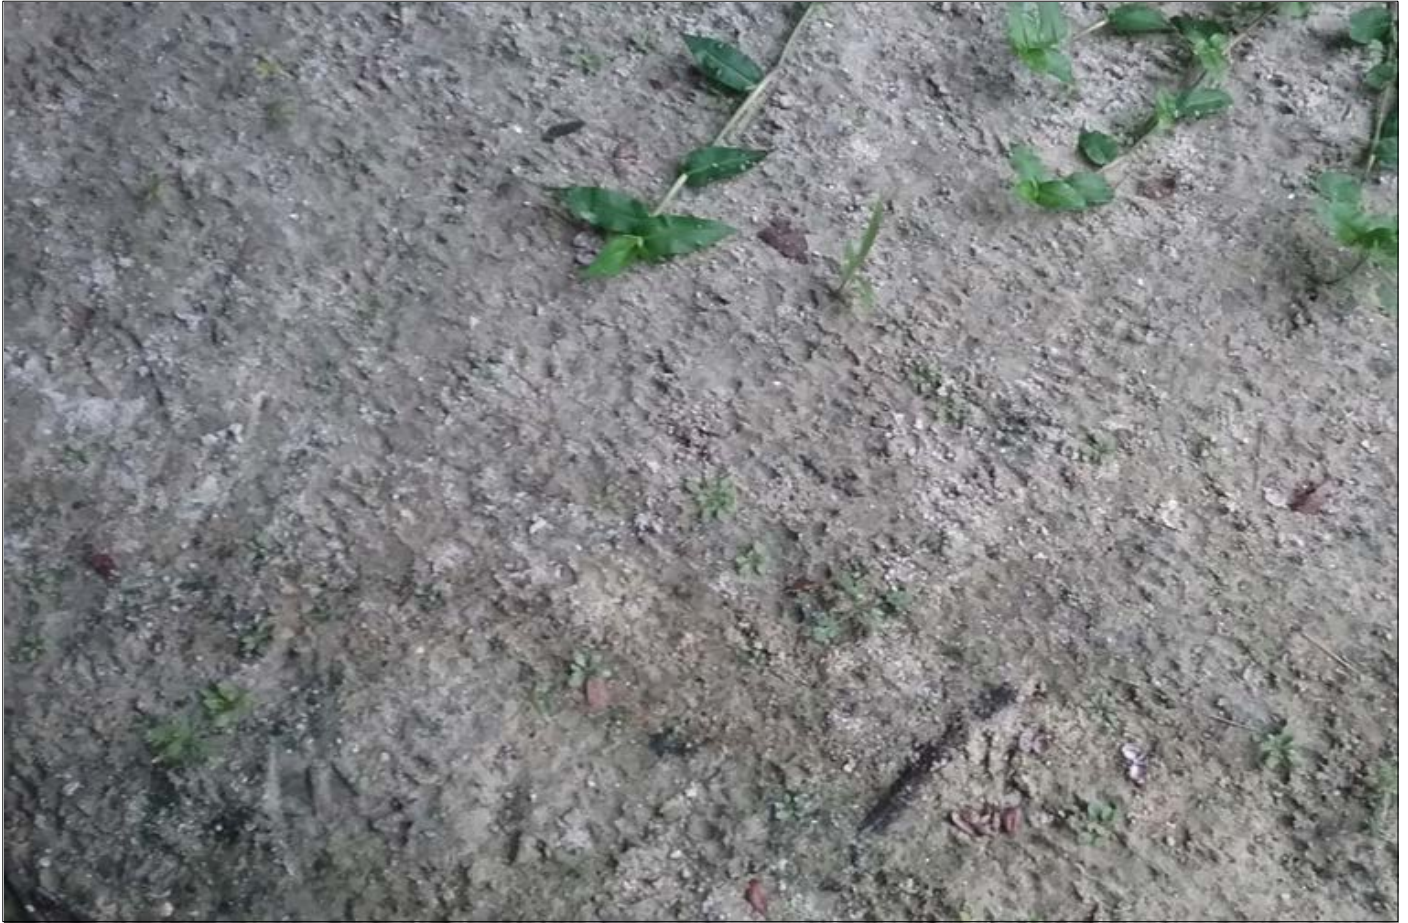
Inspector(s):	Date:	Photo Location	Photo Direction
K.O'Hara/M.Holland	12/15/2016	Same as above	SW
Comments: Showing the many animal tracks in the sand at the sandy area.

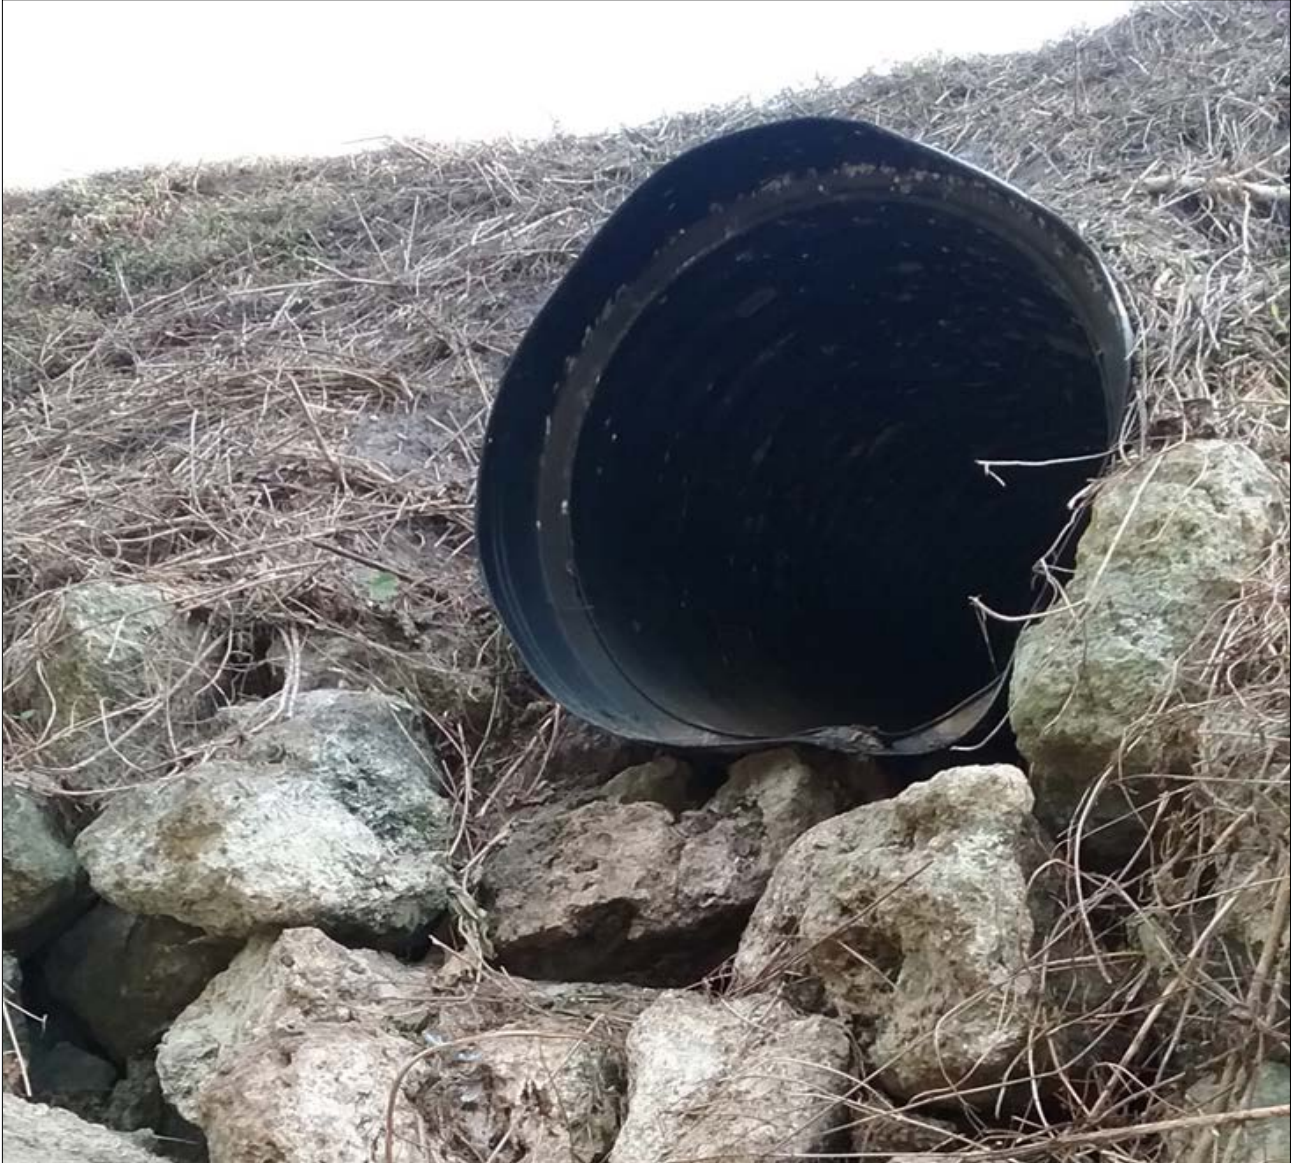
Inspector(s):	Date:	Photo Location	Photo Direction
K.O'Hara/M.Holland	12/15/2016	outfall of upstream pond	NE
Comments: Outfall for privately maintained pond P4-43. Pond was not discharging at the time of the site visit. Pond P4-43 receives stormwater runoff from the adjacent subdivision, which may contain pet waste from dog walking and yards. There was also wildlife (turtles) seen in the pond - another potential contributor.

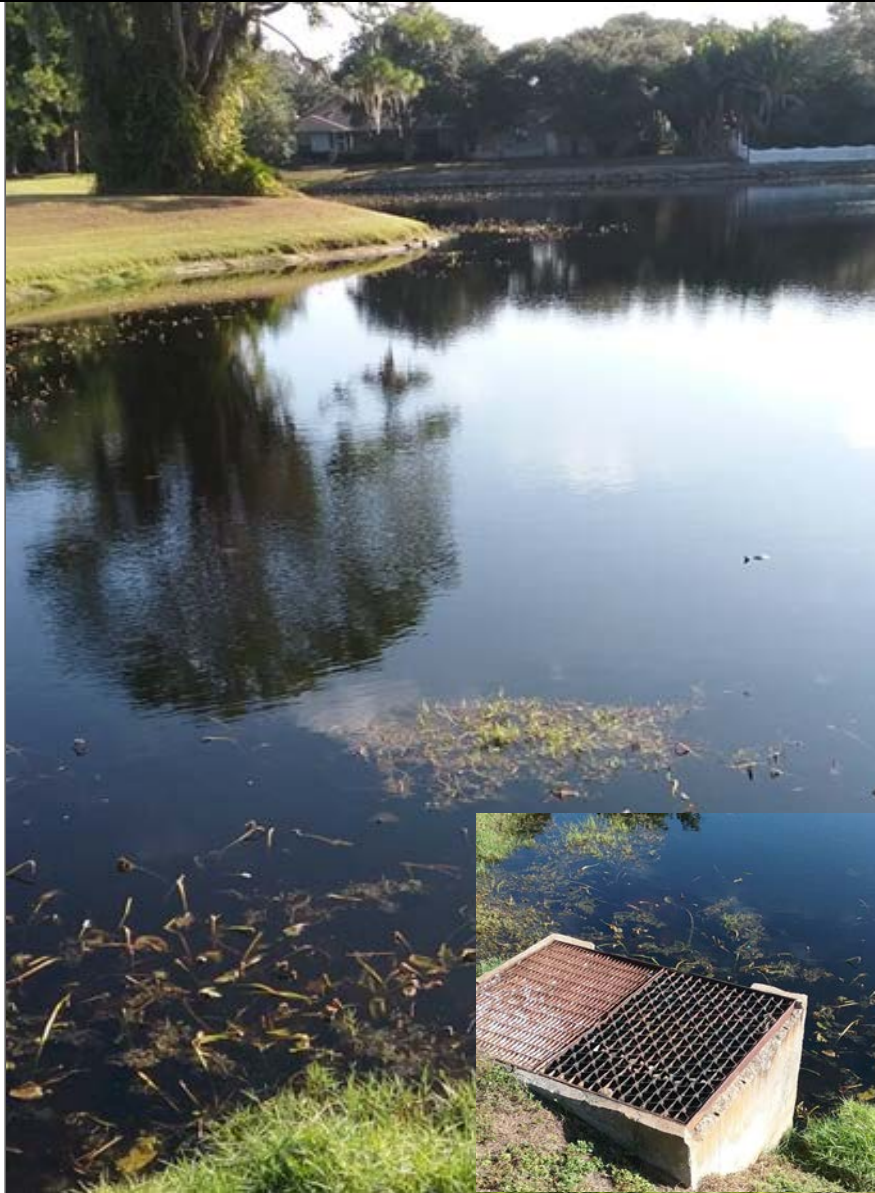
Inspector(s):	Date:	Photo Location	Photo Direction
K.O'Hara/M.Holland	12/15/2016	Pond P4-43	NE
Comments: Showing pond P4-43 and the outfall . Pond is well maintained with some vegetation at the outfall. Turtles were the only wildlife seen at the time of the site visit.

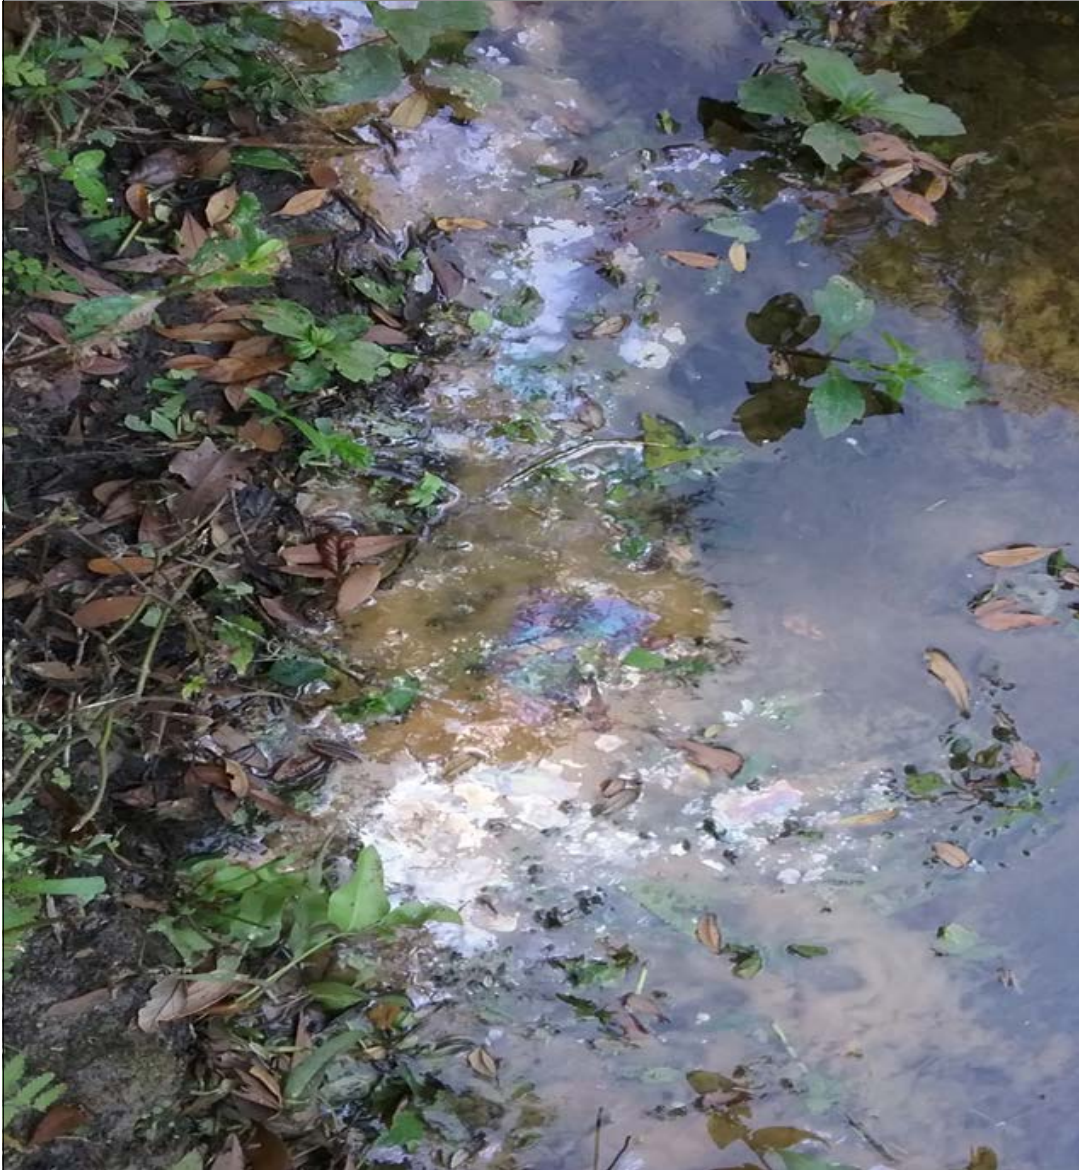
Comments: Showing a cottony precipitate at the edge of the water. PPT was orange, potentially indicative of iron falling out of solution from water leaching through the soil. Biofilm is evident in areas where vegetation is present. This situation was only present on the east bank of the canal.

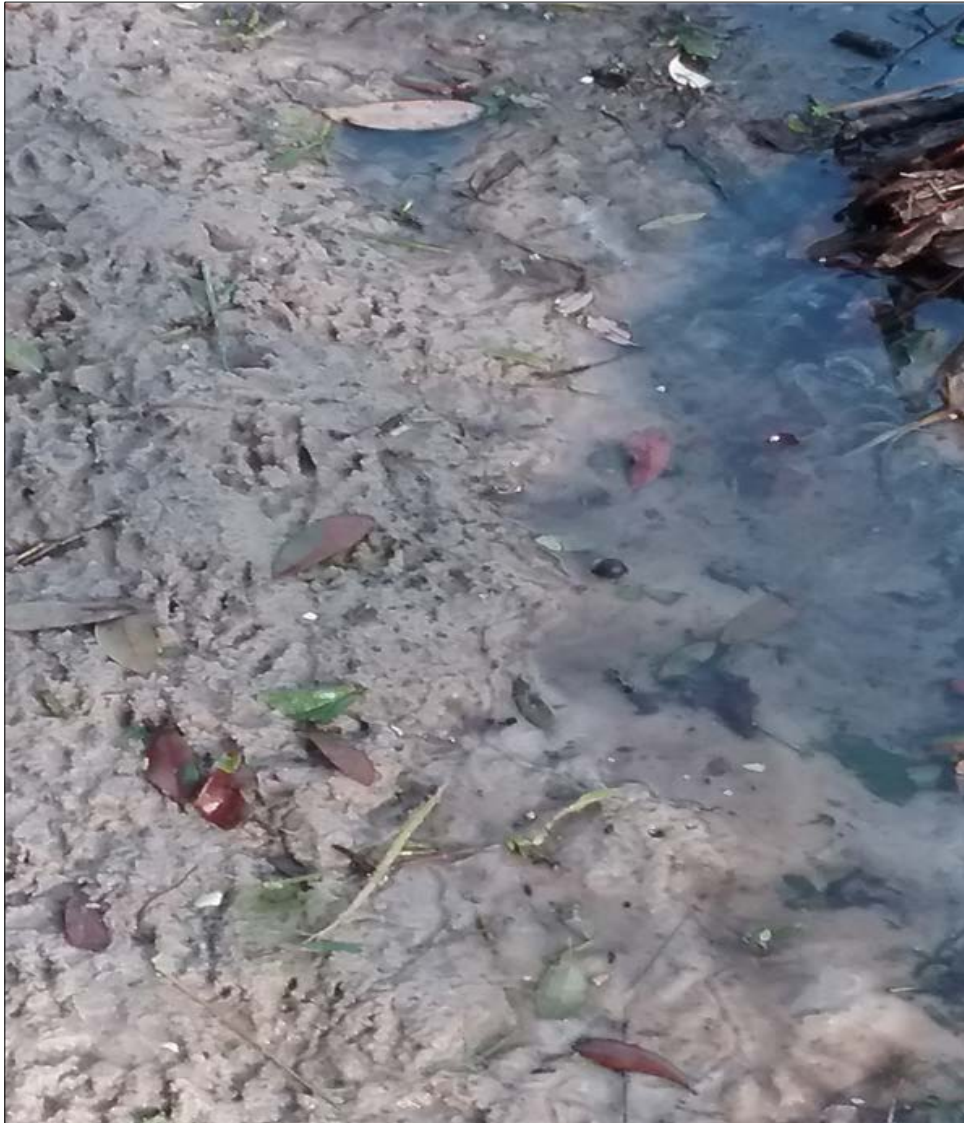
Inspector(s):	Date:	Photo Location	Photo Direction
K.O'Hara/M.Holland	12/15/2016	Same as above	N/A
Comments: Plenty of animal tracks along the canal.

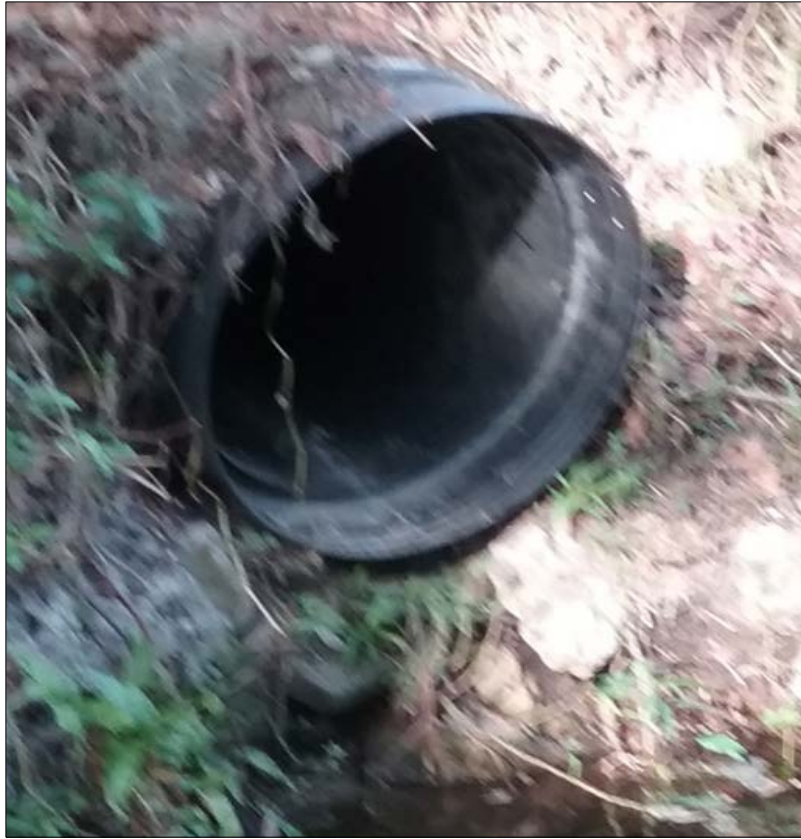
Inspector(s):	Date:	Photo Location	Photo Direction
K.O'Hara/M.Holland	12/15/2016	Outfall off Midwest PKWY	West
Comments: Attempting to show no discharge from the road.

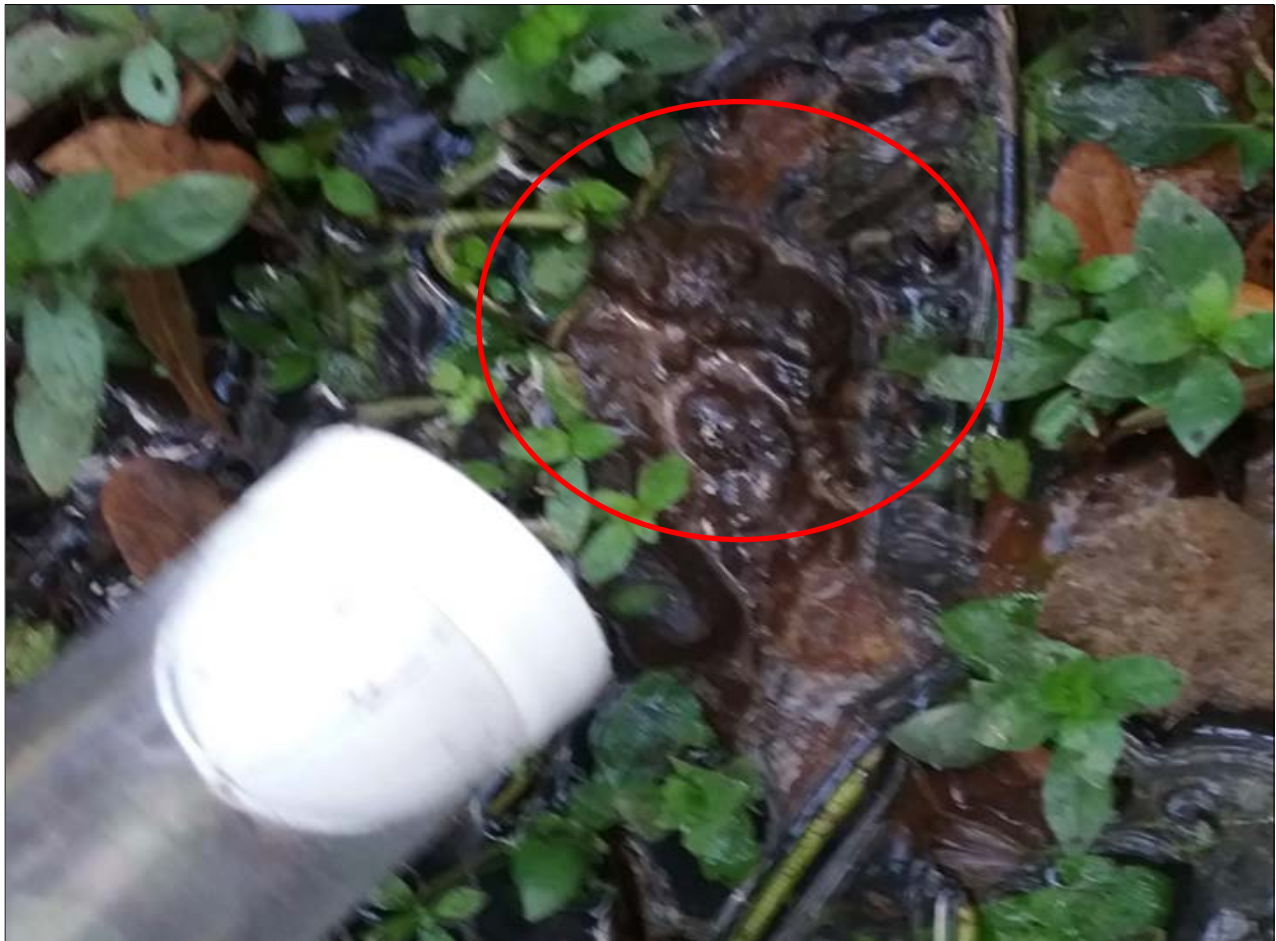
Inspector(s):	Date:	Photo Location	Photo Direction
K.O'Hara/M.Holland	12/15/2016	Downstream of above pipe	N/A
Comments: Showing animal feces in the canal.

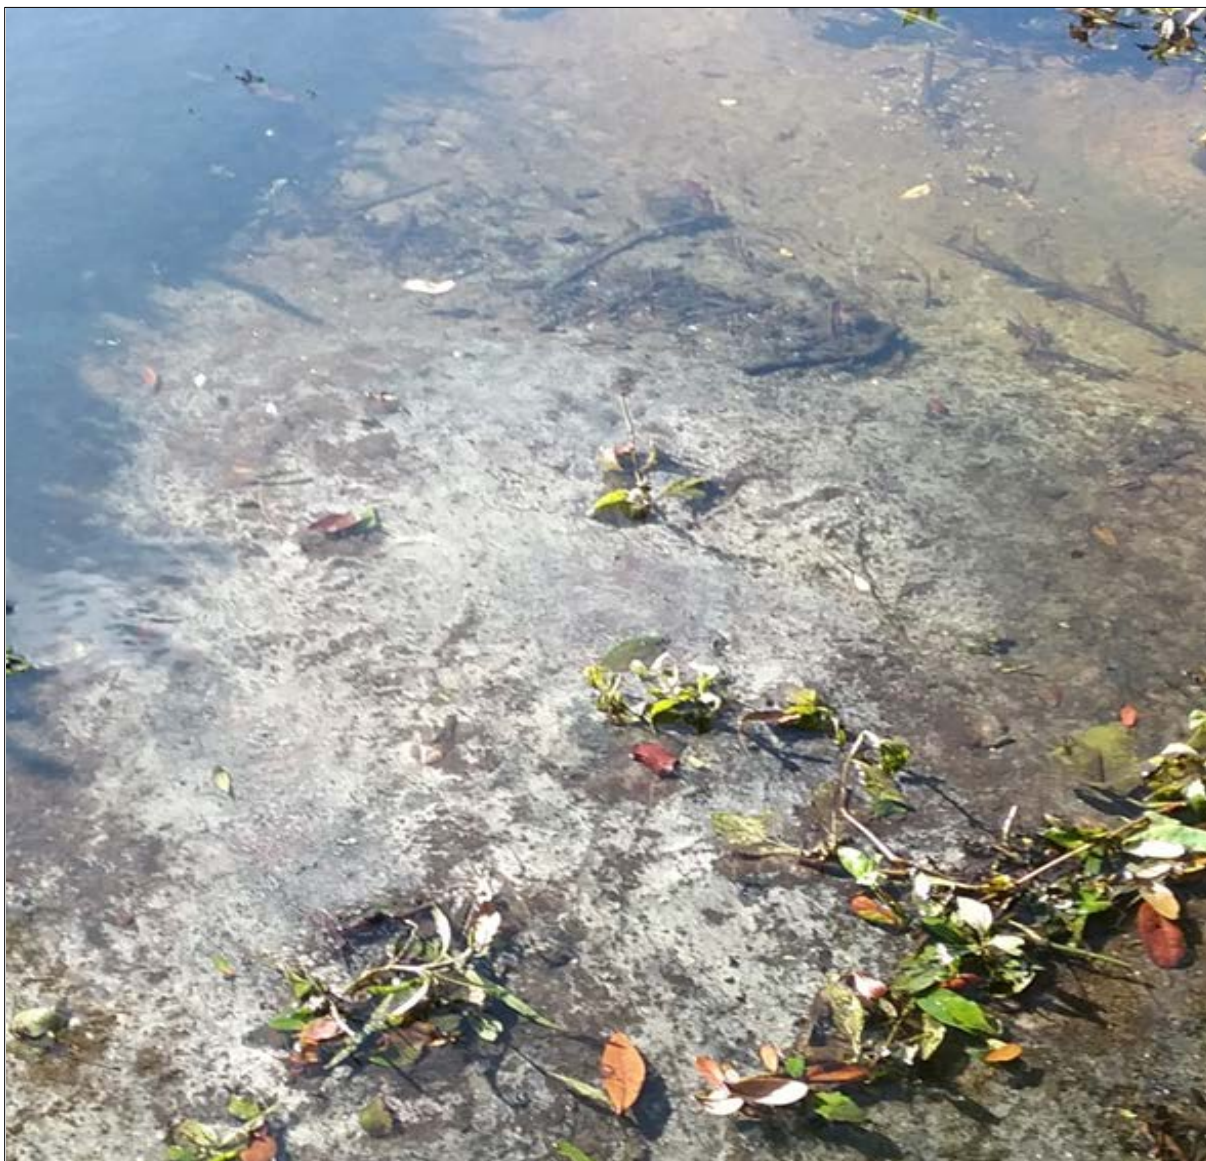
Inspector(s):	Date:	Photo Location	Photo Direction
K.O'Hara/M.Holland	12/15/2016	Same as above	SW
Comments: Showing the sediment and the white material on the sediment. This is only present after this pipe enters the canal.

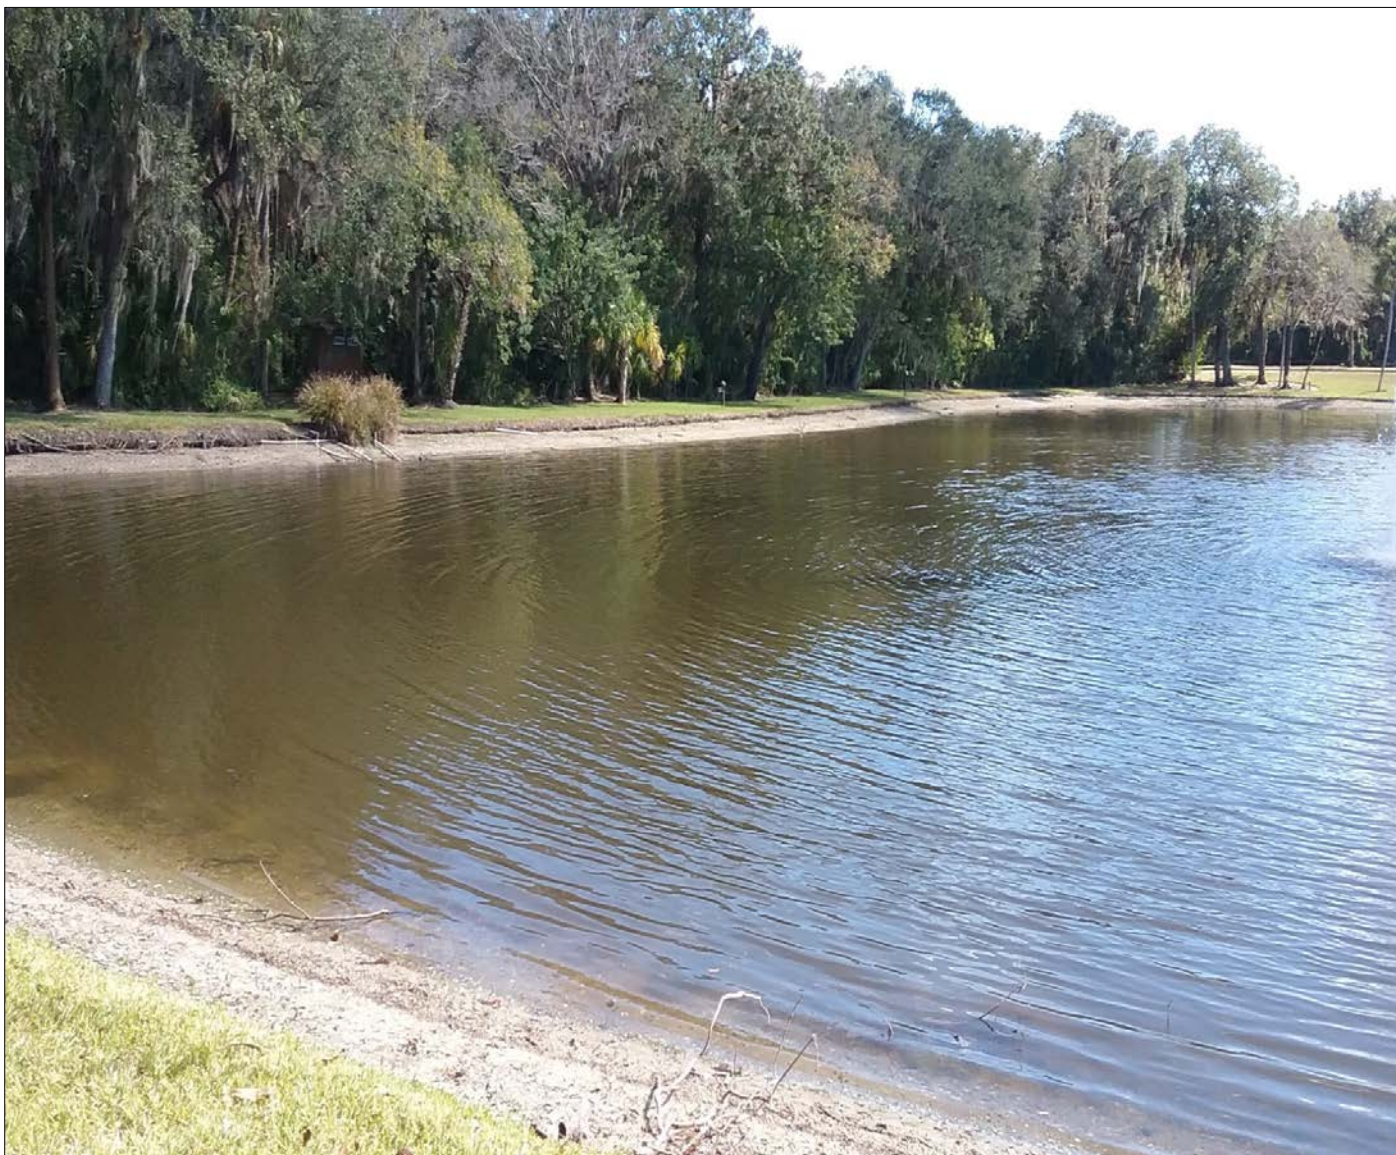
Inspector(s):	Date:	Photo Location	Photo Direction
M.Holland	1/31/2017	Pond at 17th & Longmeadow	SE

Comments: (#1)Showing a typical pond in the Meadows Subdivision. Ponds are usually well utilized by wildlife - birds and turtles. Water quality is fair, the pond is cloudy. All ponds are low from the lack of rain.
