Summary of Results

Walk the WBID Exercise for Philippi Creek
(WBID1937)

FINAL DRAFT

September 27, 2017

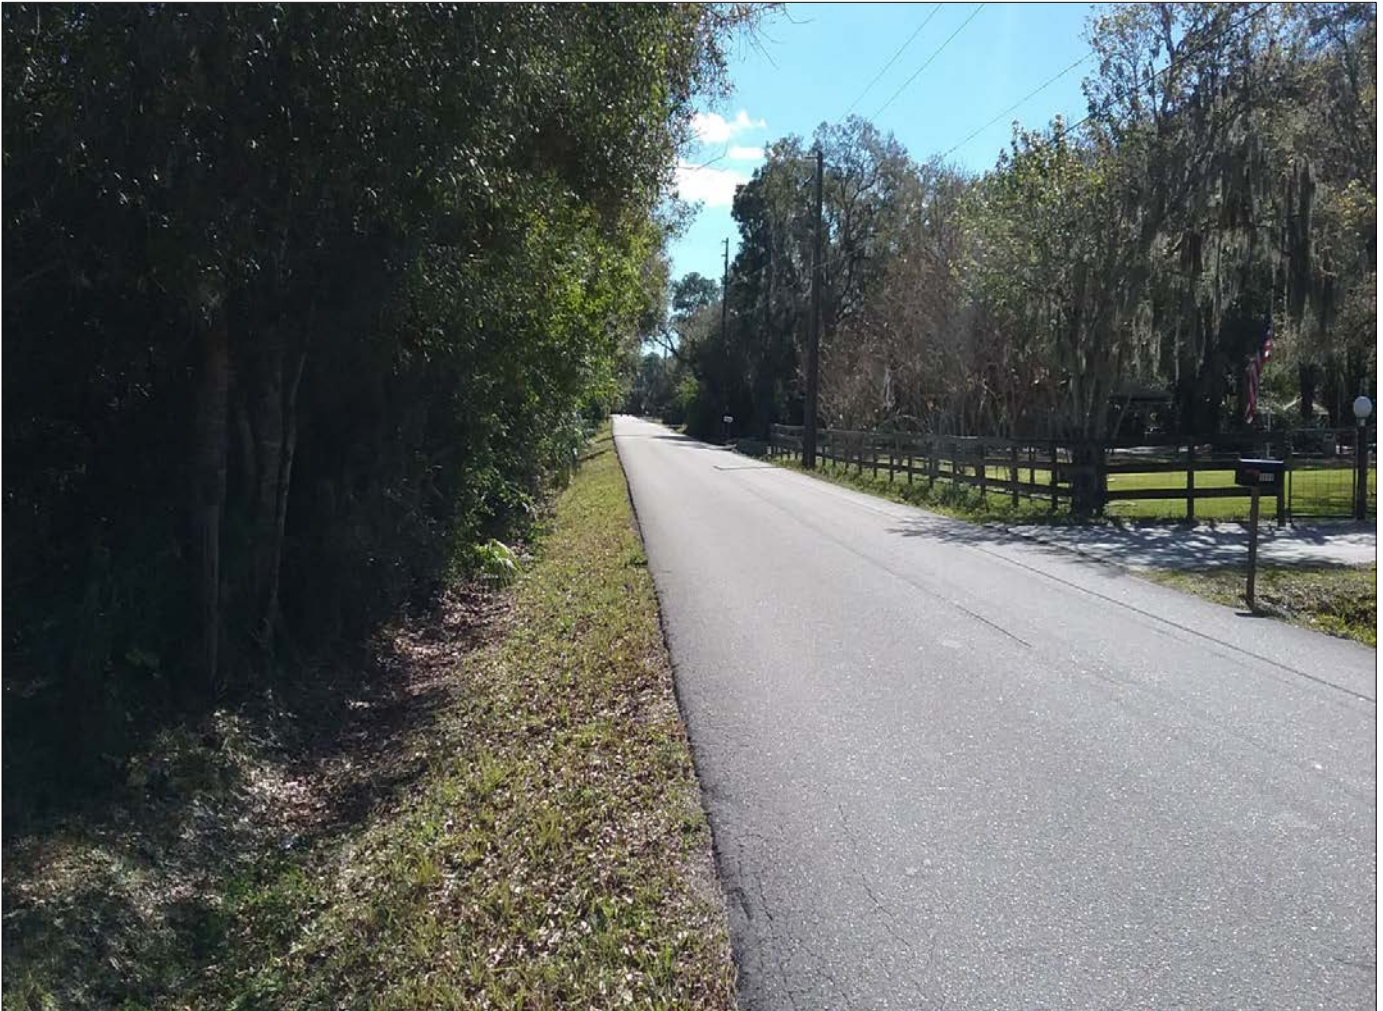
Inspector(s):	Date:	Photo Location	Photo Direction
M.Holland	1/31/2017	On Harold Ave S of Desoto	S
Comments: Showing a typical street in this neighborhood. Property sizes vary from high denisty residential to lots and larger tracts of land. With the exception of the higher density residential parcels, there is no treatment for the roadways or properties. Only 3 parcels in this area were seen to have livestock on site (horses 2-4 total; 1 pig - a very large pig).

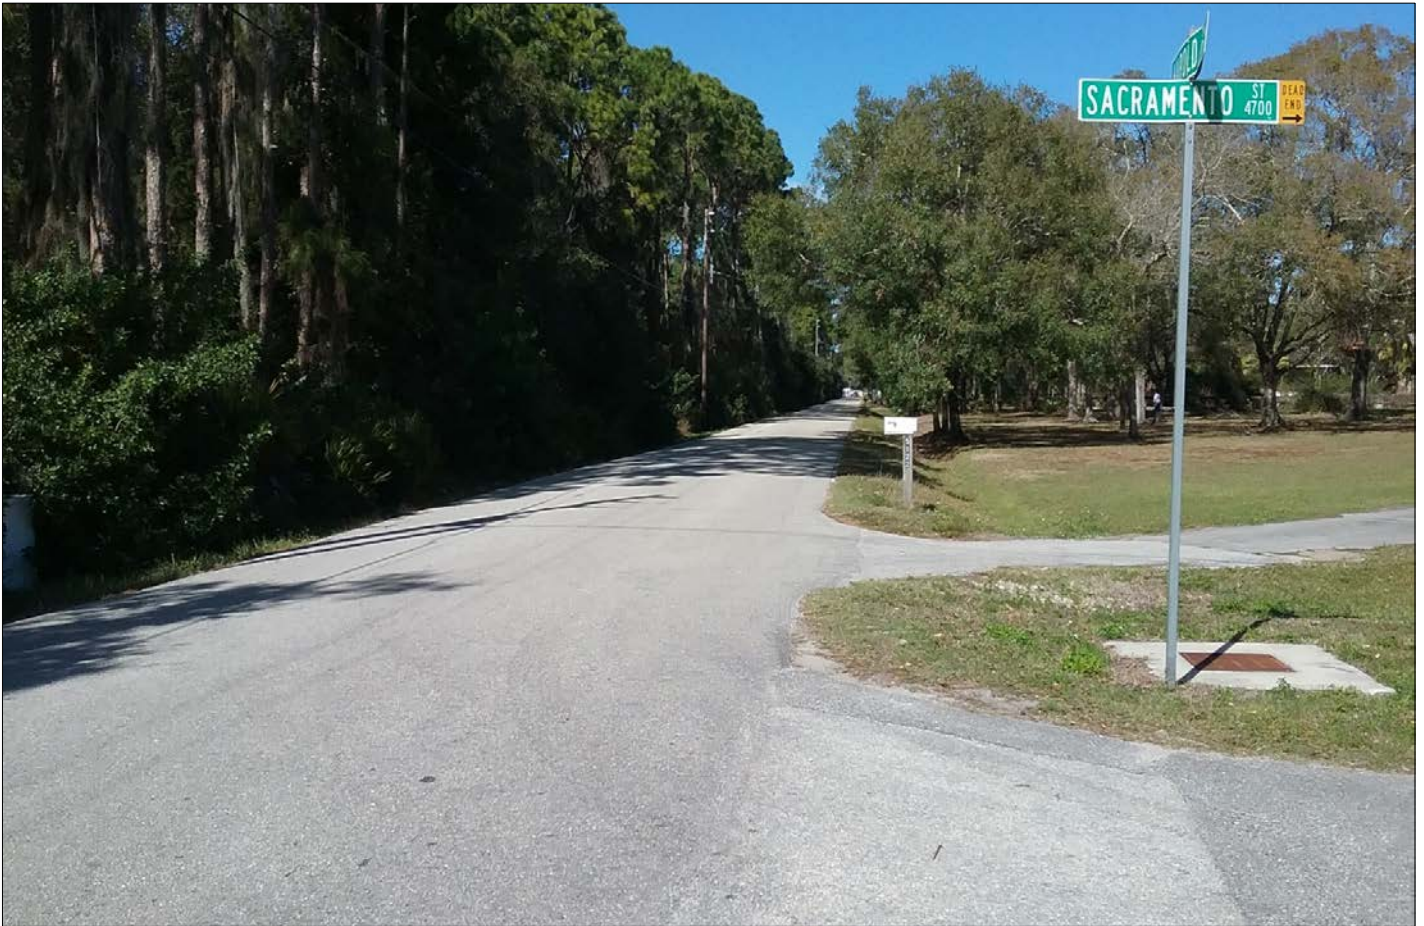
Inspector(s):	Date:	Photo Location	Photo Direction
M.Holland	1/31/2017	Intersection of above	North
Comments: (#3)Typical roadside swale in the neighborhood. All smaller swales throughout were dry. Only the large cross drains contained water. Swales and larger cross drains are well vegetated and were a mixture of sunny and shady exposure.

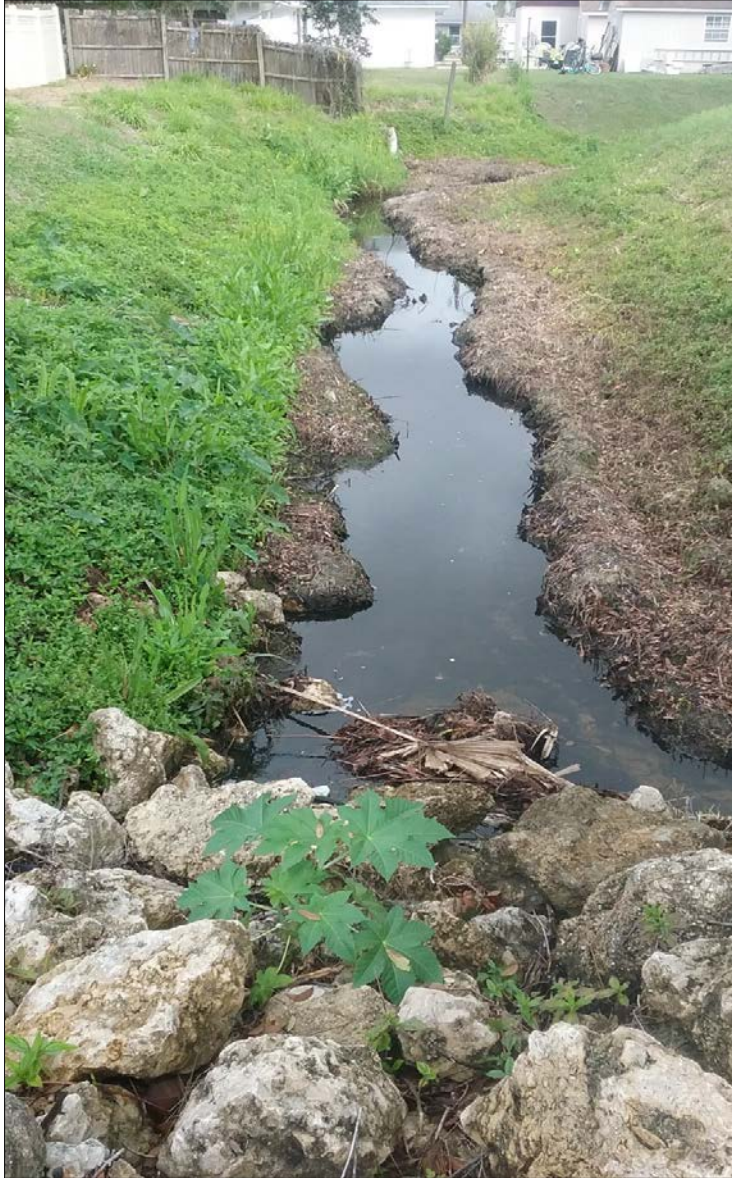
Inspector(s):	Date:	Photo Location	Photo Direction
M.Holland	2/23/2017	Seaview Street	North
Comments: (#1). Showing the ditch that flows to Phillippi Creek. Flow direction is to the south (coming towards us). Water was clear, light brown and odor free.

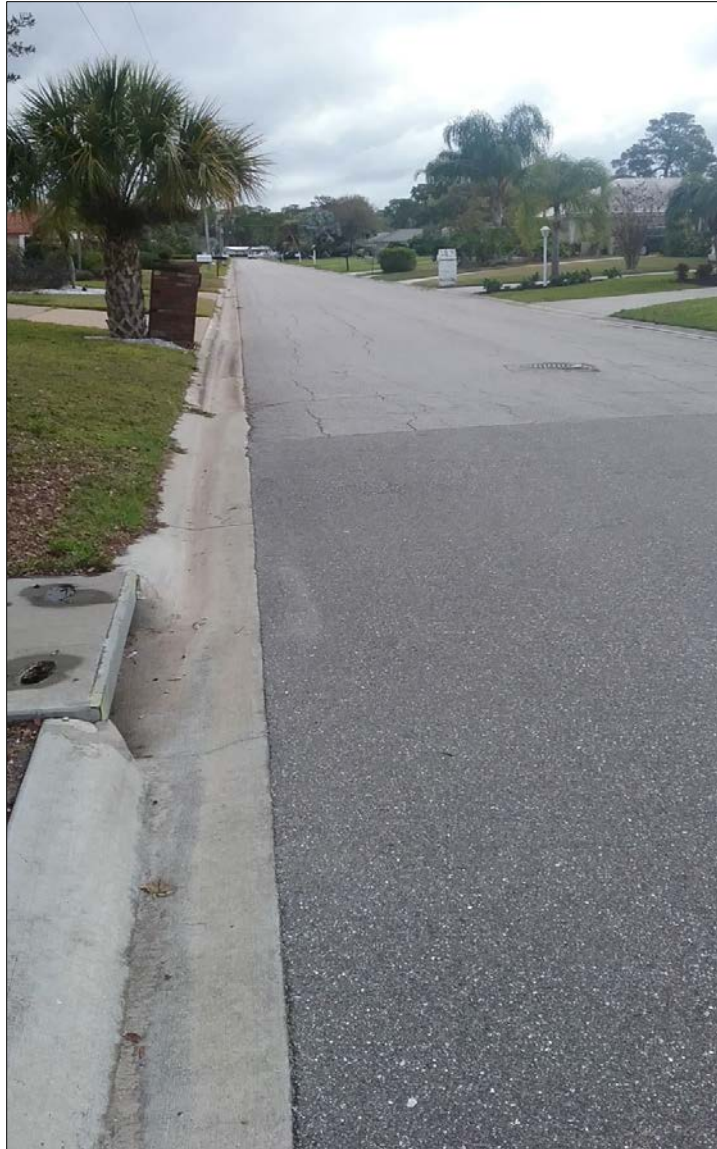
Inspector(s):	Date:	Photo Location	Photo Direction
M.Holland	2/23/2017	Seaview	West
Comments: (#1) Showing Seaview Drive. Landuse is residential, lower density. Landscapes are a varying degree of maintained. Some lawns are very lush, others not. There is evidence of the the lawn maintenance people mowing/blowing grass clippings in to the street.

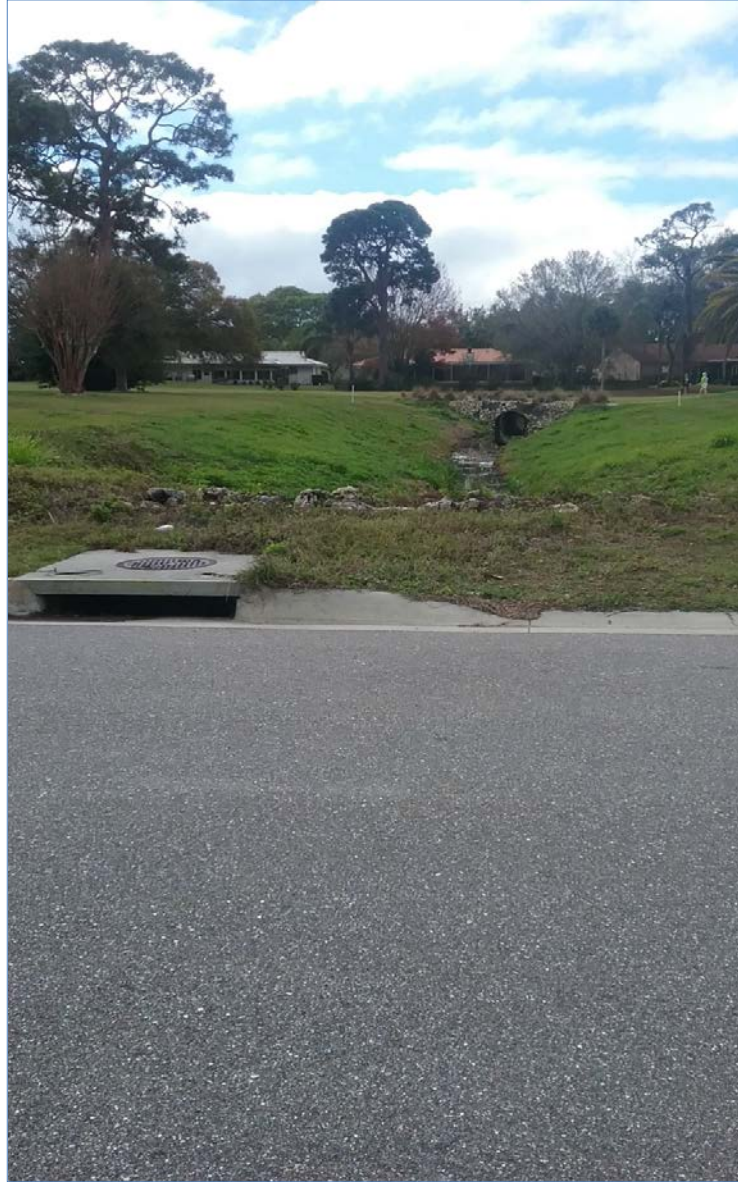
Inspector(s):	Date:	Photo Location	Photo Direction
M.Holland	2/23/2017	Seaview	South
Comments: (#1) Showing ditch south of Seaview. Area in the background is a golfcourse. The ditch makes a right hand turn after the culvert and heads to the creek.

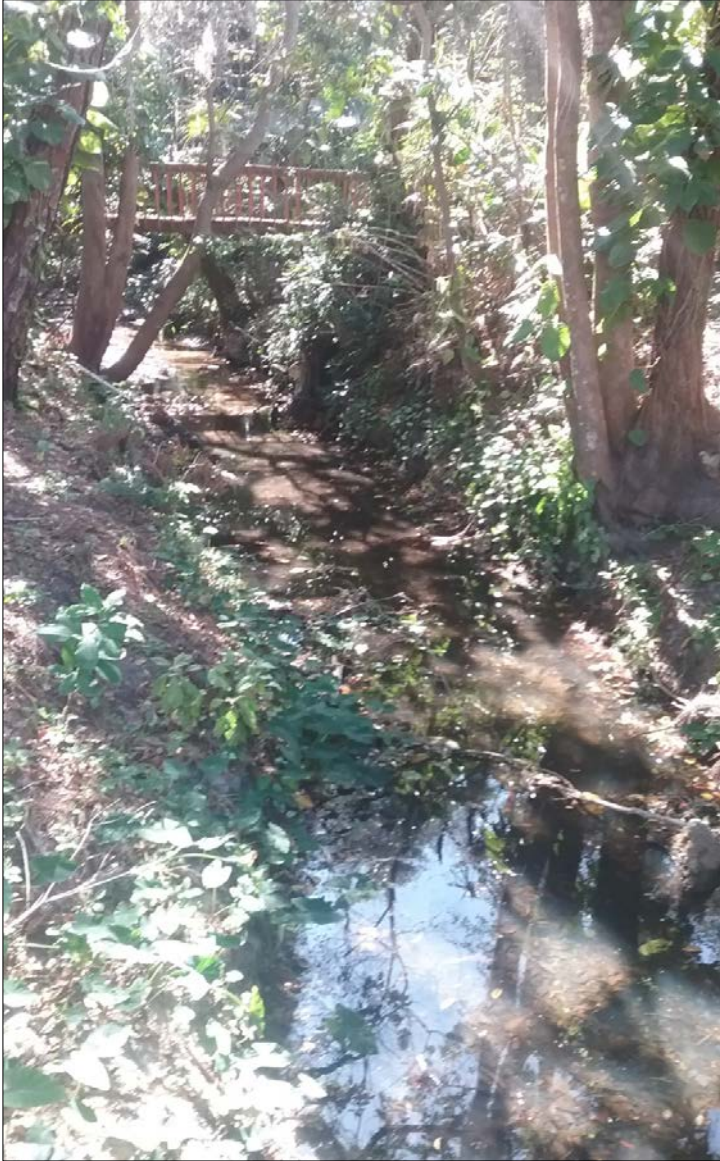
Inspector(s):	Date:	Photo Location	Photo Direction
M. Holland/J. Talbott/N.ladavia	3/1/2017	Nassau Street	South
Comments: (#1). Looking upstream. Land use is mostly residential along Red Bug Slough. Water is clear and mostly colorless. Substrate is a mix of shelly and organic matter. Side banks are steep and vegetated with N/E species. Some minnows in the water, less than 10. No apparent wildlife activity in the visible area. Properties in this area have been transitioned to the County Sewer system.

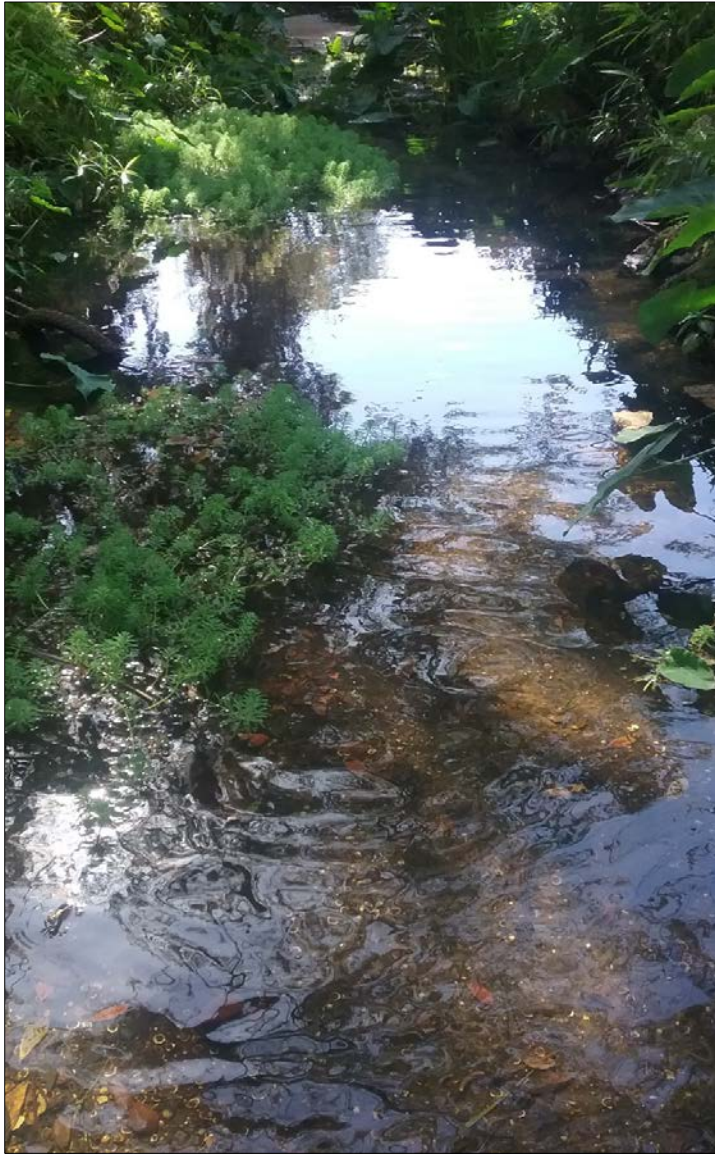
Inspector(s):	Date:	Photo Location	Photo Direction
M. Holland/J. Talbott/N.ladavia	3/1/2017	Same as above	South
Comments: (#2) Same location as above, just closer.

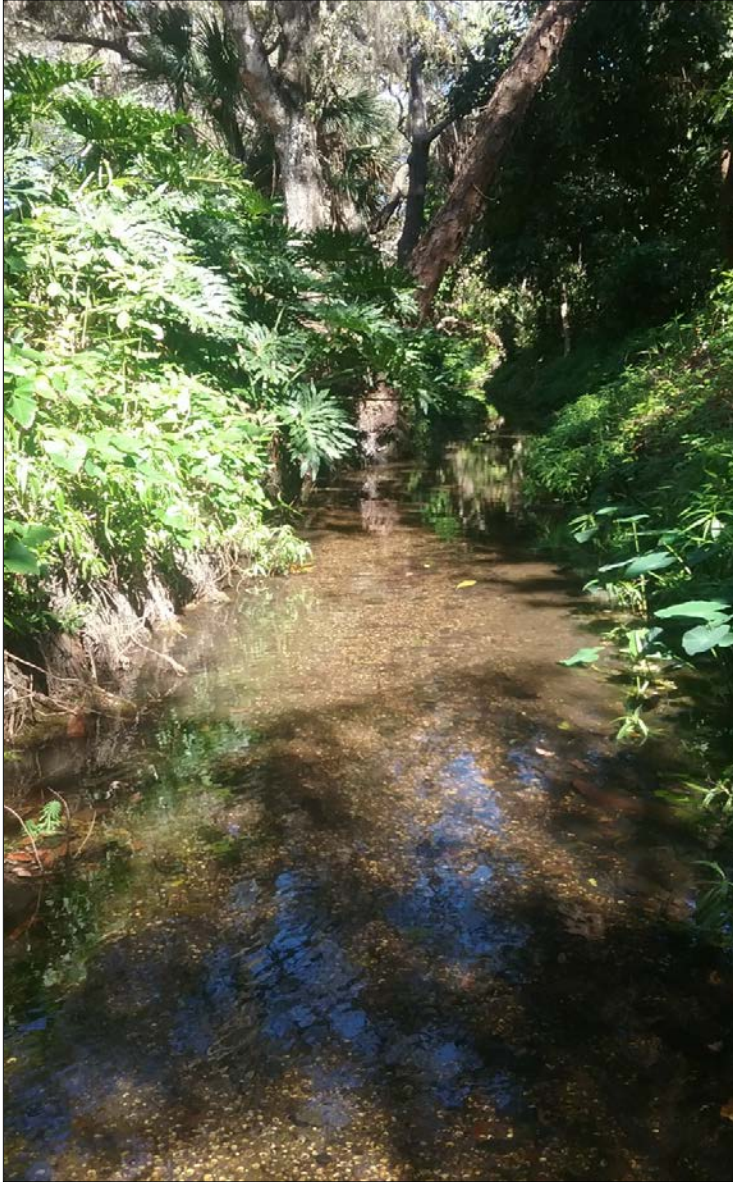
Inspector(s):	Date:	Photo Location	Photo Direction
M. Holland/J. Talbott/N.ladavia	3/1/2017	Same as above	North
Comments: (#2) Looking further up stream. Sampling spot where E.coli is elevated is just upstream from this point, about 700 ft. The slough is mostly shaded the entire way.

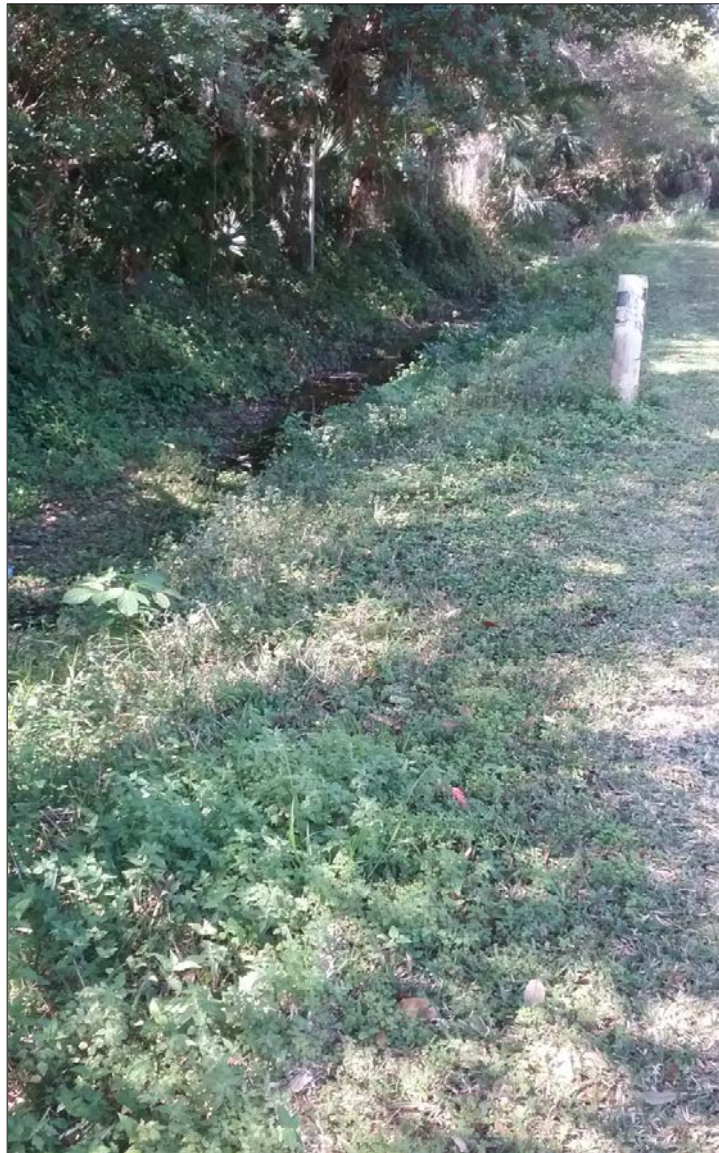
Inspector(s):	Date:	Photo Location	Photo Direction
M. Holland/J. Talbott/N.ladavia	3/1/2017	S end of Worcester Rd	West
Comments: (#3). Showing the ditch that runs east/west at the end of Worcester. Water was low, but moving. The ditch was heavily vegetated. Substrated was a mix of sand and muck.

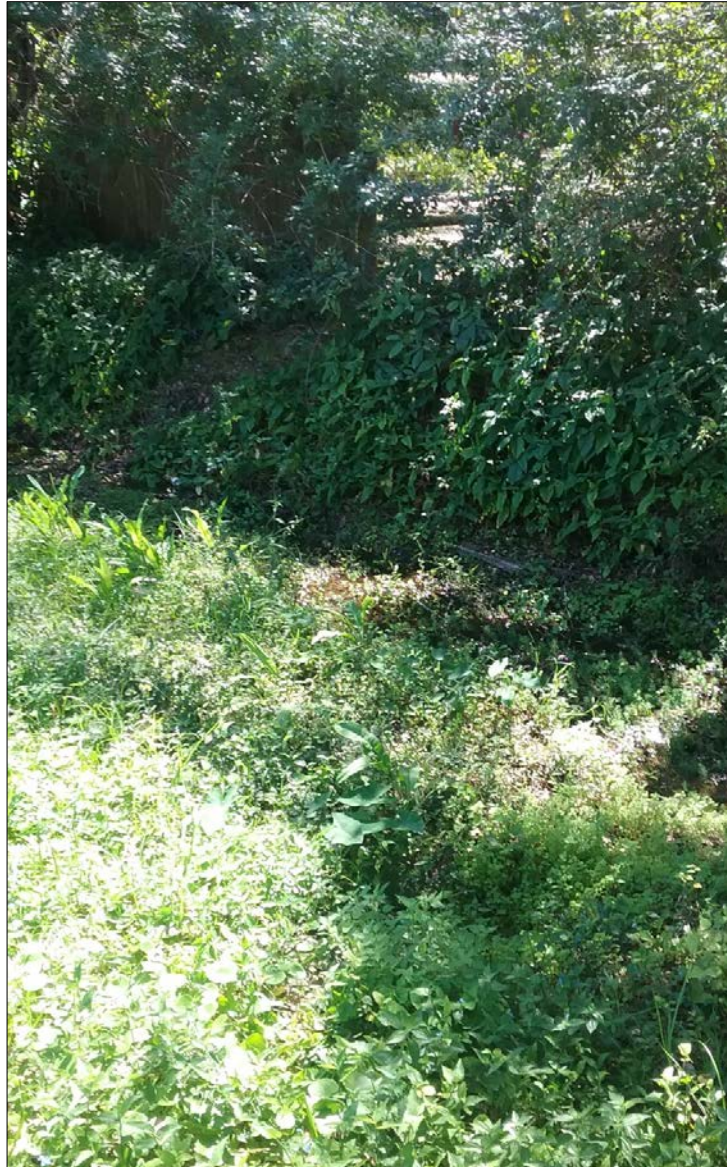
Inspector(s):	Date:	Photo Location	Photo Direction
M. Holland/J. Talbott/N.ladavia	3/1/2017	Same as above	East
Comments: (#3). Just to the east of this location, you can see the ditch is a mix of sun and shade. The ditch is heavily vegetated on both slopes, as well as a bit in the flow way.

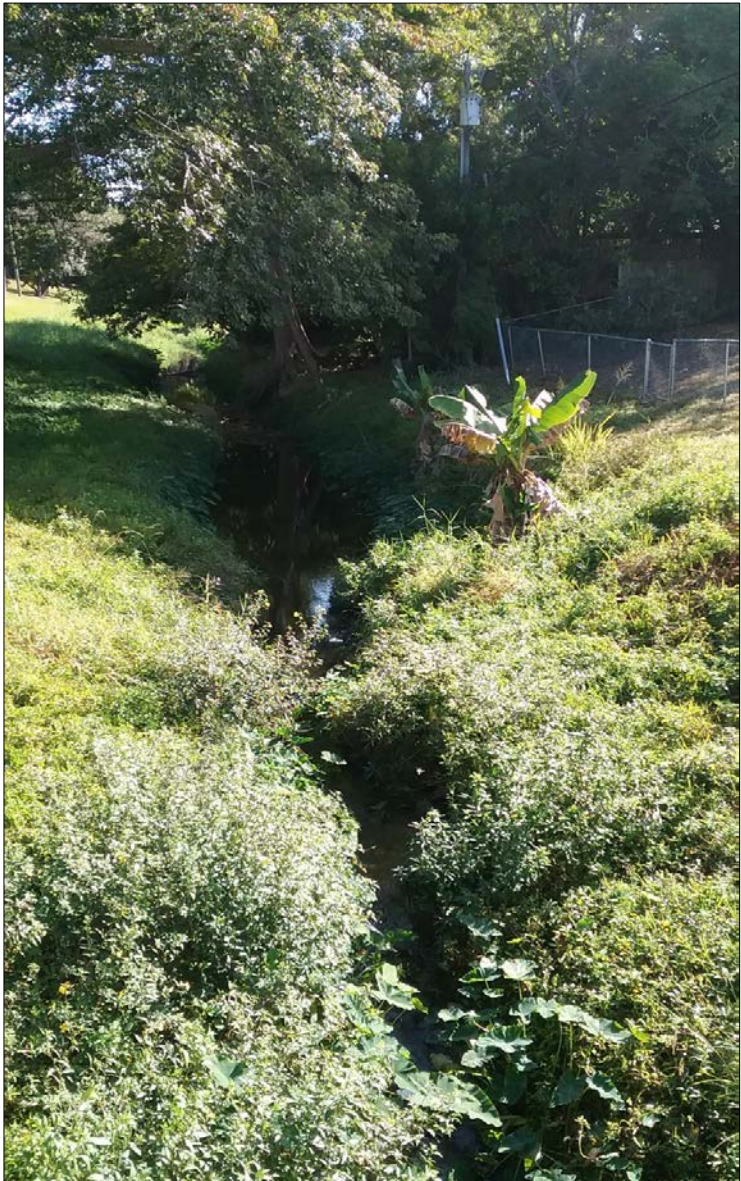
Inspector(s):	Date:	Photo Location	Photo Direction
M. Holland/A. Melton	11/29/2016	Tuttle South of Sunnyside	East
Comment: Looking east along the drainage ditch. Ditch is pretty heavily vegetated and shaded about half the time. Homes along the ditch are pretty well maintained. Heavily travelled game trails were not seen.

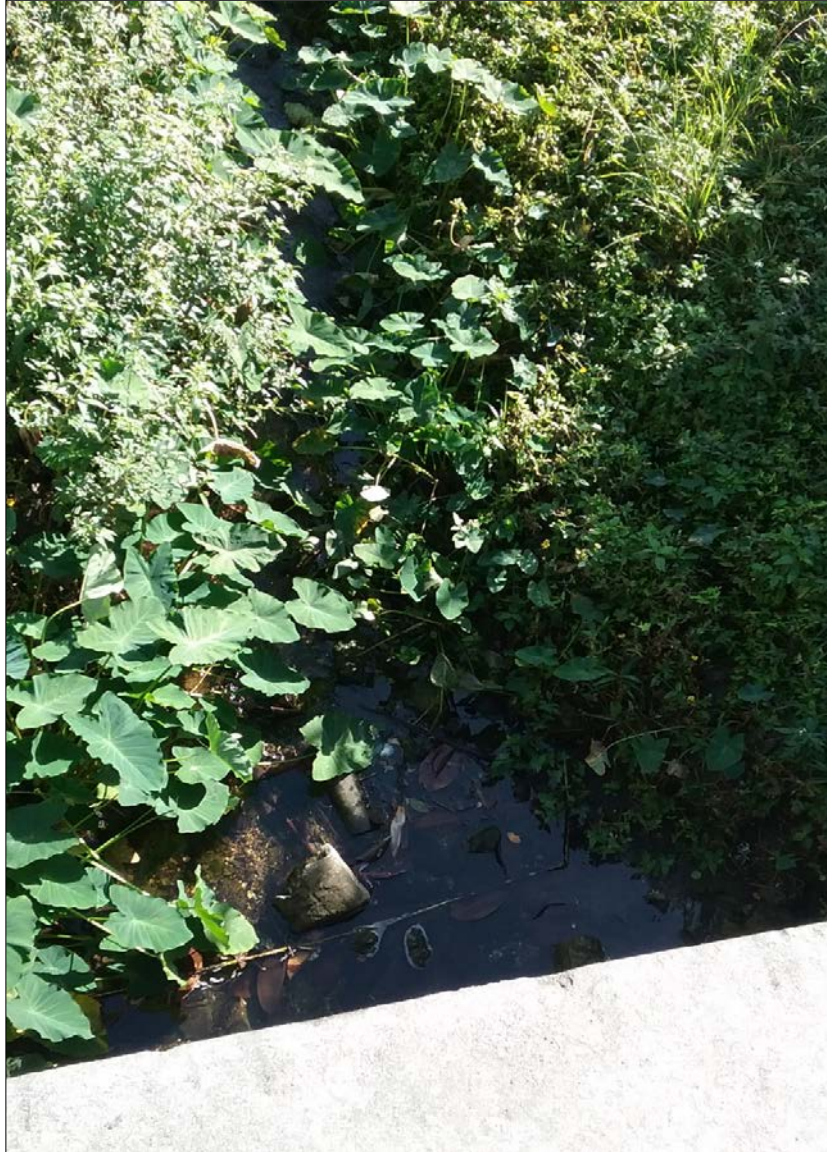
Inspector(s):	Date:	Photo Location	Photo Direction
M. Holland/A. Melton	11/29/2016	Same as above	East
Comments: Showing the general appearance of the ditch bottom. Vegetation is mostly nuisance exotic species and emergent in nature. We were unable to determine if this area is heavily travelled by wildlife due to the vegetation. A sample was taken here.

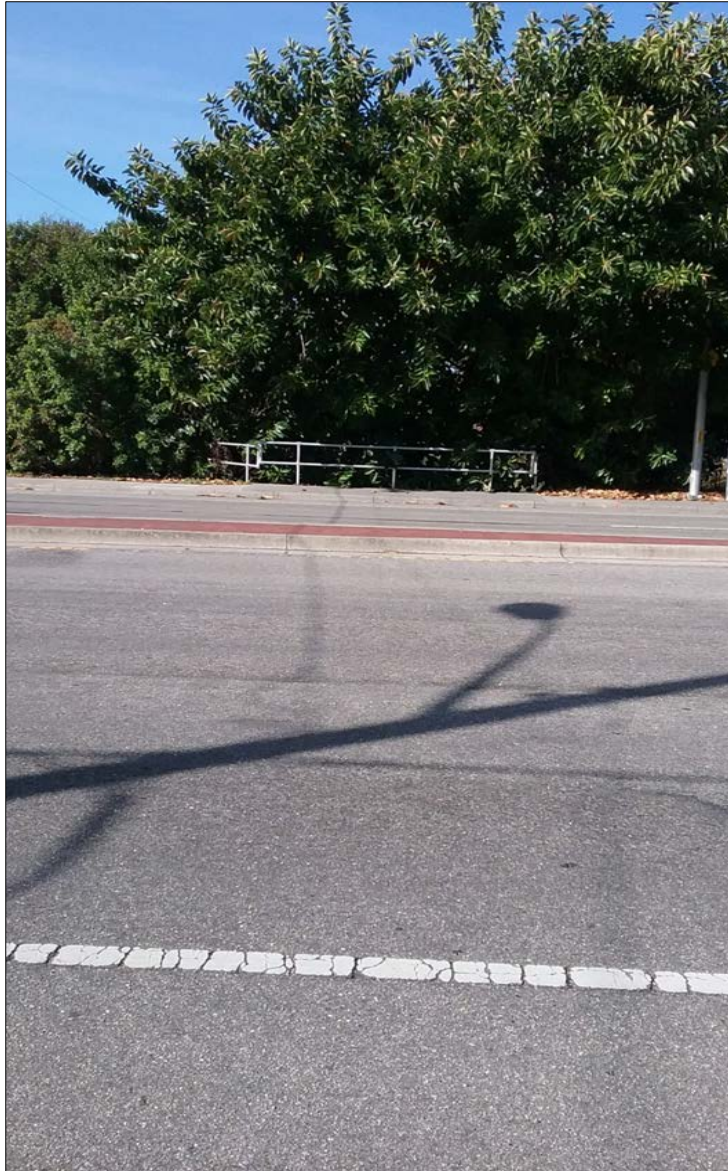
Inspector(s):	Date:	Photo Location	Photo Direction
M. Holland/A. Melton	11/29/2016	Same as above	West
Comments: Showing the west side of the road. Because of the heavy vegetation at the rail, we were not able to determine the status of the ditch on the west side of Tuttle.

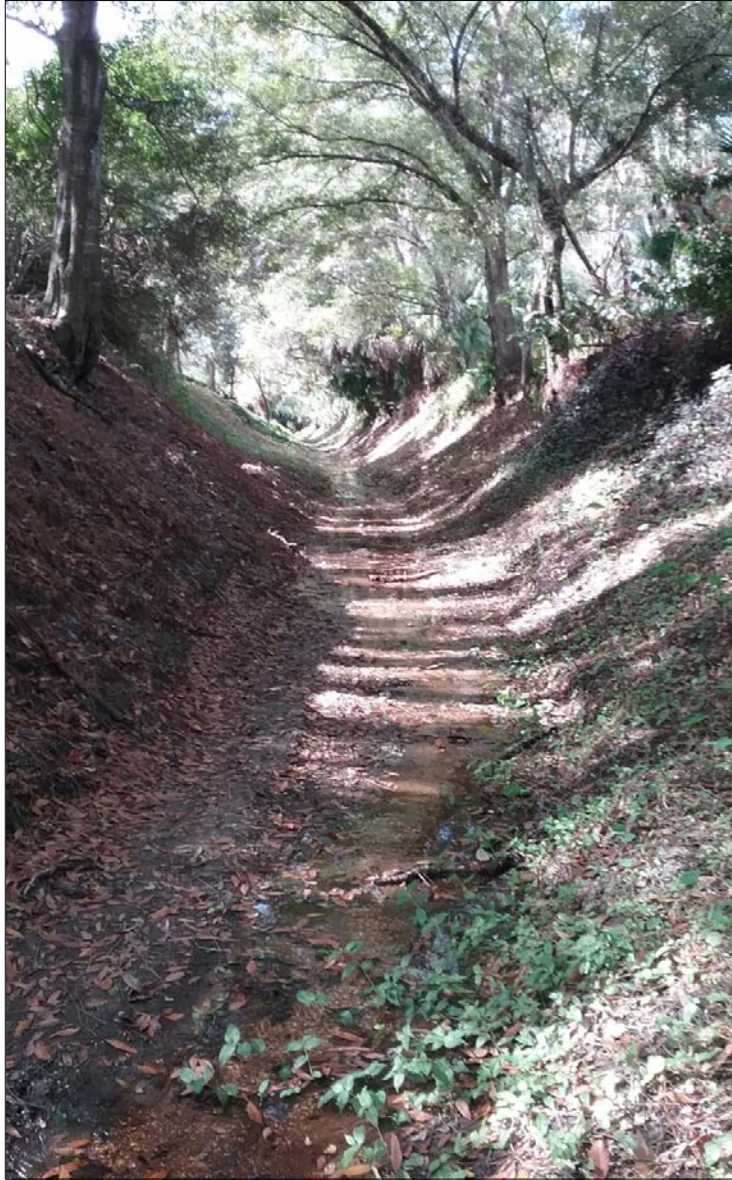
Inspector(s):	Date:	Photo Location	Photo Direction
M. Holland	11/29/2016	Ditch 4-98.2	West
Comments: Looking west along the ditch. The top of bank is mostly vegetated, shading the ditch. The water was barely flowing, just a few inches deep. The slopes were very steep the entire length.

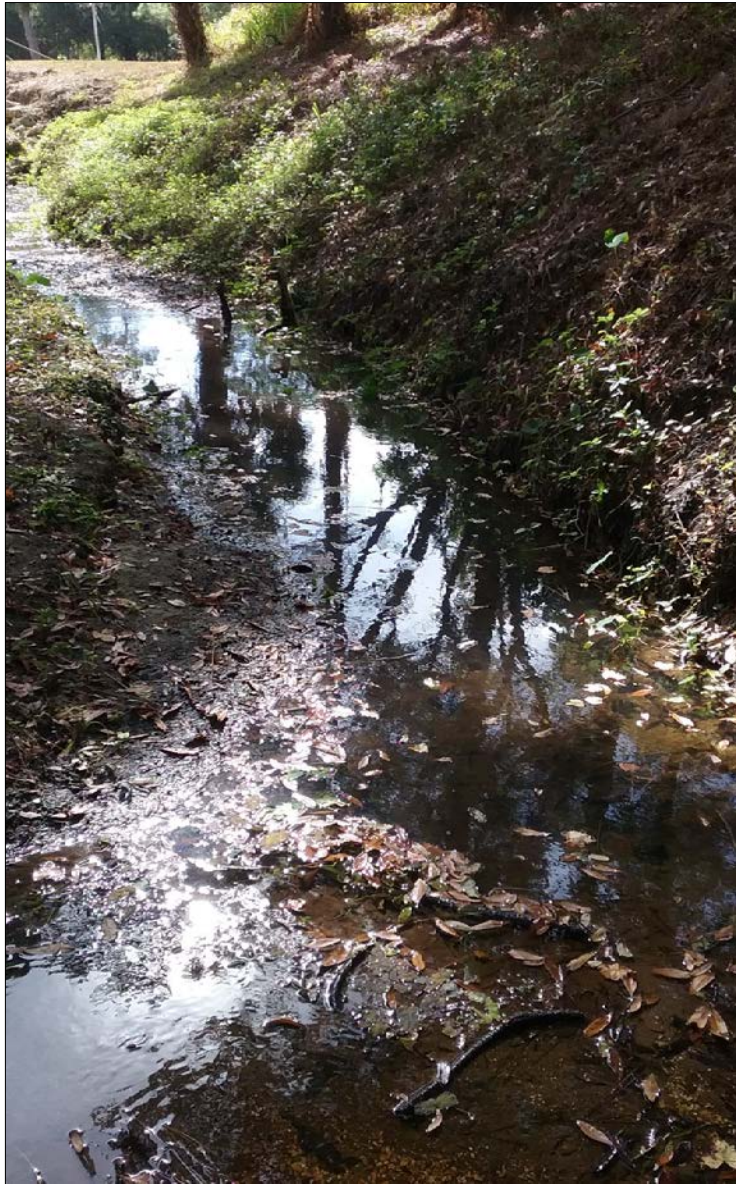
Inspector(s):	Date:	Photo Location	Photo Direction
M. Holland	11/29/2016	4-107.1	South

Comments: Looking at the conveyance ditch as it enters in to 4-98.2, 4-98.3. Residences 2 streets over - Stratford Dr - have been transitioned to sewer from on site septic. Residences from this ditch eastward still utilize on site septic systems.

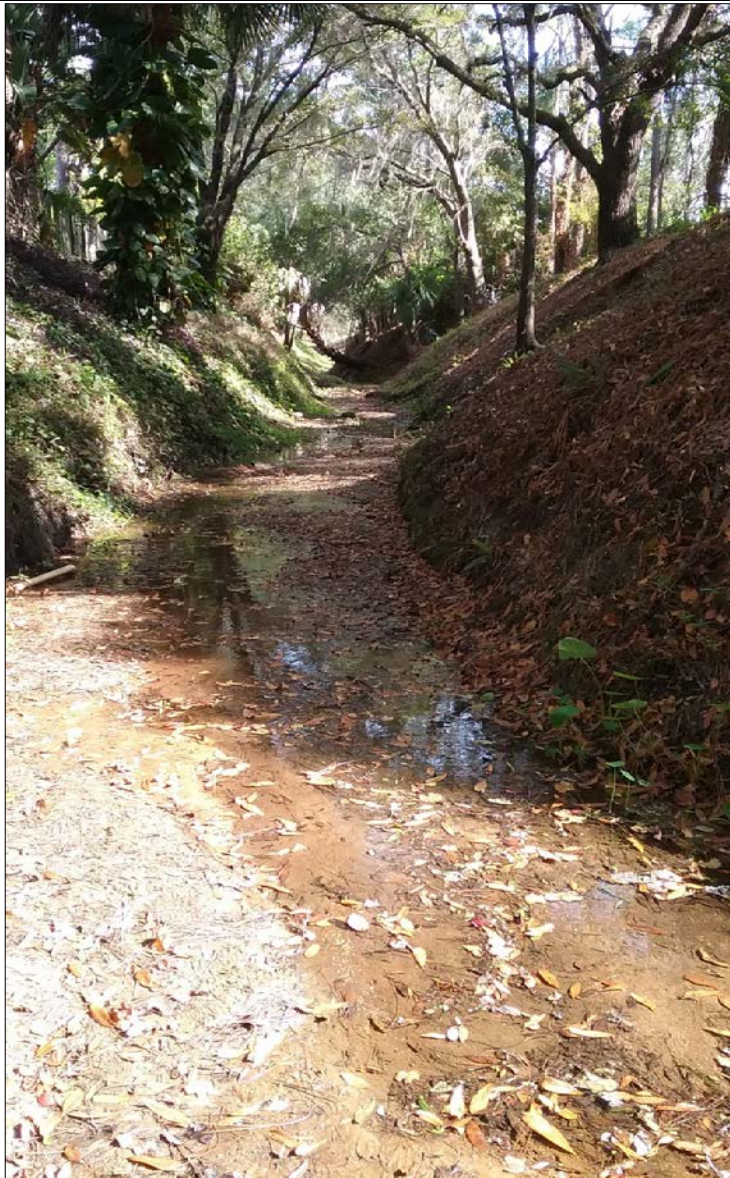
Inspector(s):	Date:	Photo Location	Photo Direction
M. Holland	11/29/2016	Same as above	East

Comments: looking east along 4-98.1. Water is barely moving in the ditch. Lots of leaf litter in the bottom of the ditch. The ditch along most of the length is completely shaded. The ditch bottom is mostly sand, with occasional patches of muck deposited throughout. Some wildlife tracks (raccoon) were visible, but difficult to tell because of the leaf litter. There are a few instances where black, flexible piping comes in to the ditch. These pipes are most likely from roof drains, but it was difficult to tell.

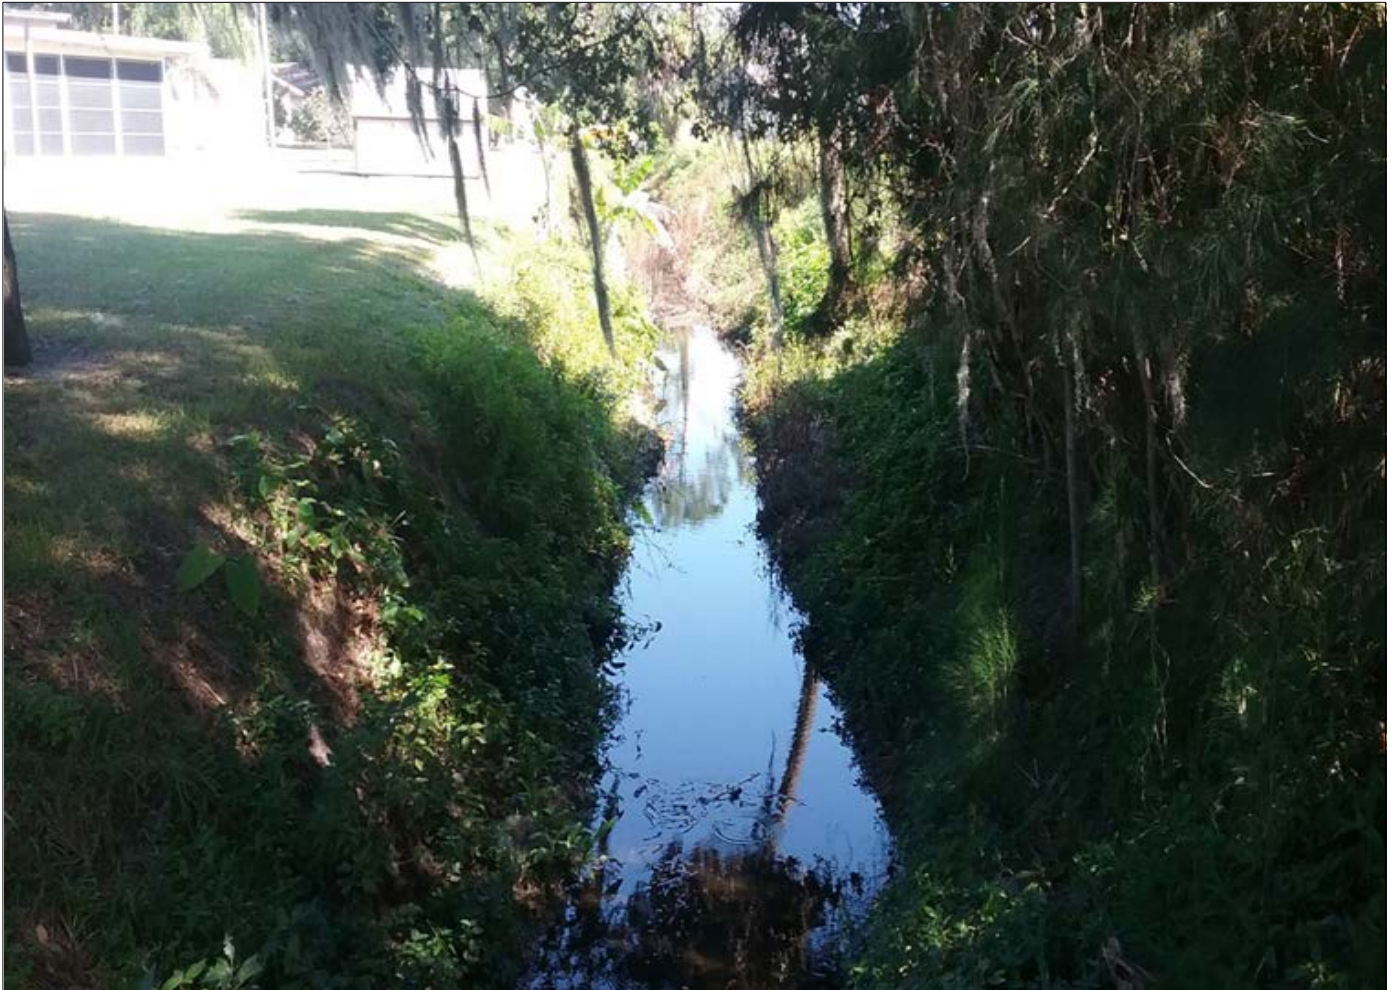
Inspector(s):	Date:	Photo Location	Photo Direction
A.Melton/M.Holland	11/16/2016	End of Schrock St.	NE
Comments: (#1*)Showing the canal it flows west through residential areas. There is a foot bridge that crosses the canal at the end of Schrock Street and Hines Ave. Homes in this area are small but well maintained. There is no treatment for stormwater in this area, direct discharge to the canal, then to Phillippi Creek.

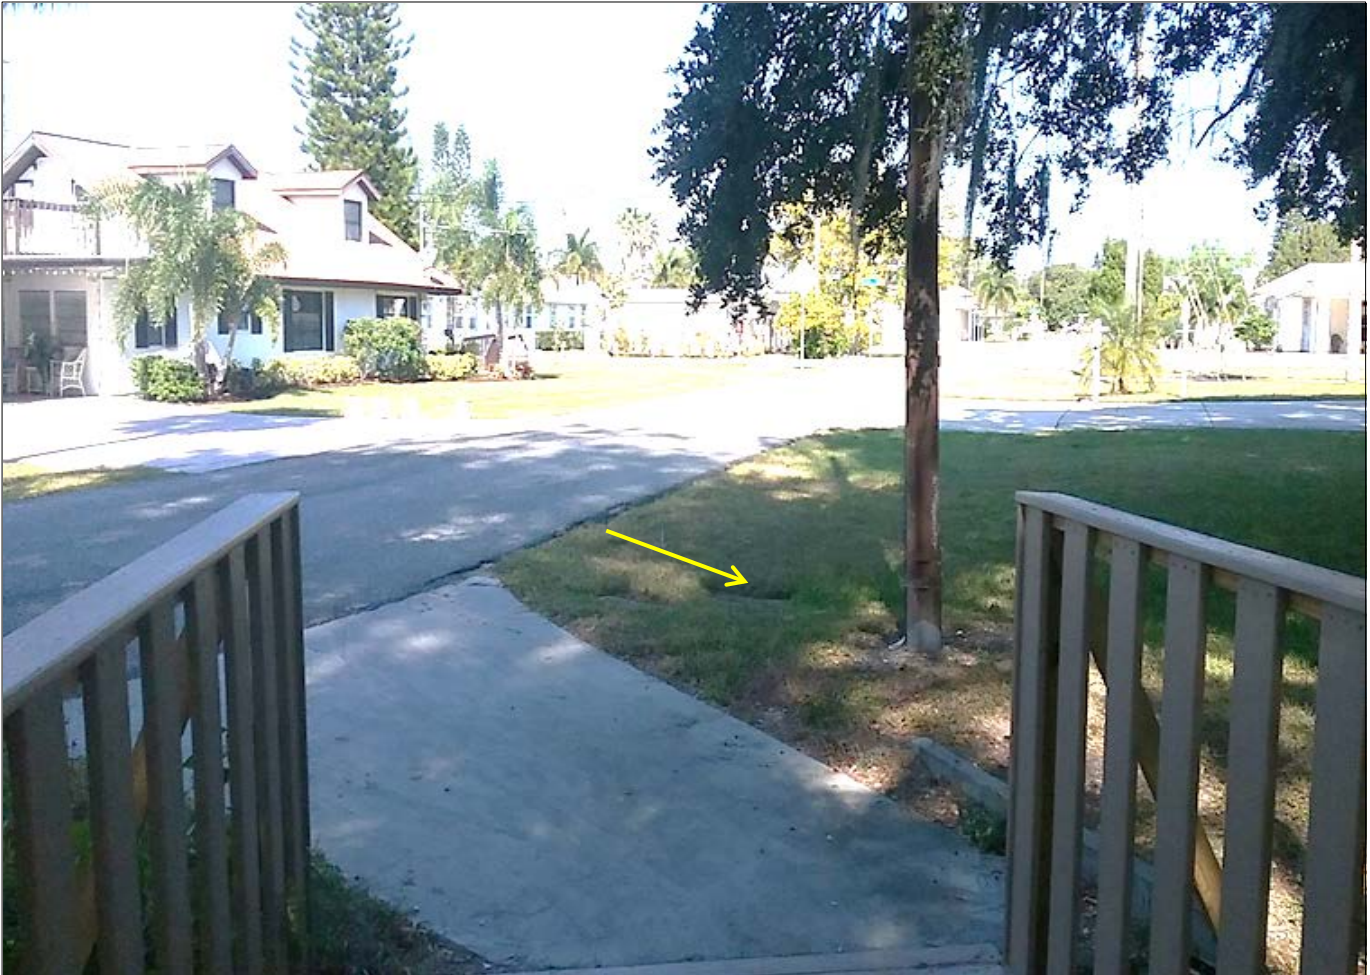
Inspector(s):	Date:	Photo Location	Photo Direction
A.Melton/M.Holland	11/16/2016	End of Hines Ave	North
Comments: To the left and right of this footbridge there are pipes that accept roadway and yard runoff, then discharge stormwater from this area into the canal. Inlet location is shown by the yellow arrow.

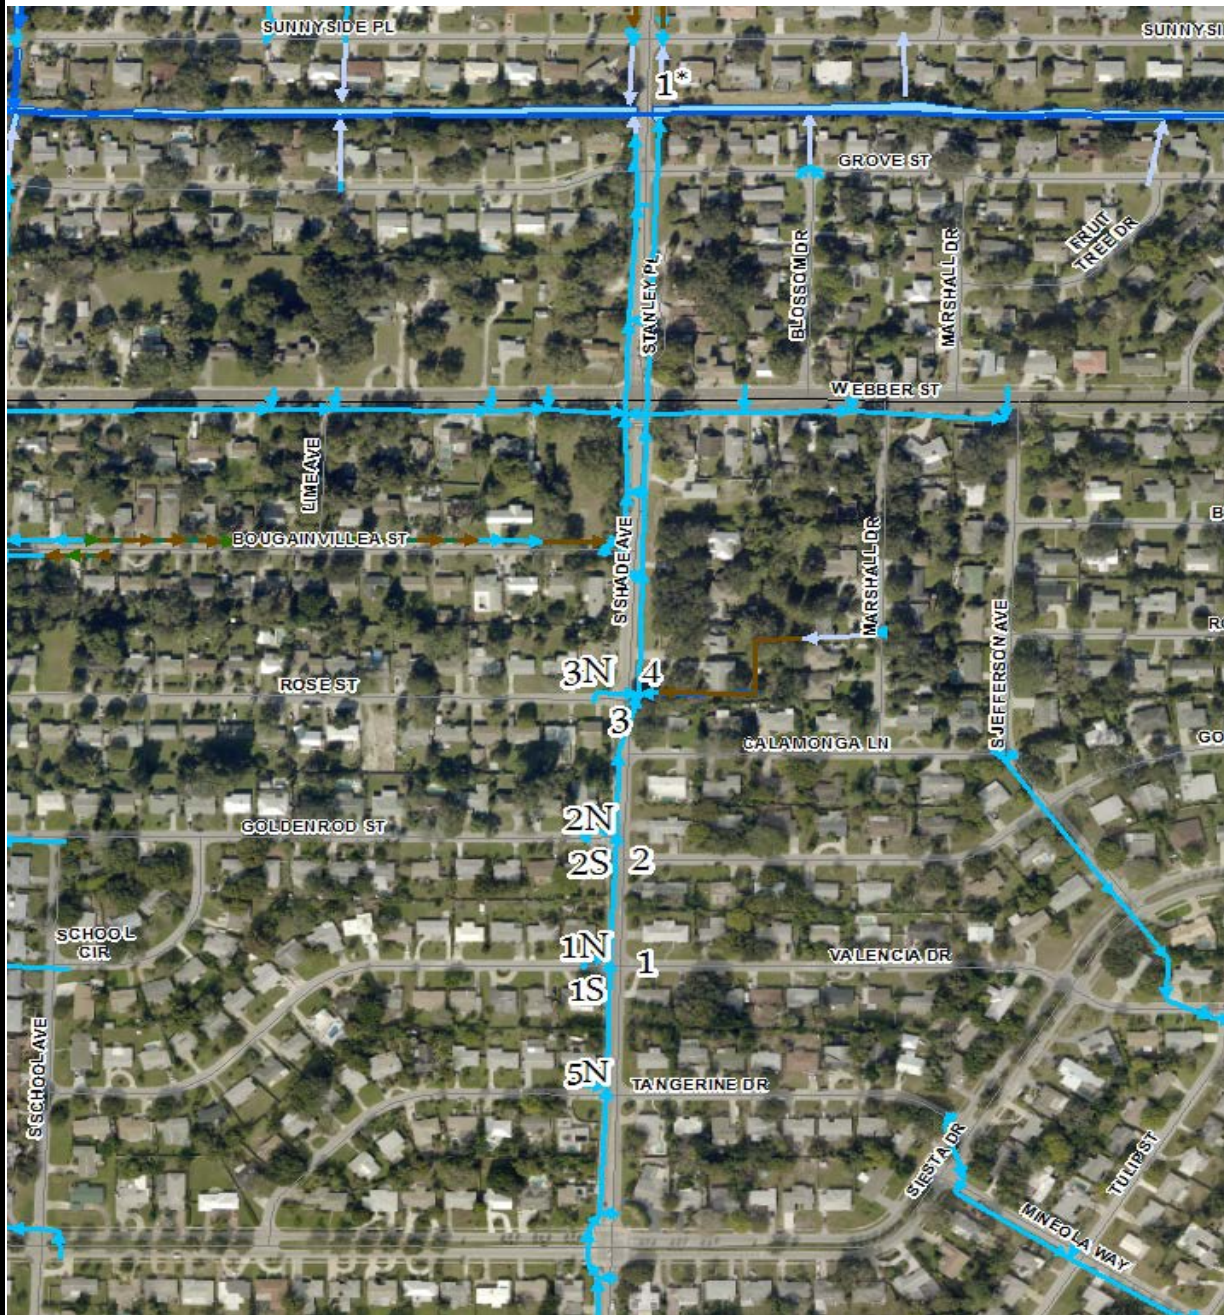
This follow up site visit occurred as a follow up to a documented discharge from a pipe in the ditch on the east side of South Shade Ave, between Grove Street and Sunnyside Street on 11/29/2016. Despite the fact that rain had been minimal, water was flowing from the pipe. Water discharging from the pipe had a biofilm, slightly elevated levels of bacteria, and a ferric precipitate. The area visited is residential and homes are well maintained. Residences in this area have been transitioned from on site septic systems to sewer systems. There was evidence of dog walking (not picking up pet waste) and improper placement of garbage cans (on top of the curb inlets). The map of the investigated area is below.

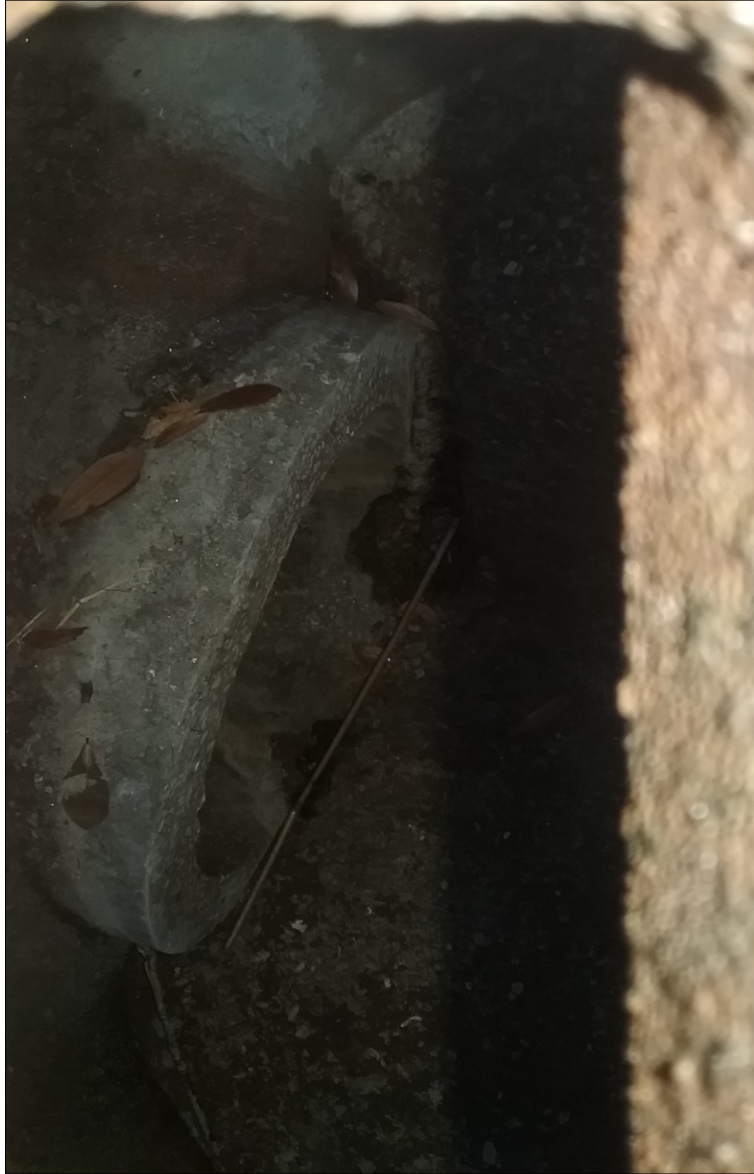
Inspector(s):	Date:	Photo Location	Photo Direction
M. Holland	12/7/2016	South Curb Inlet at Valencia	N/A
Comments: (1S) Curb inlet west of Sough Shade on Valencia. Trash cans on this inlet awaiting pick up. Inlet was dry and free from trash, leaves and sediment. No musty/odd odor was detected.

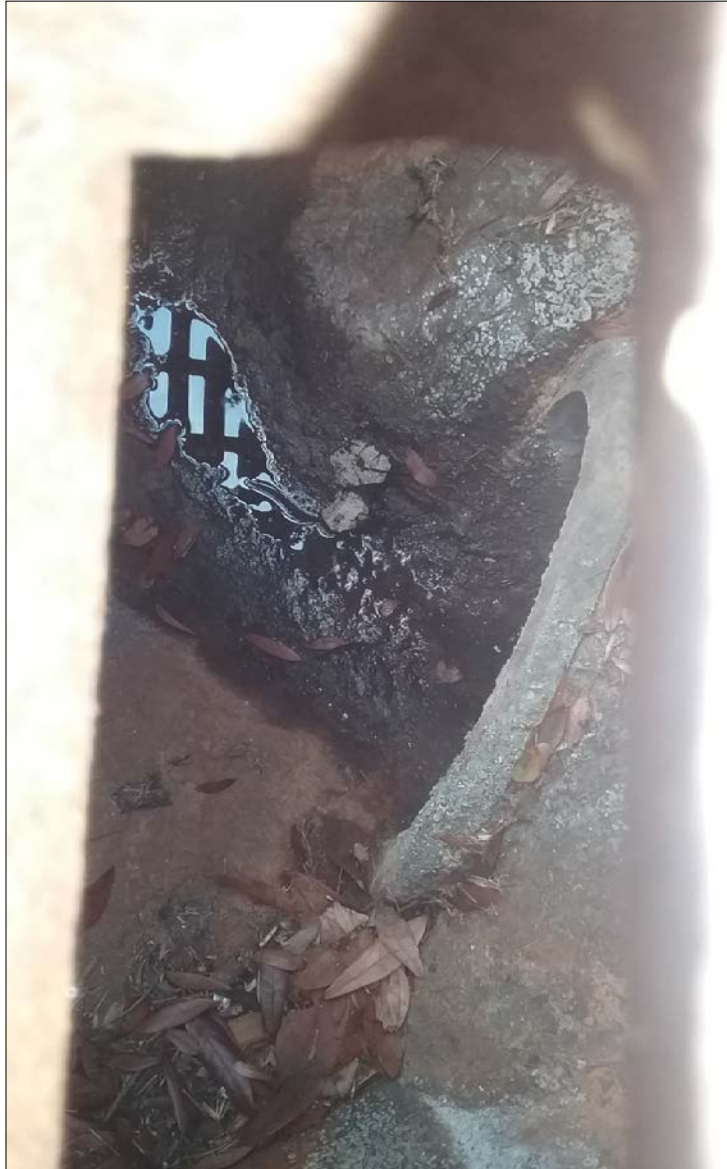
Inspector(s):	Date:	Photo Location	Photo Direction
M. Holland	12/7/2016	North Curb Inlet on Valencia	N/A
Comments: (1N) Some water (likely from lawn irrigation) and some leaves, decomposing vegetation in this inlet. No musty/odd odor was detected in this inlet.
