Summary of Results

Walk the WBID Exercise for Philippi Creek
(WBID1937)

FINAL DRAFT

September 27, 2017

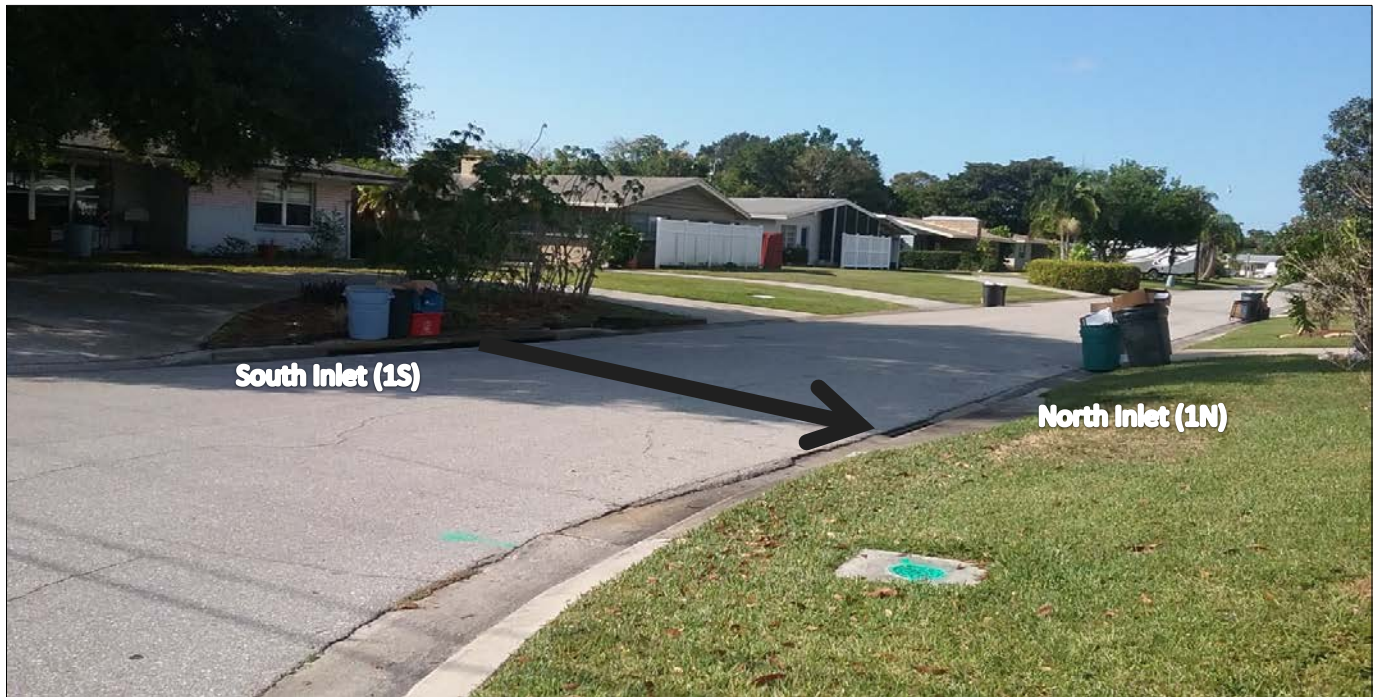
Inspector(s):	Date:	Photo Location	Photo Direction
M. Holland	12/7/2016	Valencia and S. Shade	West
Comments: (1) Showing the North and South Inlets on Valencia at South Shade. Homes in this area are generally well maintained. Large arrow indicates pipe location and flow direction.

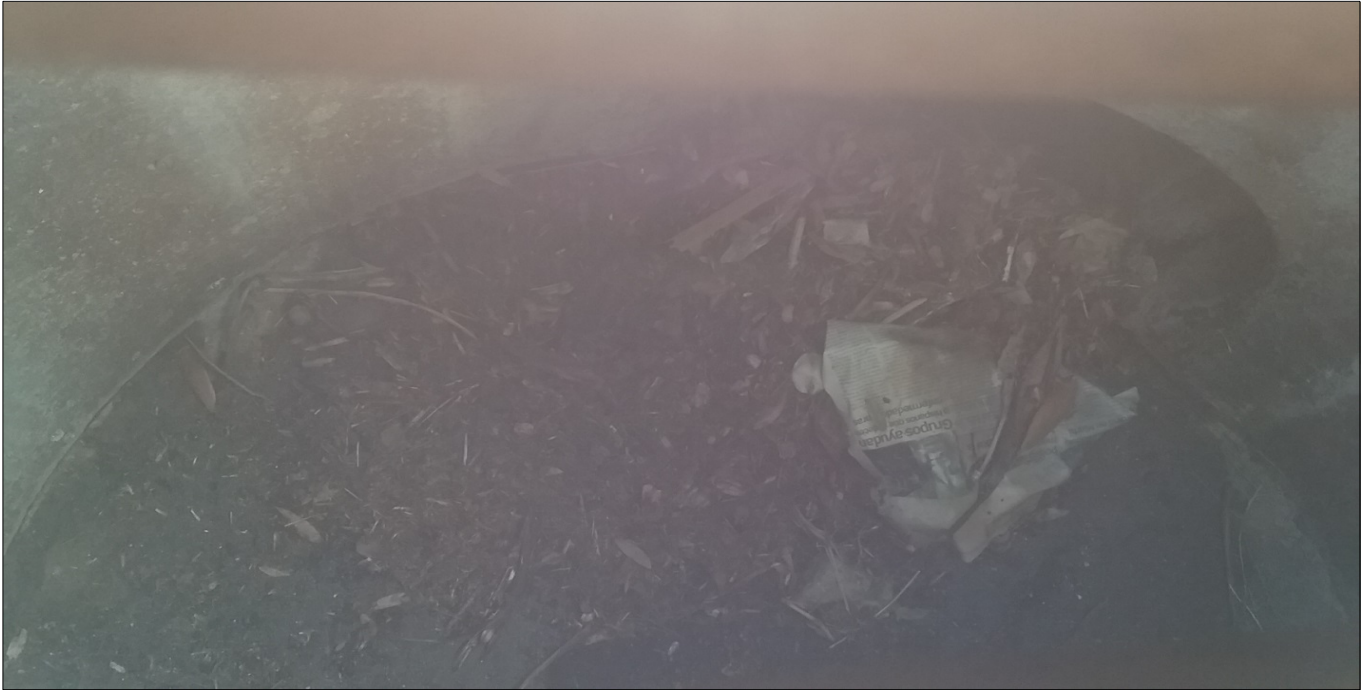
Inspector(s):	Date:	Photo Location	Photo Direction
M. Holland	12/7/2016	South Goldenrod Street	N/A
Comments: (2S). Showing the south inlet on Goldenrod street west of South Shade. The inlet has accumulated sediment, leaves and trash (about 2 inches deep in a 15 inch pipe). Garbage cans present around the inlet. No unusual musty/odd odor however.

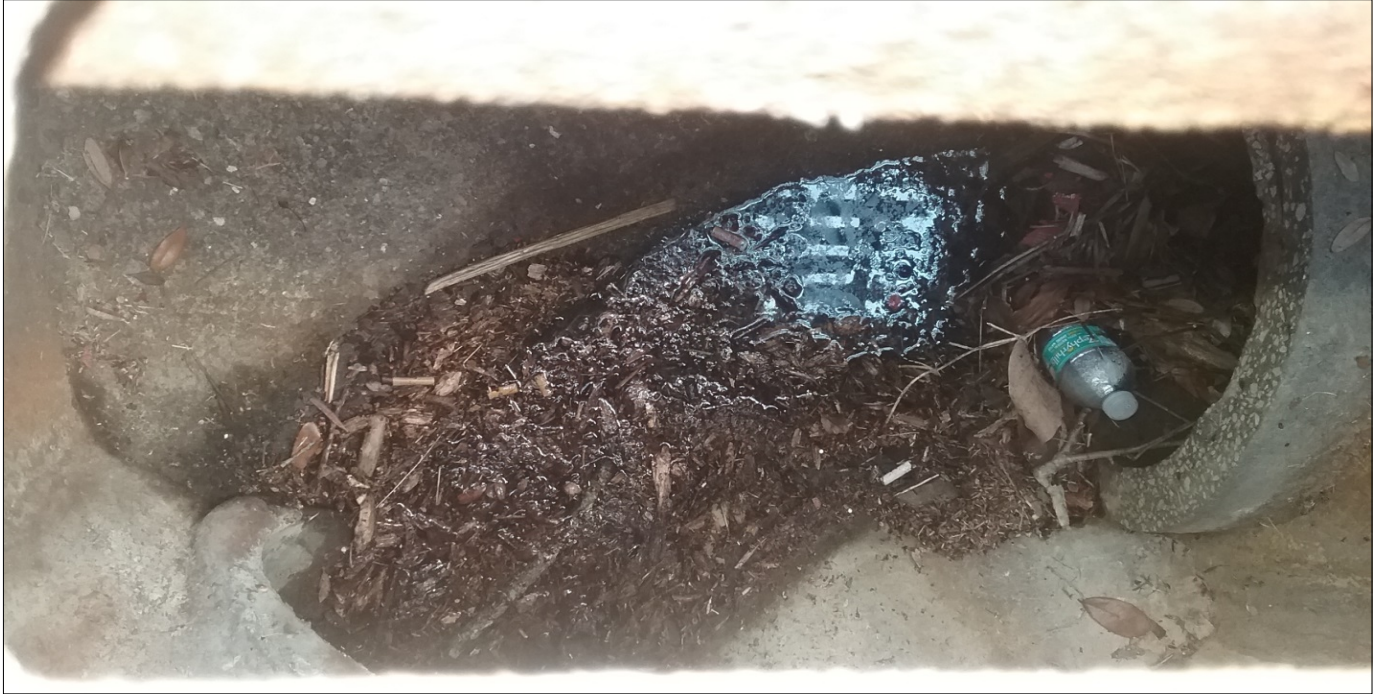
Inspector(s):	Date:	Photo Location	Photo Direction
M. Holland	12/7/2016	North side of Goldenrod St	N/A
Comments: (2N). Showing the north curb inlet on Goldenrod west of South Shade. Again and accumulation of sediment, leaves and trash (about 1-2 inches deep in a 15 inch round pipe). No musty/odd odors.

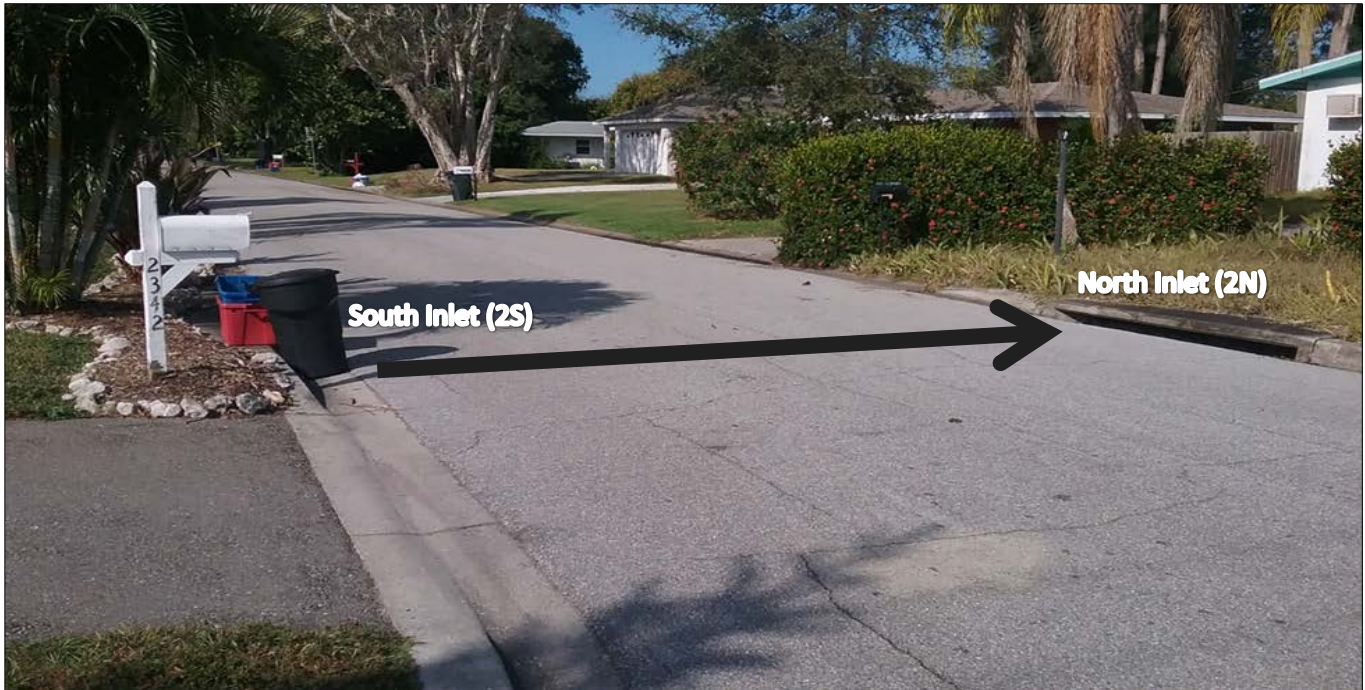
Inspector(s):	Date:	Photo Location	Photo Direction
M. Holland	12/7/2016	Goldenrod St and S. Shade	West
Comments: (2). Showing the north and south inlets on Goldenrod St. west of South Shade. Houses along this street are generally well maintained, but not overwhelmingly lush. Garbage cans present. Large arrow indicates pipe location and flow direction.

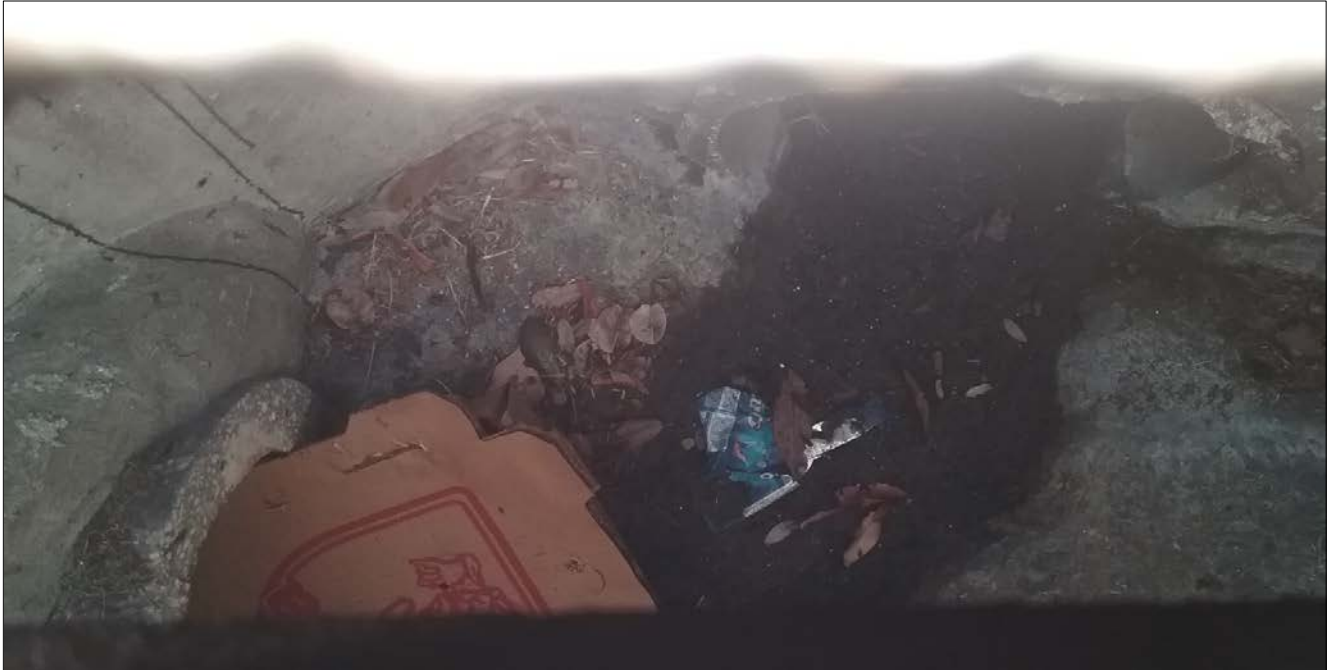
Inspector(s):	Date:	Photo Location	Photo Direction
M. Holland	12/7/2016	Rose Street West of S. Shade	N/A
Comments: (3N) Showing the north curb inlet on Rose Street West of South Shade. Inlet is relatively clear, with the exception of the pizza box. No musty/odd odors from the inlet.

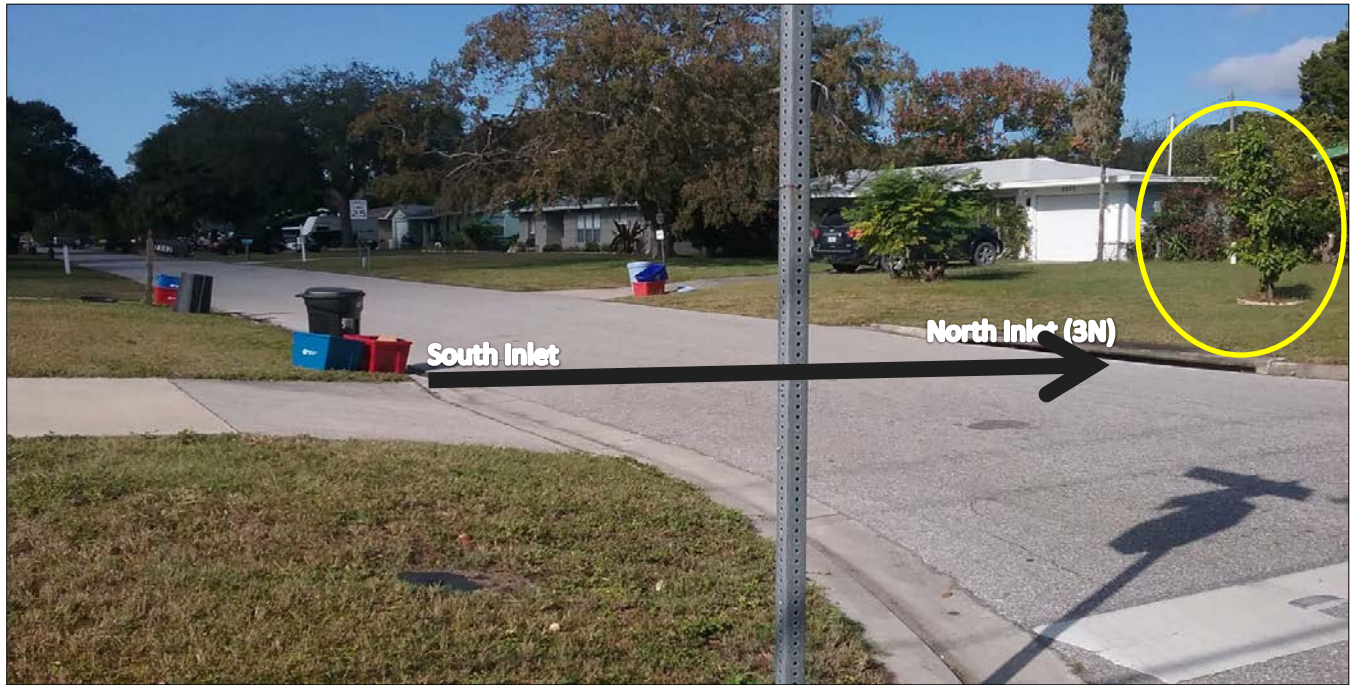
Inspector(s):	Date:	Photo Location	Photo Direction
M. Holland	12/7/2016	Rose and South Shade	West
Comments: (3) Showing the inlets on Rose Street, west of South Shade. Garbage cans present. Fruit tree directly north of the inlet to the right (highlighted in yellow), and pipe and flow directions indicated by the large arrow. Curb inlet on the south side was clean and unremarkable. No strange/musty odors from the inlets. Yards reasonably well maintained, no extremely lush yards (indicative of heavily fertilized) in the immediate area.

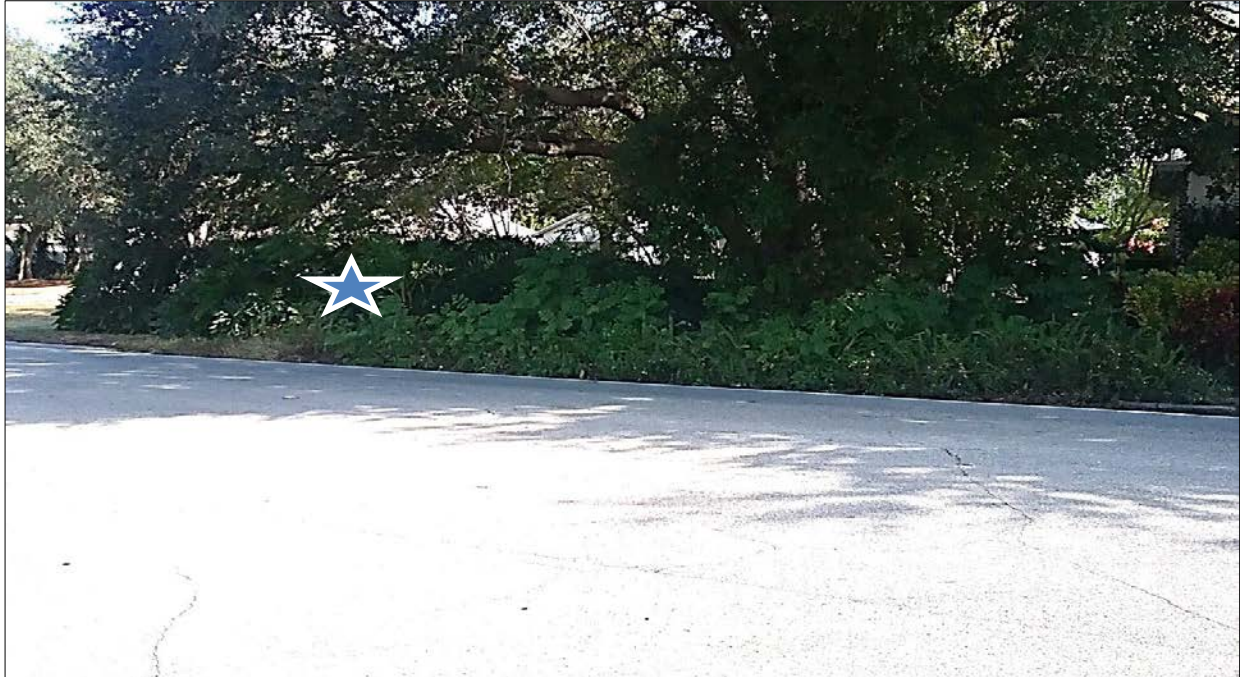
Inspector(s):	Date:	Photo Location	Photo Direction
M. Holland	12/7/2016	S. Shade and Rose St	East
<p>Comments: (4) Location of a structure that receives flow from a curb and gutter system from the south and, a drainage ditch from the east. Approximate location of the located structure indicated by the star. It was several feet east of the road, hidden in the vegetation. There was several inches of decaying vegetation on the grate that had to be removed to look inside the structure.</p>

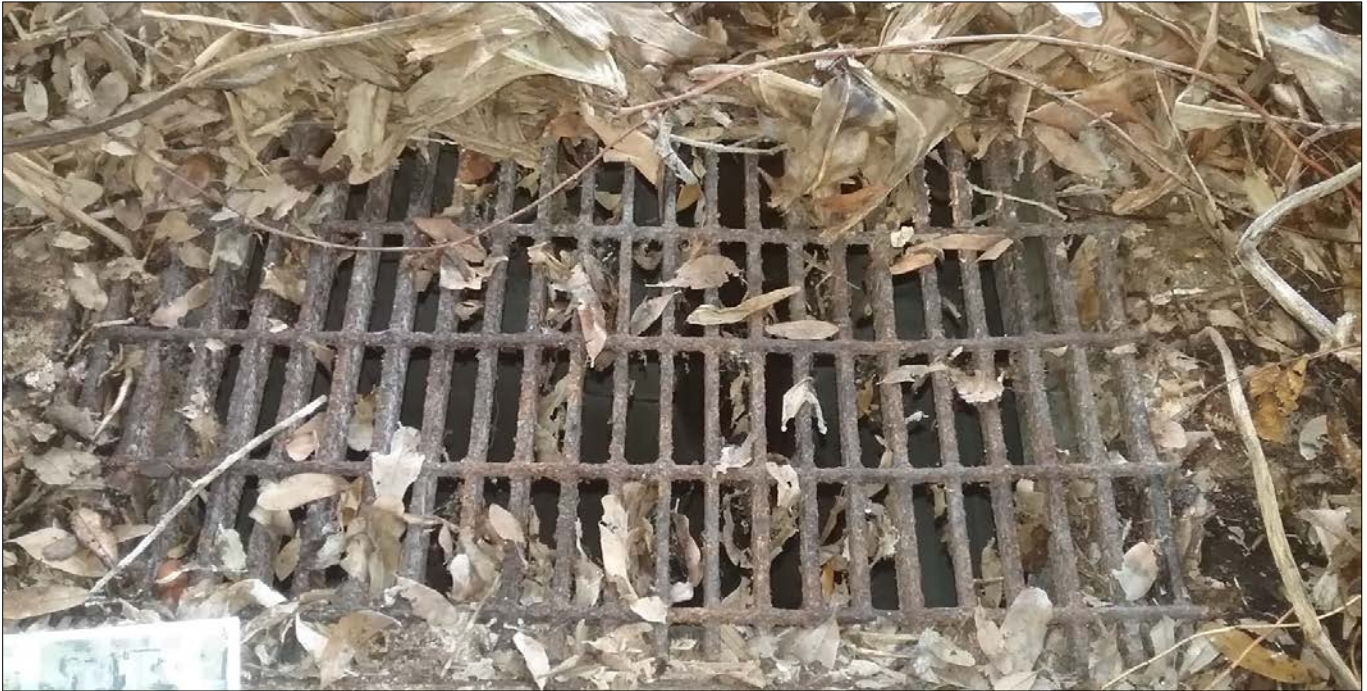
Inspector(s):	Date:	Photo Location	Photo Direction
M. Holland	12/7/2016	Rose and S. Shade	N/A
<p>Comments: (4). Found the structure. The grate was covered by a few inches of decaying vegetation. Water was discharging into this structure, but it was not determined if it was coming from the east drainage ditch or from the curb and gutter system from the west. The only way this structure was found was one could hear water spilling in to the bottom of the structure. Warm, moist air was coming up through the grate. This warm moist air could have been a result of water (warmed from the air or sun) coming from the ditch to the east, or irrigation/stormwater warmed from contact with the pavement, and exposure to the environment.</p>

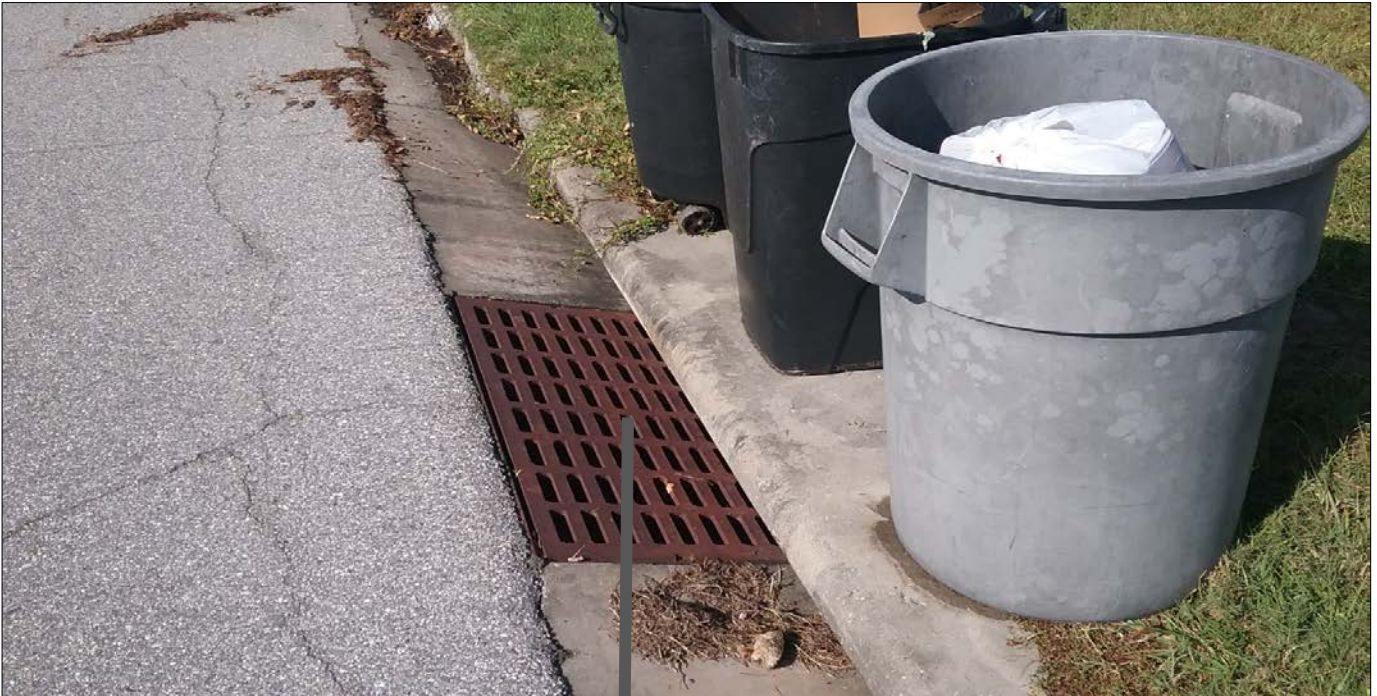
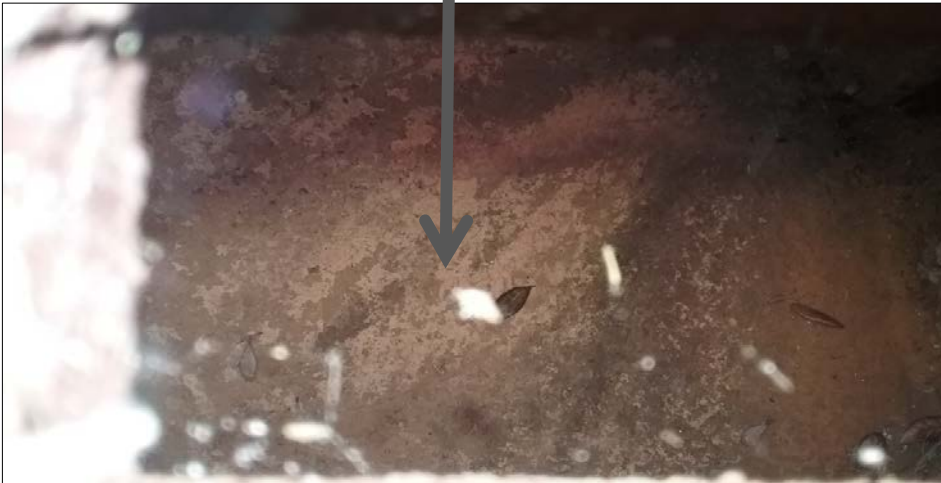
Comments: Showing the curb inlet on the north side of the road. Trash cans stacked for trash day right above the inlet. Homes on this street are maintained but not overly so. The inlet was clean and dry, with no strange/musty odors coming from the inlet.

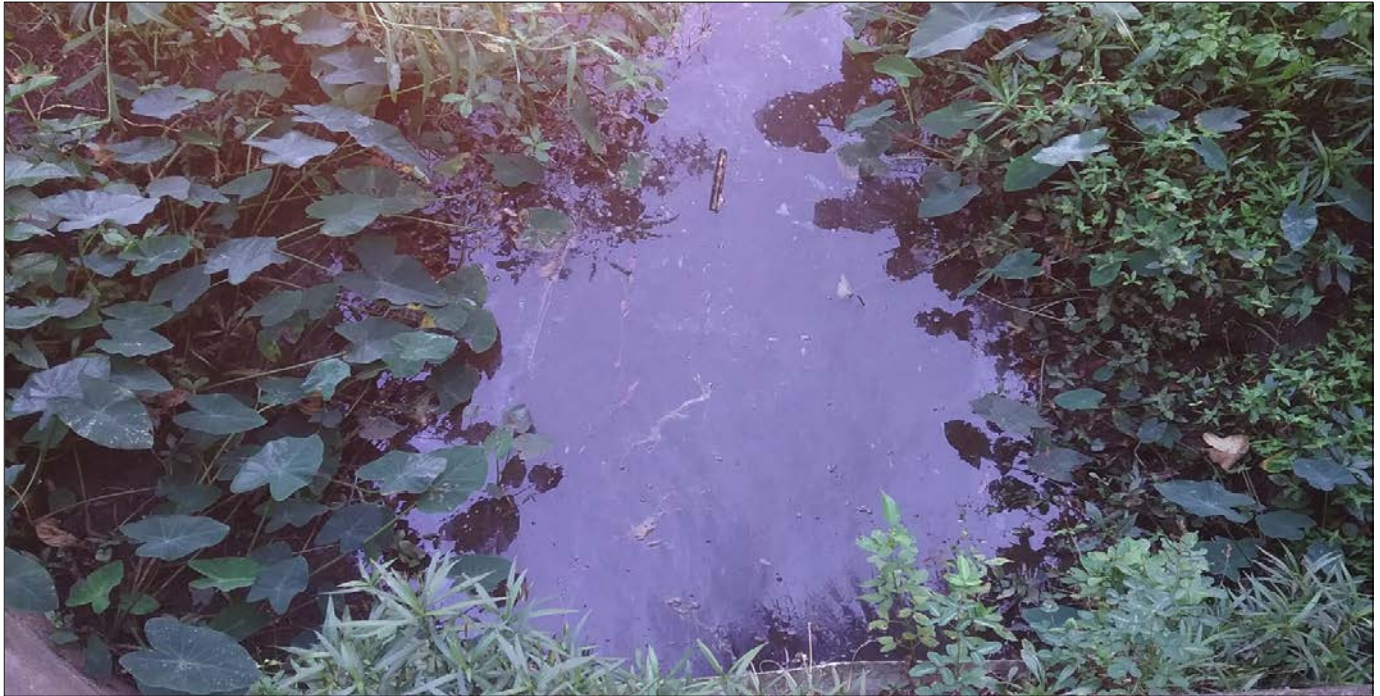
Inspector(s):	Date:	Photo Location	Photo Direction
M. Holland	12/7/2016	Discharge at Grove St	North
Comments: (1*)Water still discharging at the pipe, despite minimal rain. Water could be from irrigation runoff from the yards, but no standing water in gutter along the roads were seen. Access to the stormwater pipes was not available. The manhole covers were in the road, so traffic would have to be maintained to view those access points.
